**PRE-DEMOLITION  
HAZARDOUS BUILDING MATERIALS ASSESSMENT  
FORMER CONSTRUCTION CAMP SITES  
BAY D'ESPOIR – AVALON TRANSMISSION LINE (TL202/TL206)  
NEWFOUNDLAND AND LABRADOR**

**Newfoundland and Labrador Hydro,  
a Nalcor Energy Company**  
Hydro Place, 500 Columbus Drive  
PO Box 12400  
St. John's, NL A1B 4K7

April 2019

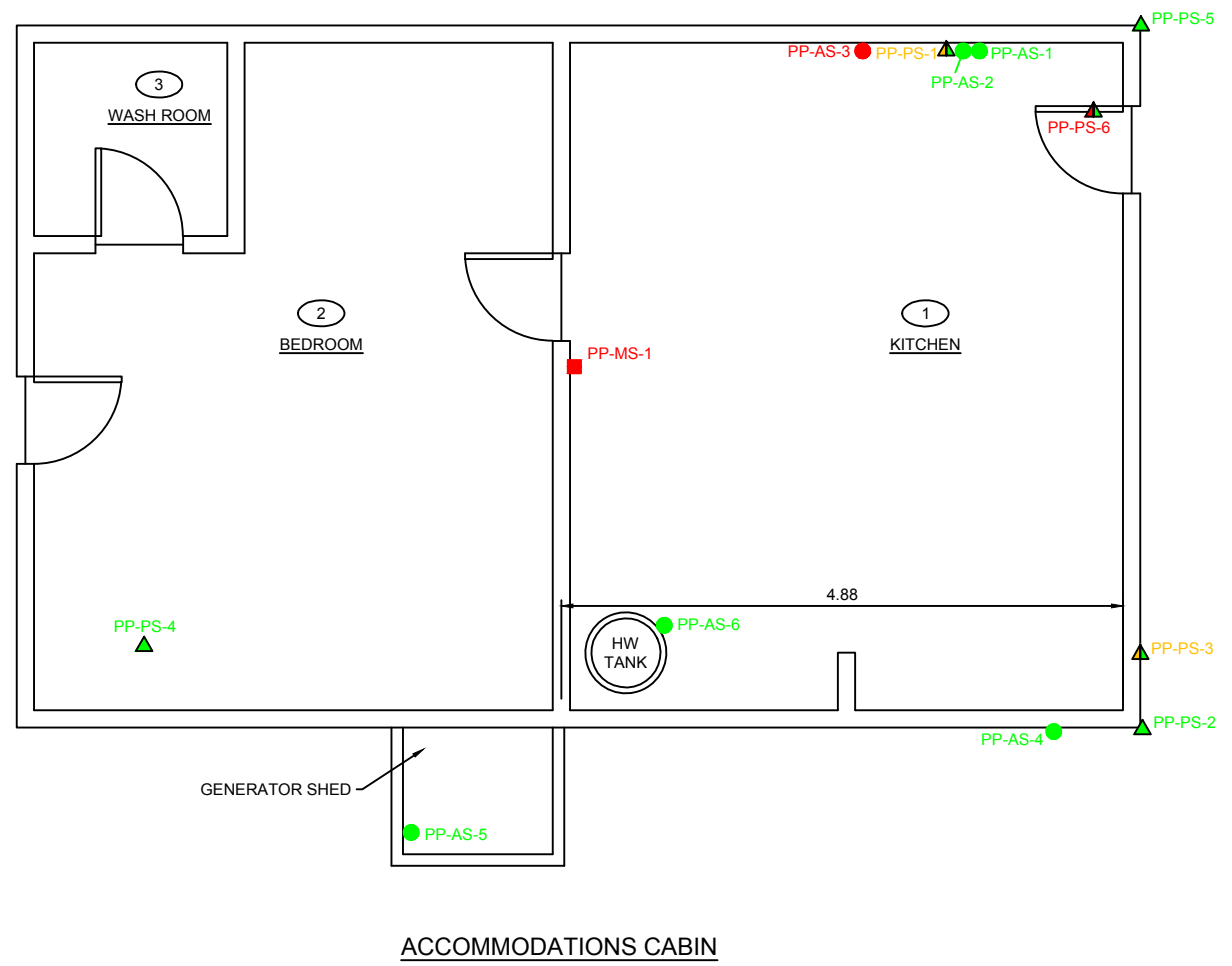
Figure No.  
 3.1

- ASBESTOS SAMPLE LOCATION - ASBESTOS NOT DETECTED
- ASBESTOS SAMPLE LOCATION - RESULTS > 1% FOR ASBESTOS
- ▲ PAINT SAMPLE LOCATION - NO CRITERIA EXCEEDANCES FOR LEAD OR MERCURY OR PCBs WHERE APPLICABLE
- ▲ PAINT SAMPLE LOCATION - RESULTS EXCEED 90 mg/kg AND LESS THAN 5000 mg/kg FOR LEAD AND NO CRITERIA EXCEEDANCES FOR MERCURY OR PCBs WHERE APPLICABLE
- ▲ PAINT SAMPLE LOCATION - RESULTS EXCEED 5000 mg/kg FOR LEAD AND NO CRITERIA EXCEEDANCES FOR MERCURY OR PCBs WHERE APPLICABLE
- ABUNDANT MOULD GROWTH DETECTED
- Ⓣ TREATED WOOD SAMPLE LOCATION - NO CRITERIA EXCEEDANCES

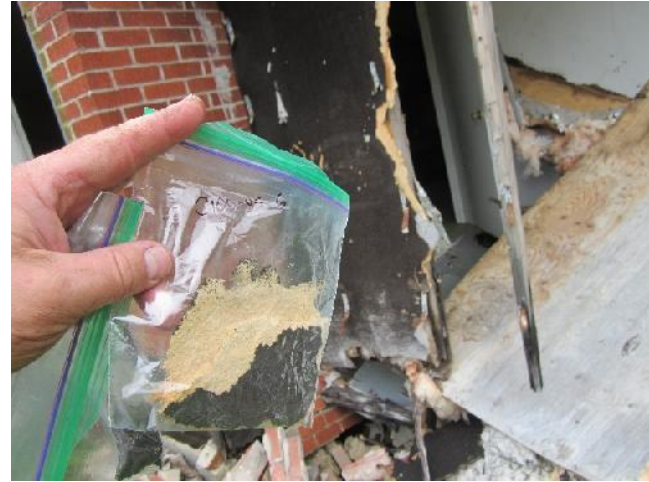
Photo 18: View of bulk material sample C100-PP-AS-6, black pressed board, outhouse exterior.
