NEWFOUNDLAND AND LABRADOR HYDRO

PRE-DEMOLITION HBMA, FORMER CONSTRUCTION  
CAMP SITES, TL228, NL

MARCH 15, 2023

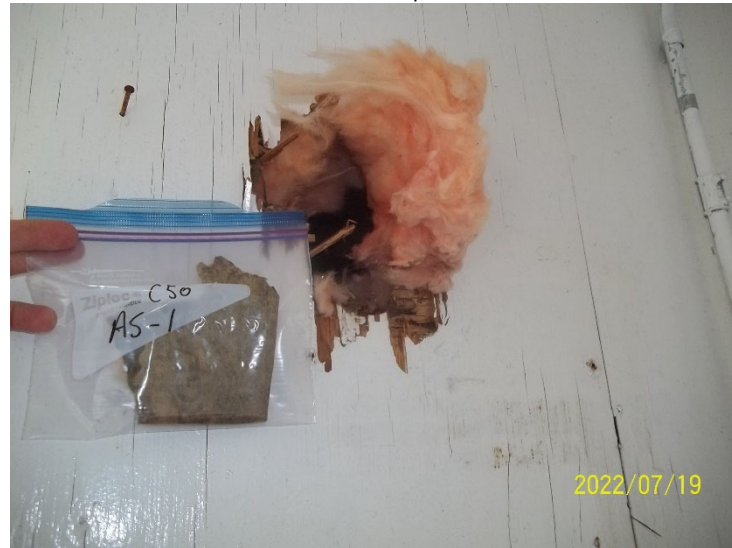
Photo 12: View of bulk material sample C50 AS-1, tar paper, cabin interior.

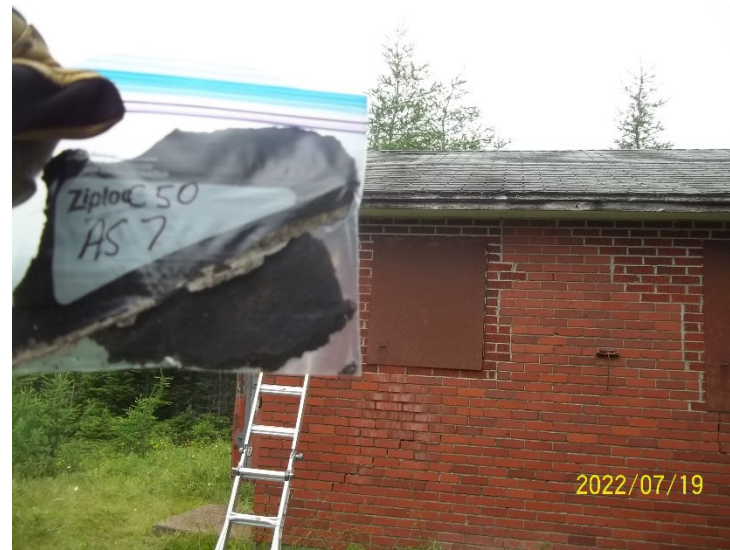
Photo 18: View of bulk material sample C50 AS-7, shingle and tar paper, cabin exterior.

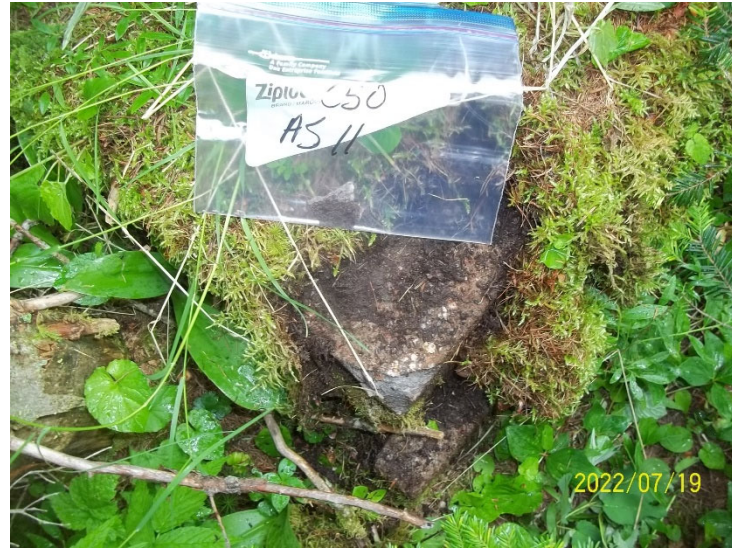
Photo 22: View of bulk material sample C50 AS-11, concrete, outhouse exterior.

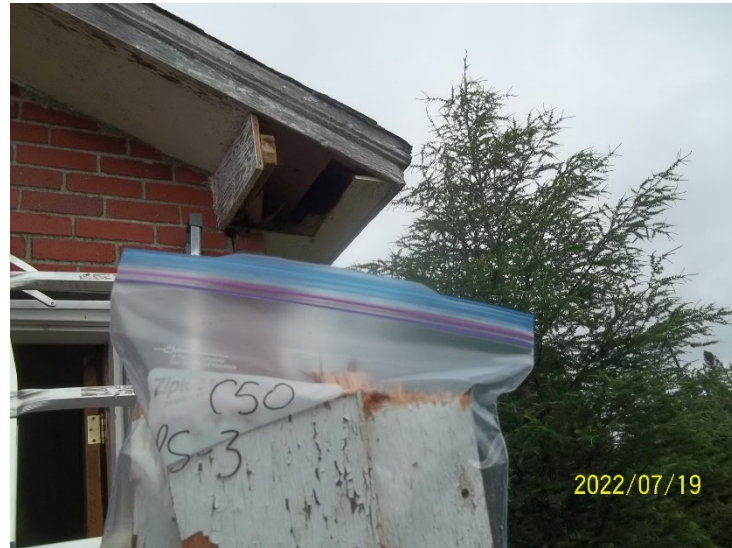
Photo 24: View of paint sample C5 PS-3, roof, cabin exterior.

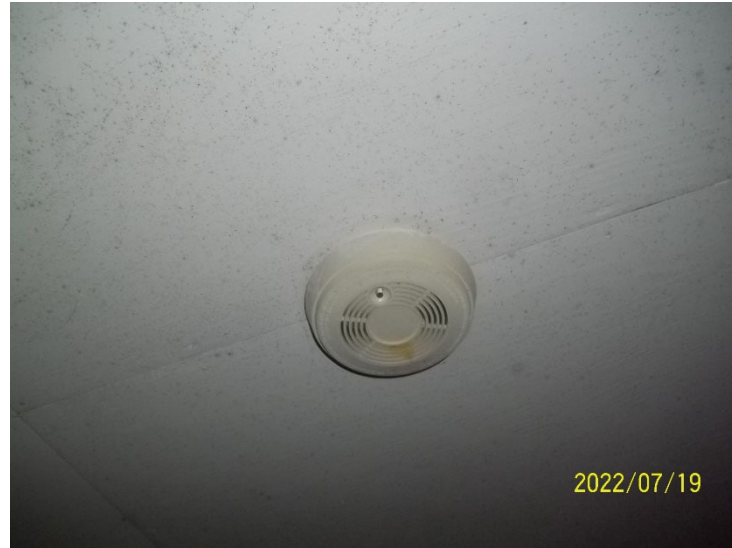
Photo 26: View of smoke detector inside the accomodations cabin.

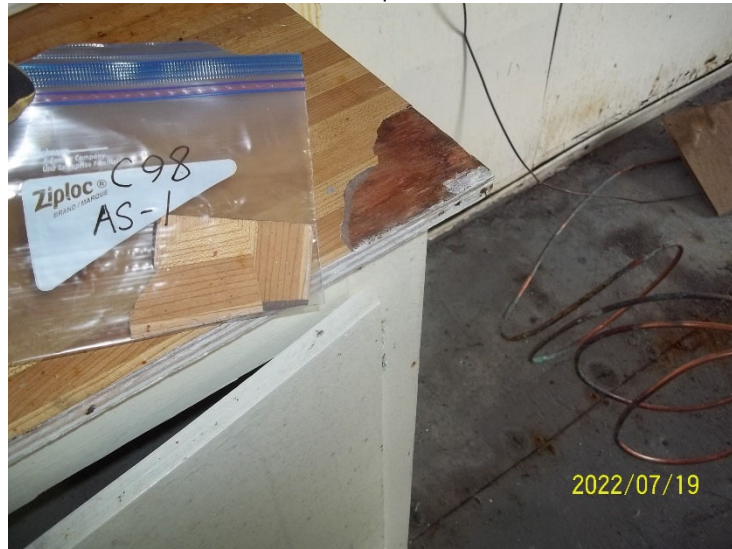
Photo 12: View of bulk material sample C98 AS-1, countertop mastic, cabin interior.

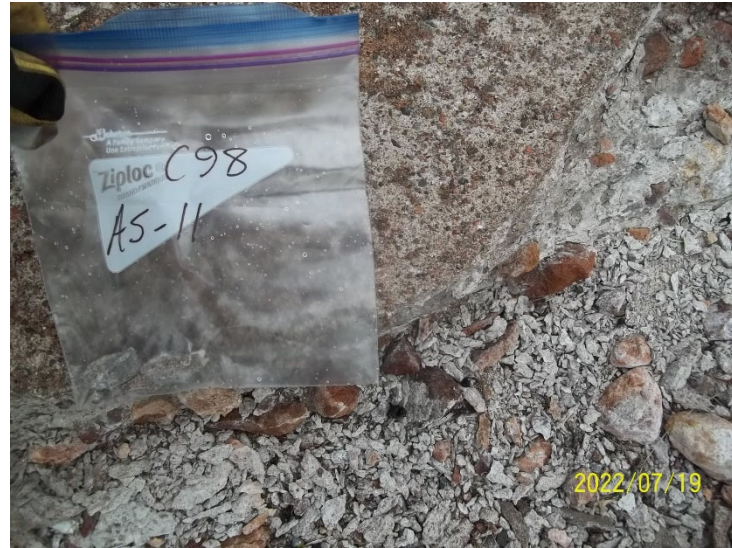
Photo 22: View of bulk material sample C98 AS-11, concrete, outhouse exterior.

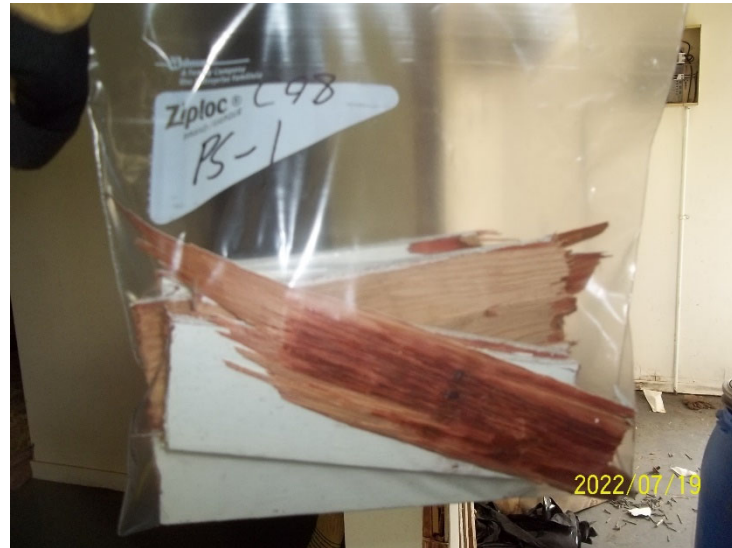
Photo 24: View of paint sample C98 PS-1, wall, cabin interior.

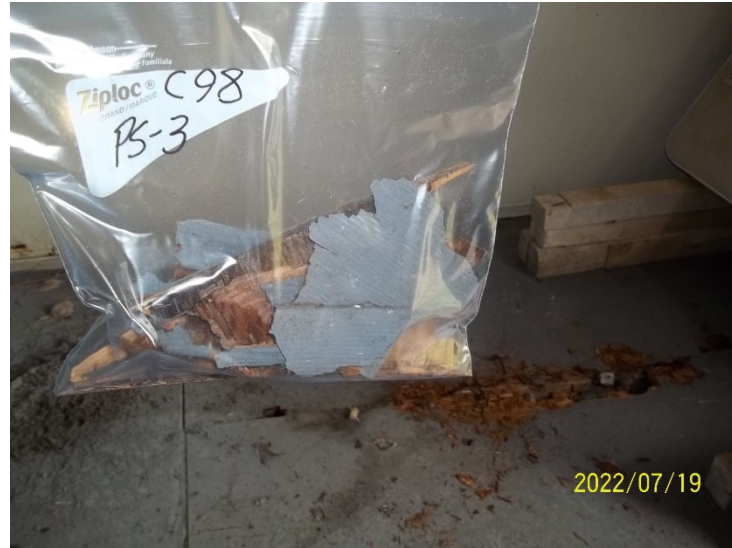
Photo 26: View of paint sample C98 PS-3, floor, cabin interior.

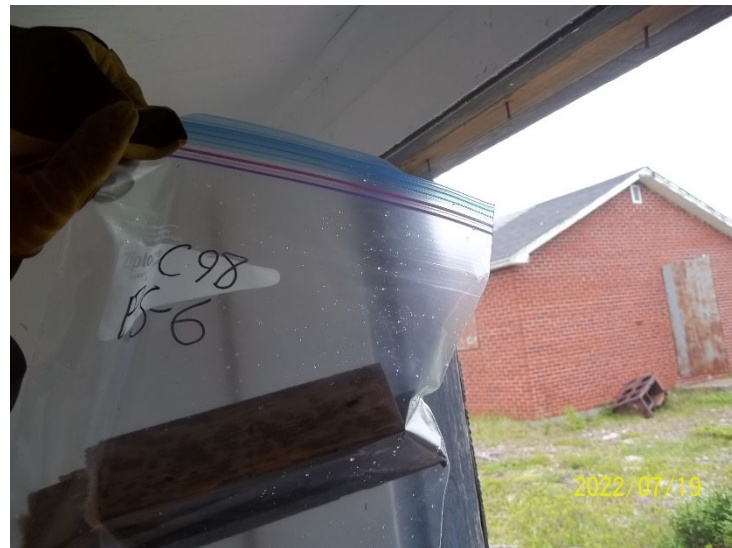
Photo 28: View of paint sample C98 PS-6, wall, outhouse interior.

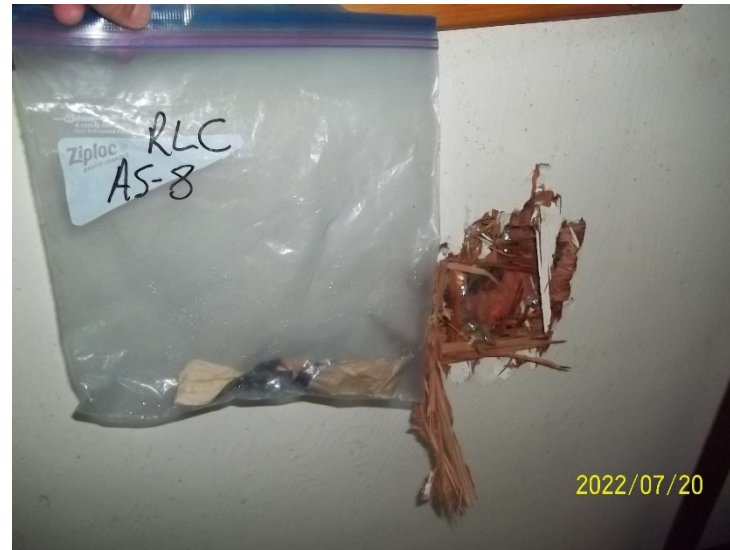
Photo 14: View of bulk material sample RLC AS-8, foil paper, cabin exterior.

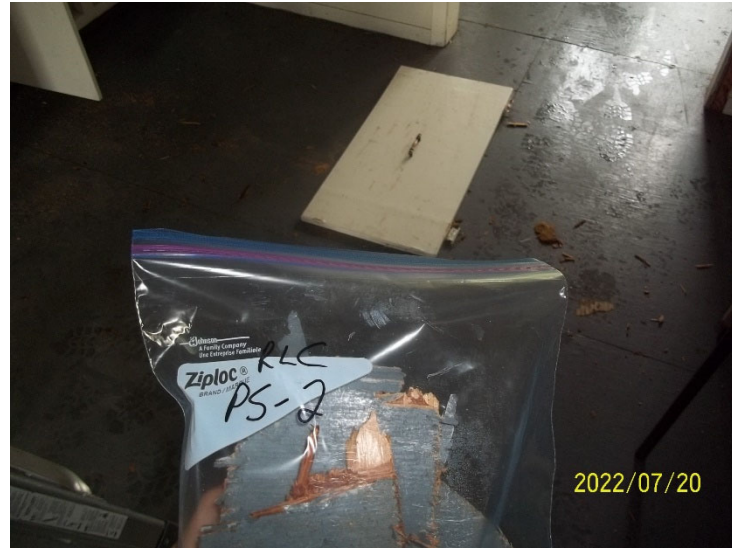
Photo 18: View of paint sample RLC PS-2, floor, cabin interior.

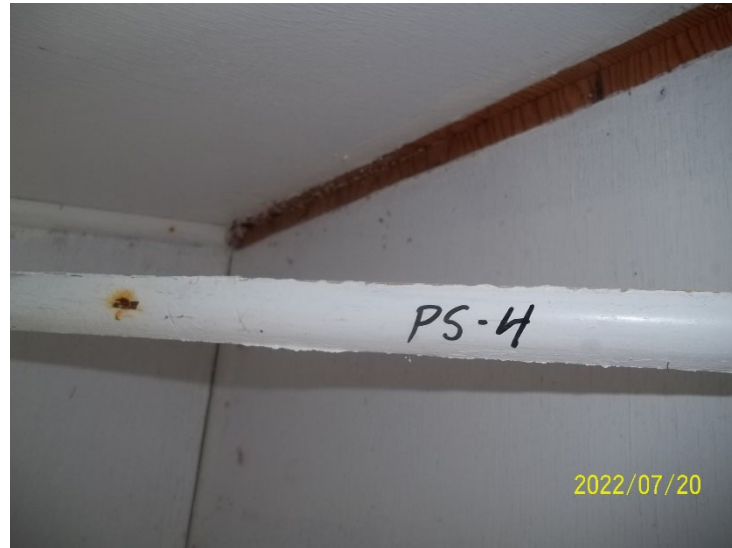
Photo 20: View of paint sample RLC PS-4, trim, outhouse interior.

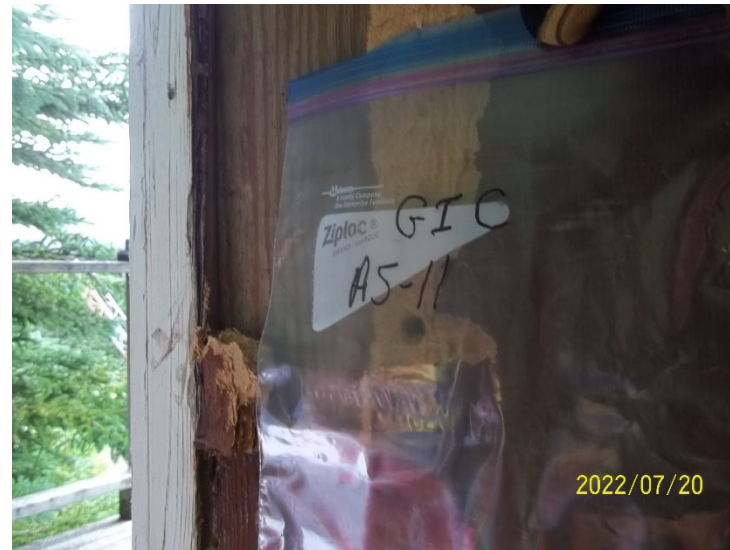
Photo 22: View of bulk material sample GIC AS-11, caulking, cabin exterior.

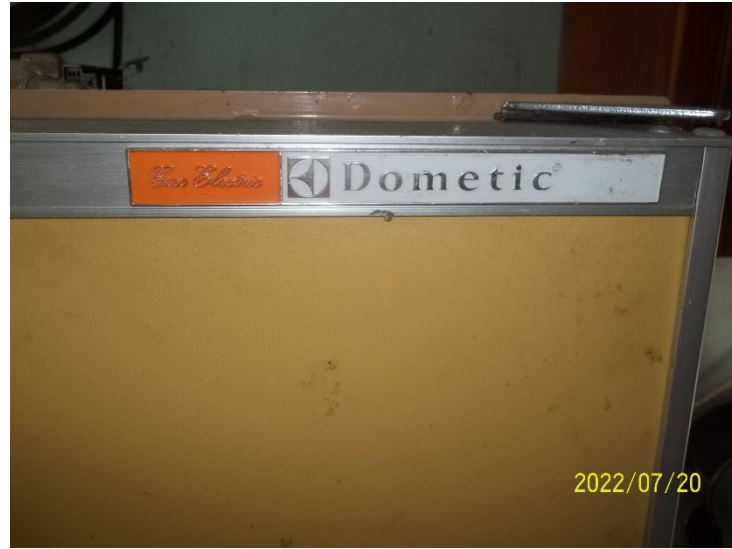
Photo 34: View of refrigerator located on the interior of the accommodations cabin.
