Your Inspection Report

123 Main Street
Any Town, MB X1X 1X1

INSPECTION DATE:
Thursday, May 25, 2017

RE: Report No. 1005, v.0
123 Main Street
Any Town, MB
X1X 1X1

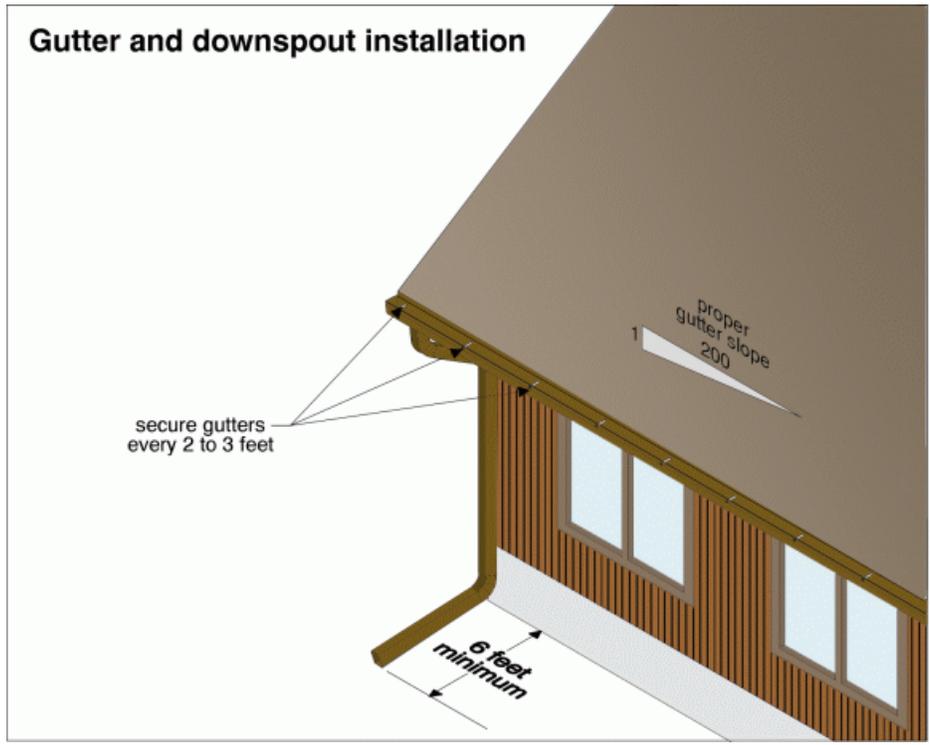
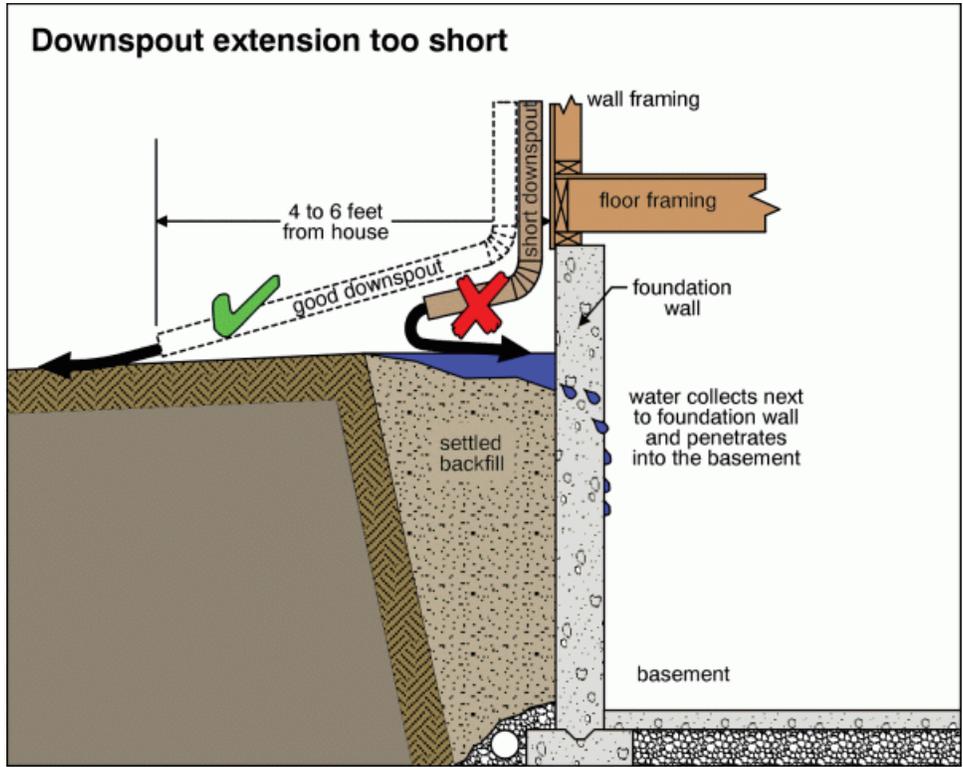
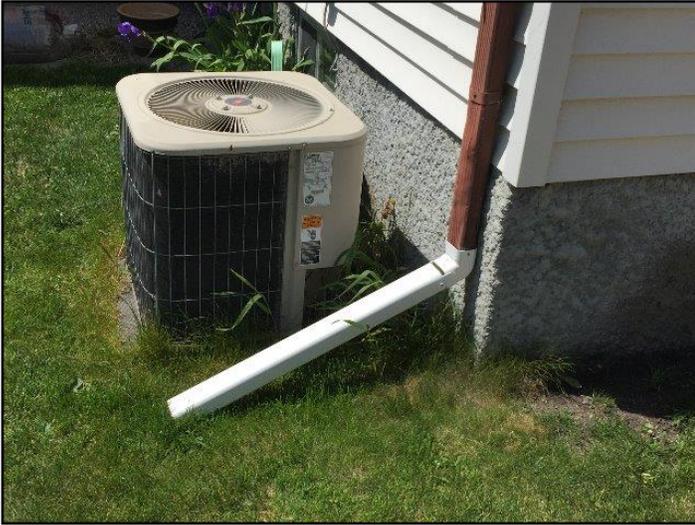
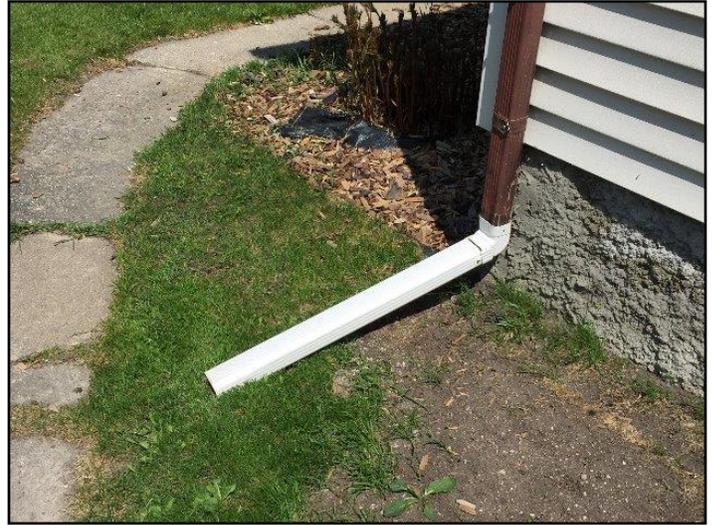
1. **Condition:** • [Downspouts end too close to building](#)

Implication(s): Chance of water damage to contents, finishes and/or structure

Location: Various Exterior

Downspout extension too short

2. Downspouts end too close to building

3. Downspouts end too close to building

Task: Improve

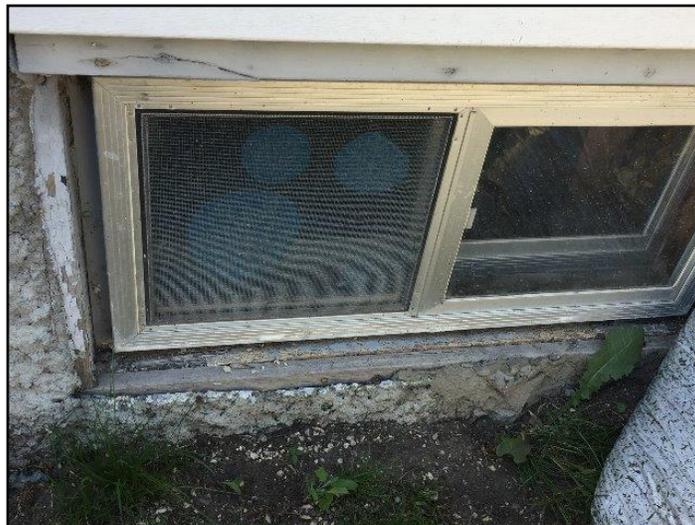
2. Condition: • [Caulking loose, missing or deteriorated](#)

Implication(s): Chance of water damage to contents, finishes and/or structure | Increased heating and cooling costs

Location: South/East Exterior

4. Caulking loose, missing or deteriorated

Task: Improve

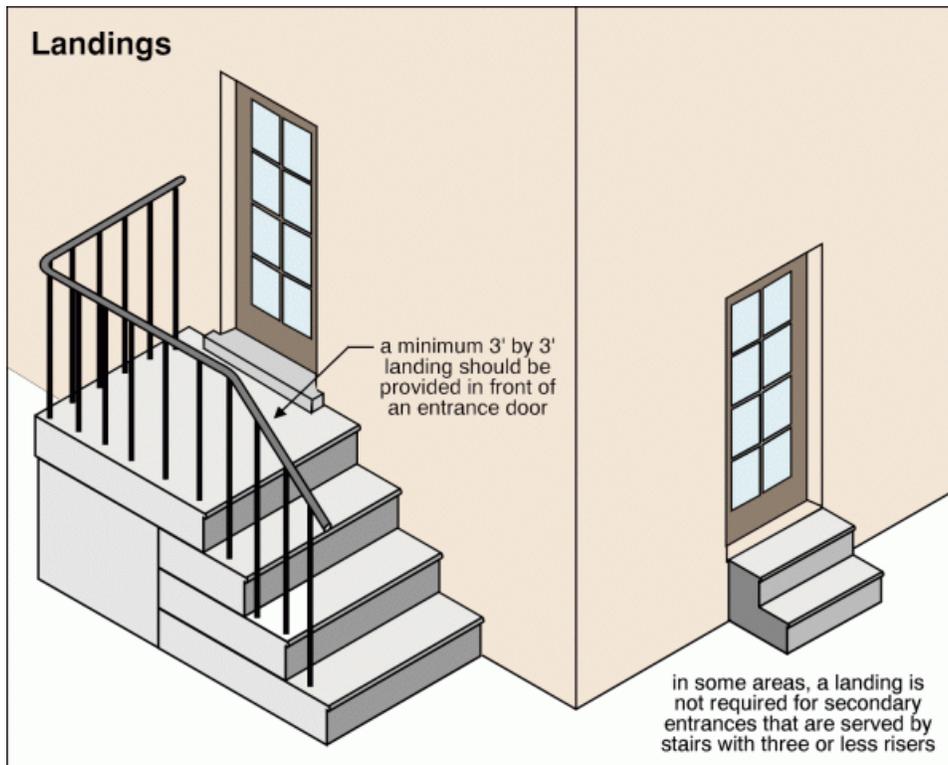
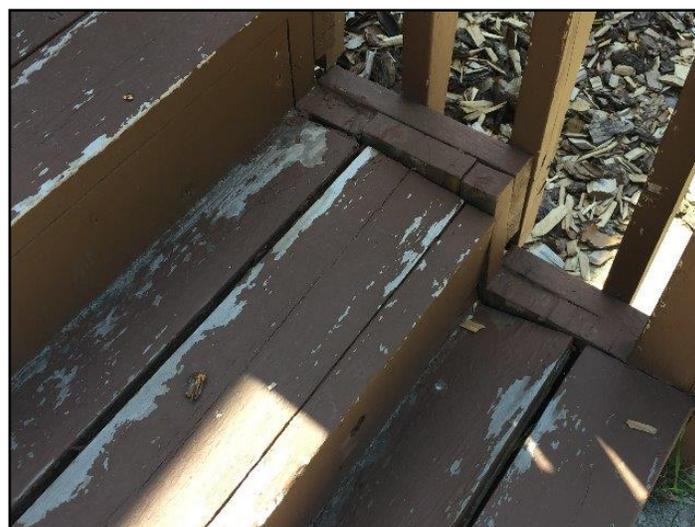
4. Condition: • [Steps slope](#)

Implication(s): Trip or fall hazard

Location: North Exterior

5. Steps slope

Task: Repair

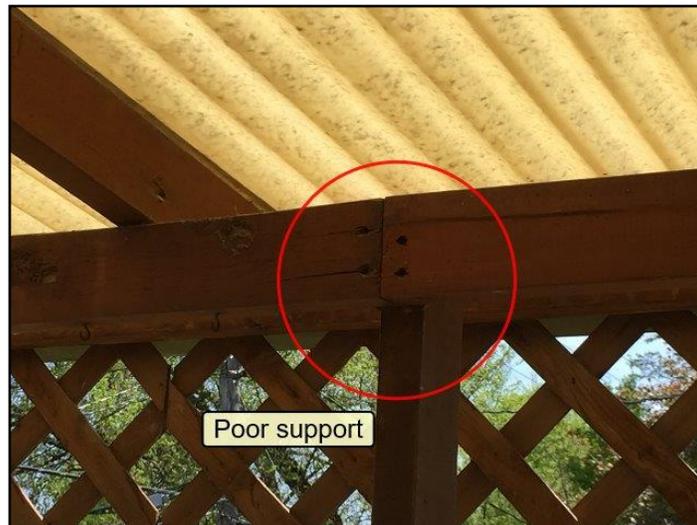
6.

5. Condition: • Roof is poorly supported over deck

Implication(s): Roof could collapse under load, resulting in damage to structure and possible personal injury.

Location: Rear Deck

Task: Improve

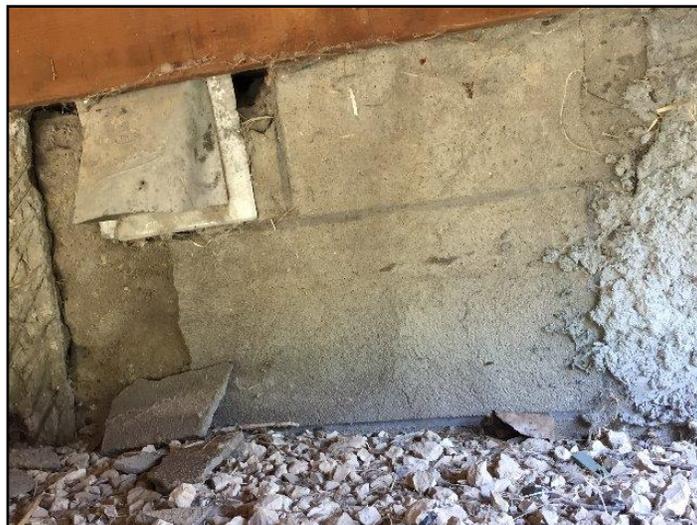
- 6. Condition:** • [Parging damaged or missing](#)
- Implication(s):** Chance of damage to structure | Shortened life expectancy of material
- Location:** South Exterior Wall
- Task:** Repair
- Time:** Less than 1 year

7. Parging damaged or missing

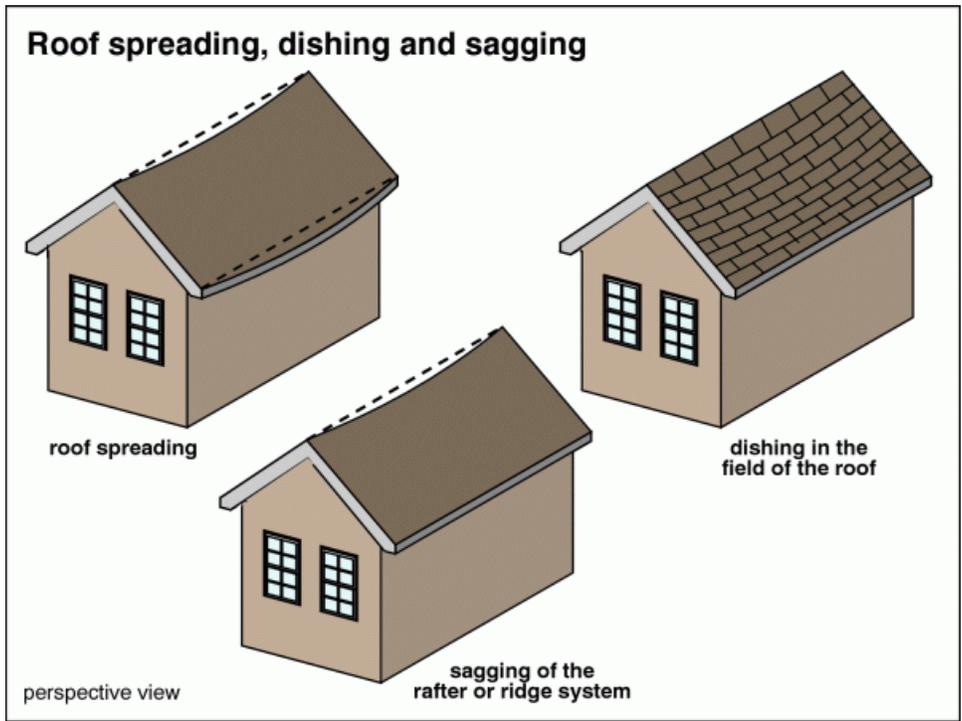
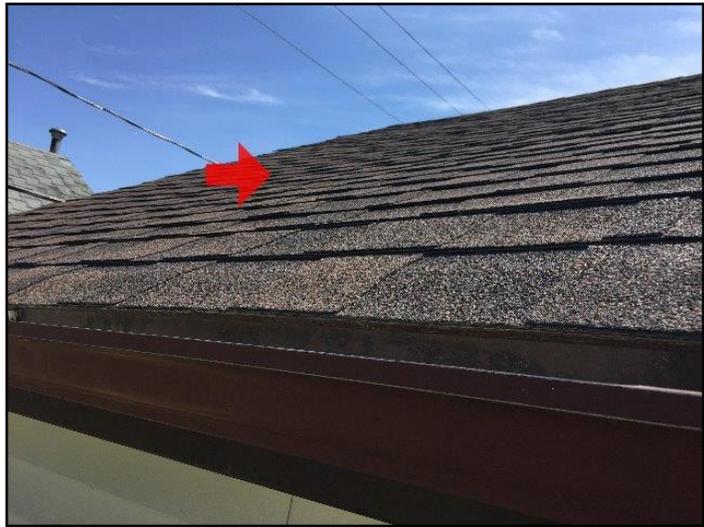
Minor sagging was noted on both sides of the roof.

- 7. Condition:** • [Sagging](#)
- Minor sagging was noted on both sides of the roof.
- Implication(s):** Weakened structure | Chance of structural movement
- Location:** Various Roof
- Task:** Further evaluation by a qualified contractor

8. Sagging

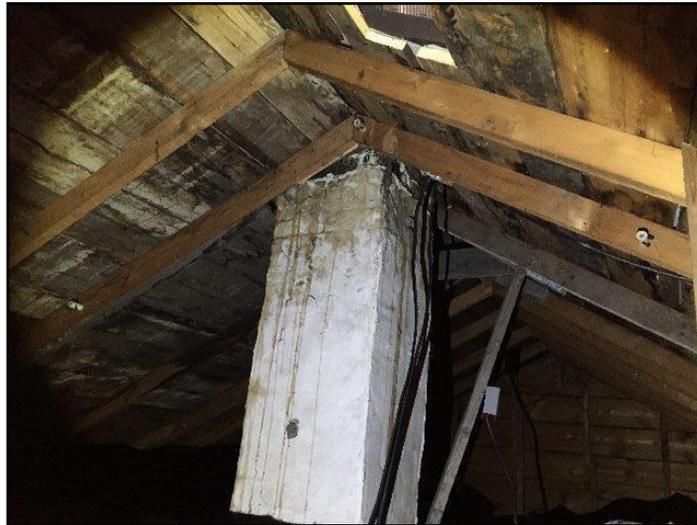
8. Condition: • [Water stains](#)

Water staining may be the result of previous roof leakage. Such widespread staining may also be caused from condensation building up in the attic as a result of poor ventilation and inadequate insulation in the attic space.

Implication(s): Material deterioration

Location: Throughout Attic

9. *Water stains*

Task: Monitor

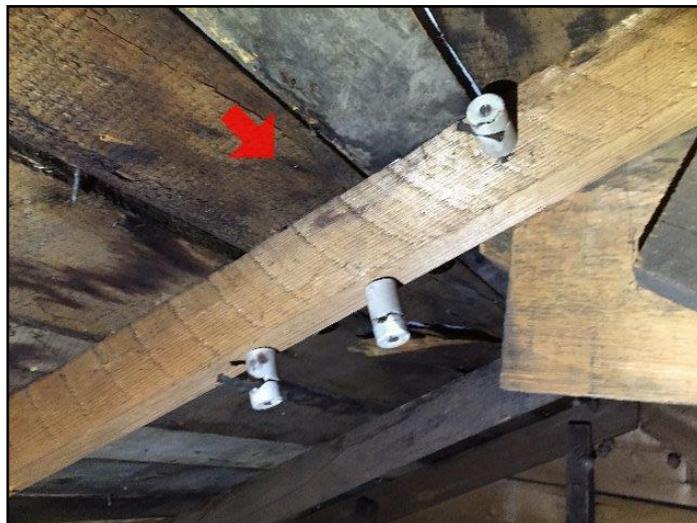
All visible signs of knob and tube wiring show that it has been taken out of service and removed.

11. Copper - knob and tube

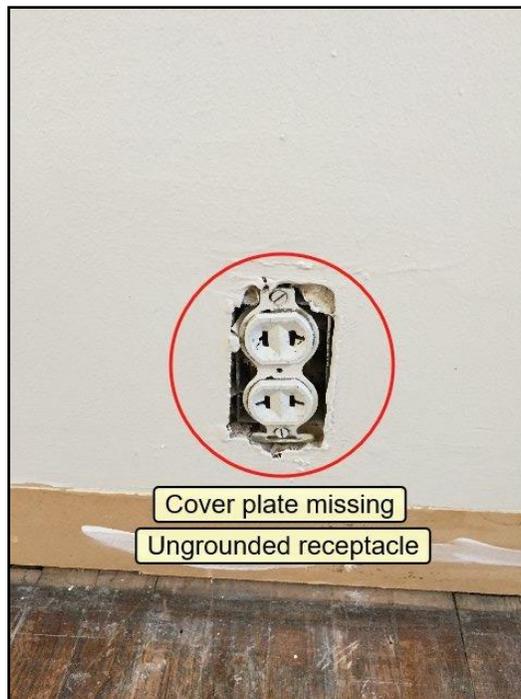
9. Condition: • [Ungrounded](#)

Implication(s): Electric shock

Location: Various

12. Ungrounded

Task: Improve

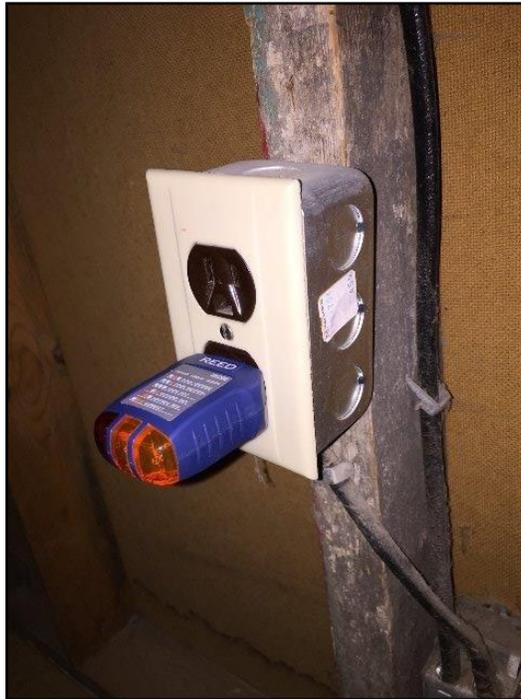
10. Condition: • [Ground needed for 3-slot outlet](#)

Implication(s): Electric shock

Location: North Basement Furnace Room

13. Ground needed for 3-slot outlet

Task: Improve

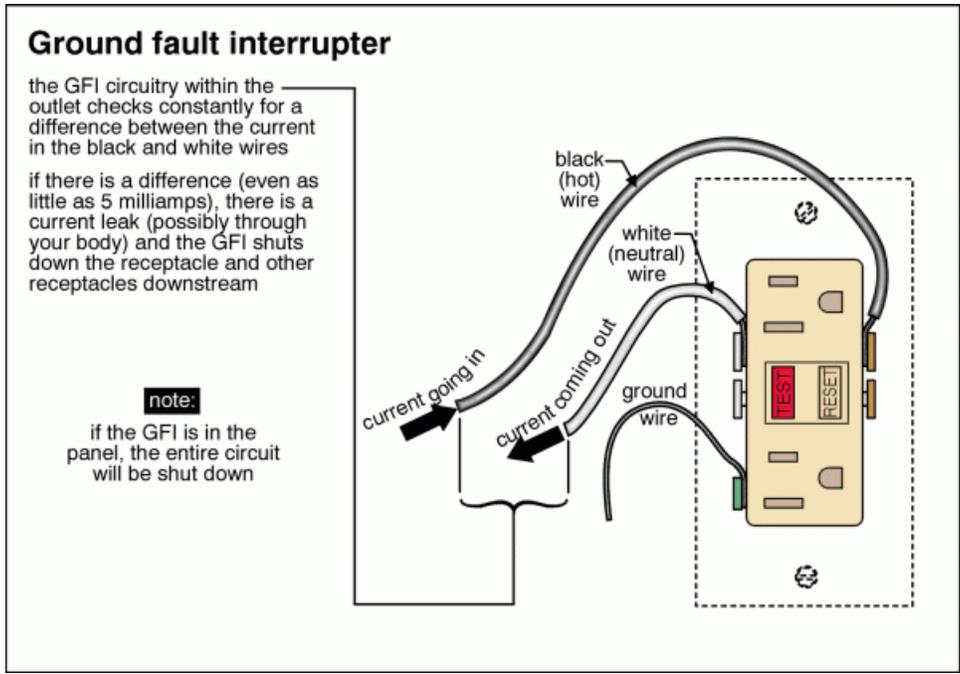
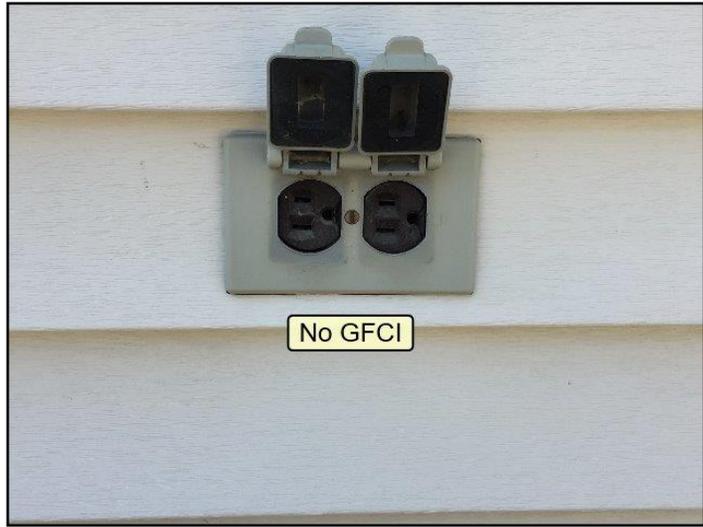
11. Condition: • [No GFCI/GFI \(Ground Fault Circuit Interrupter\)](#)

Implication(s): Electric shock

Location: East Exterior Wall

14. No GFCI/GFI (Ground Fault Circuit...

Task: Provide

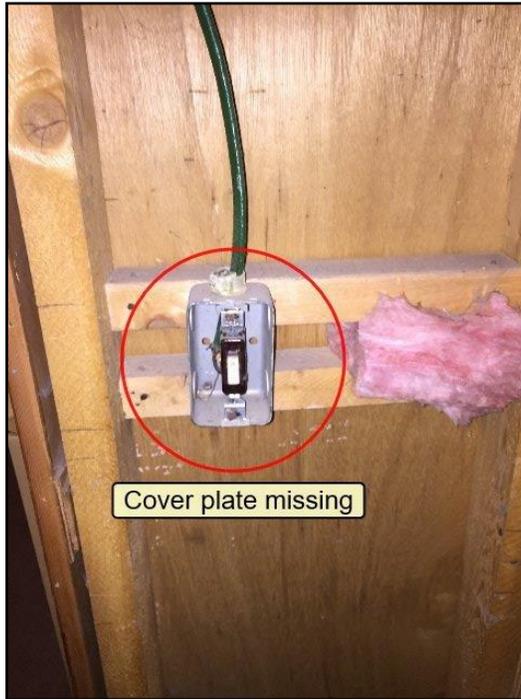
13. Condition: • [Missing](#)

Implication(s): Electric shock

Location: Basement Cold Room

15. Missing

Task: Replace

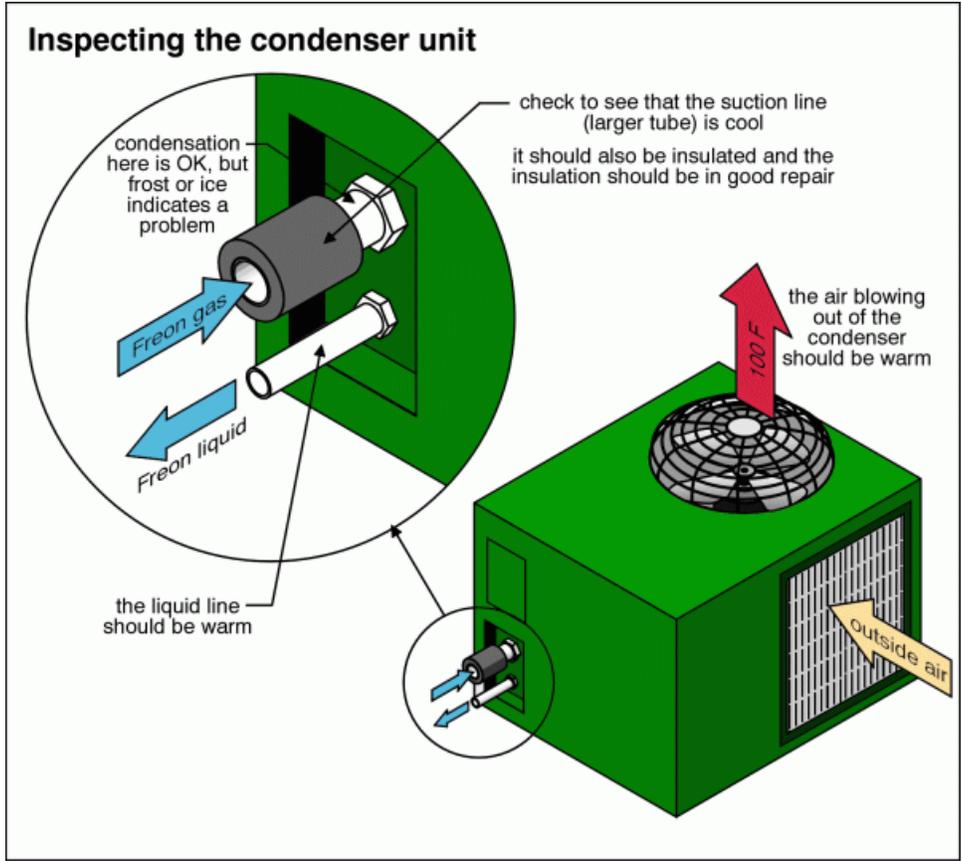
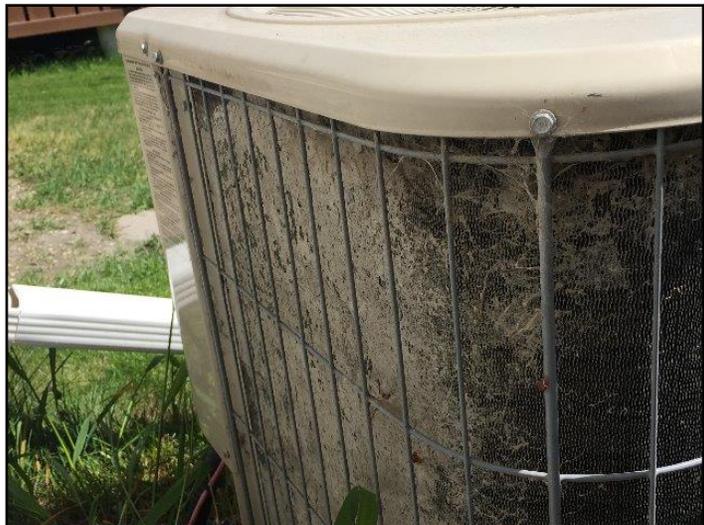
- 17. **Condition:** • [Dirty](#)
- Implication(s):** Reduced system life expectancy | Increased cooling costs | Reduced comfort

Location: South Exterior
Task: Clean
Time: Regular maintenance

18. Dirty

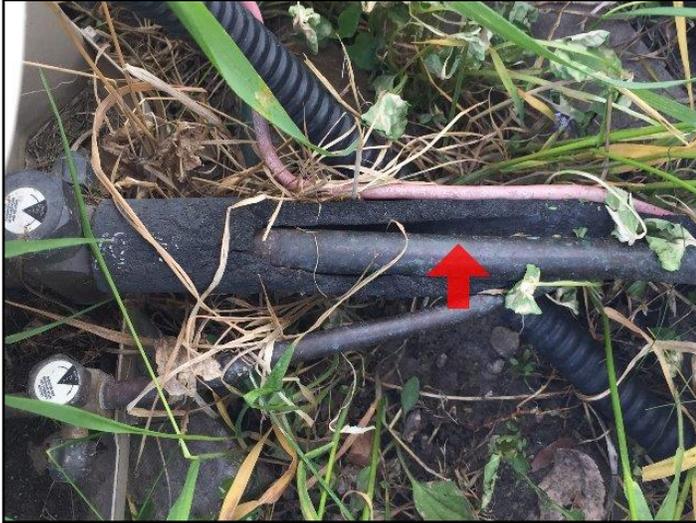
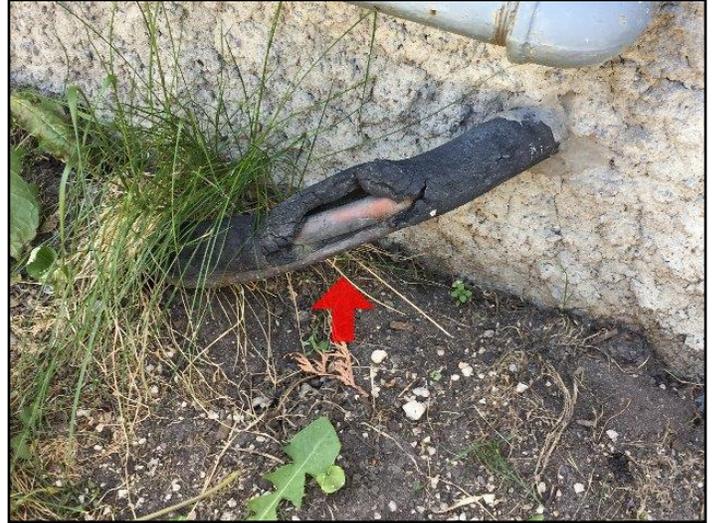
18. Condition: • Insulation missing/damaged

Task: Repair

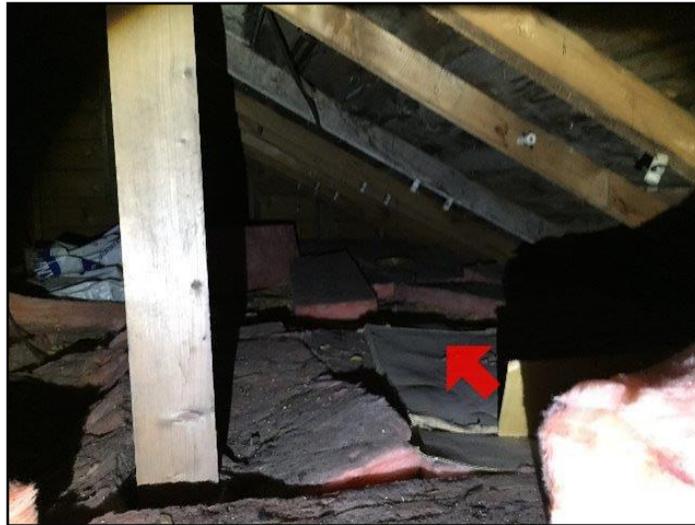
20. Condition: • [Gaps or voids](#)
Implication(s): Increased heating and cooling costs | Reduced comfort
Location: Throughout Attic
Task: Improve
Time: Less than 1 year

21. Gaps or voids

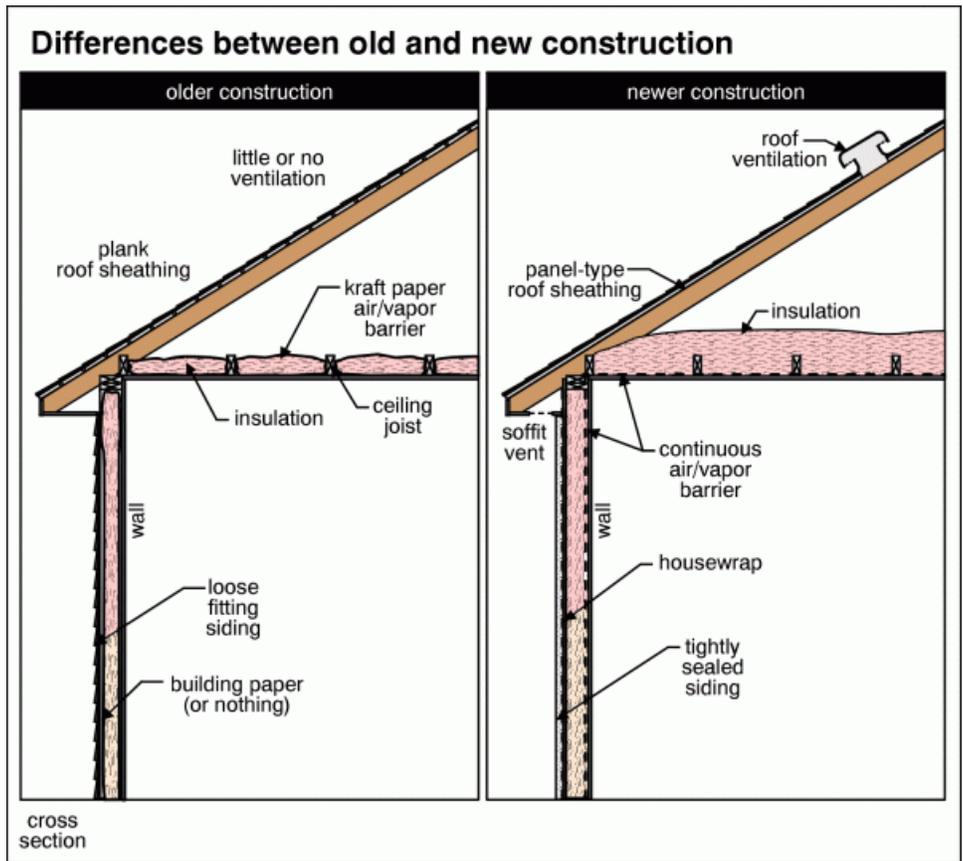
21. Condition: • [Missing](#)

Implication(s): Chance of condensation damage to finishes and/or structure | Increased heating and cooling costs | Reduced comfort

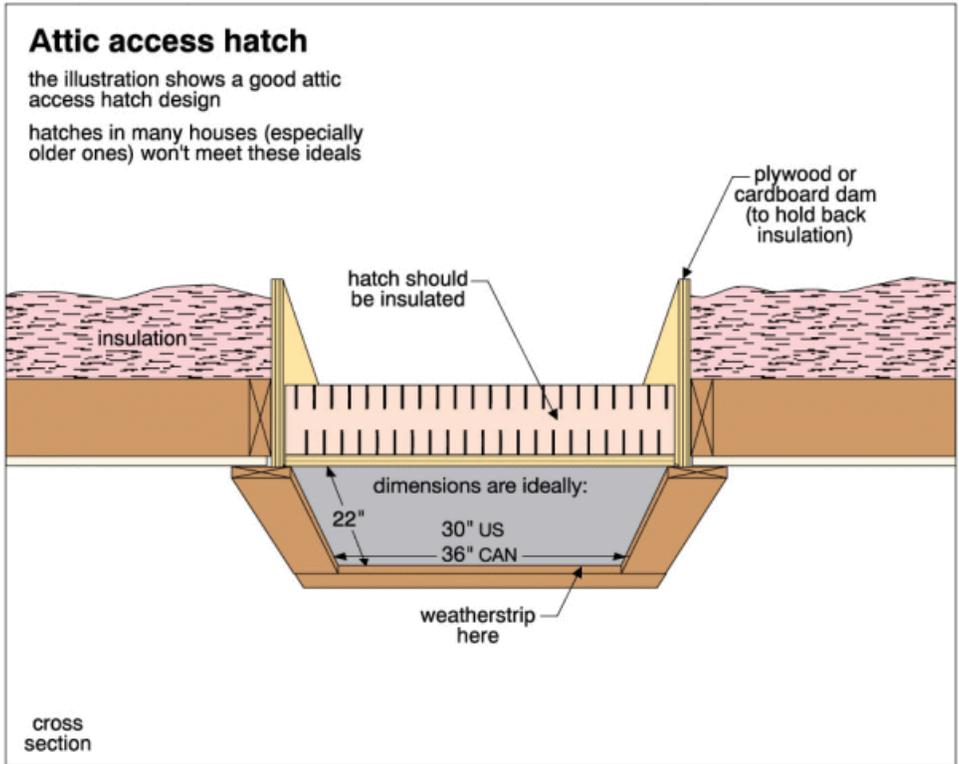
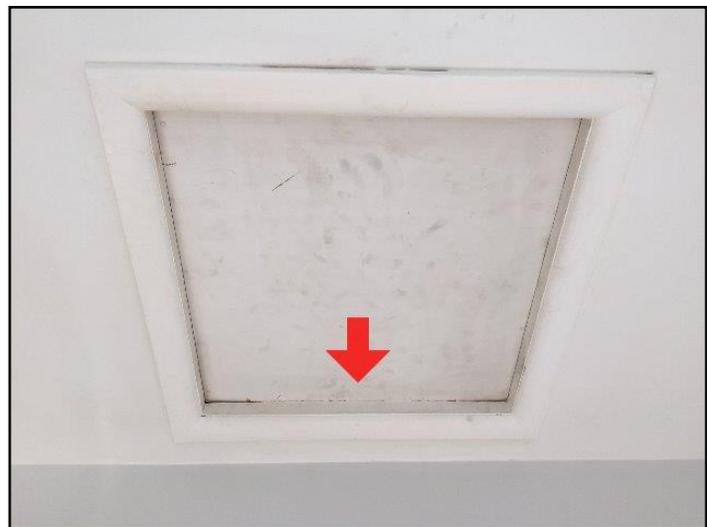
22. Condition: • [Not insulated and not weatherstripped](#)

Implication(s): Chance of condensation damage to finishes and/or structure | Increased heating and cooling costs | Reduced comfort

22. Not insulated and not weatherstripped

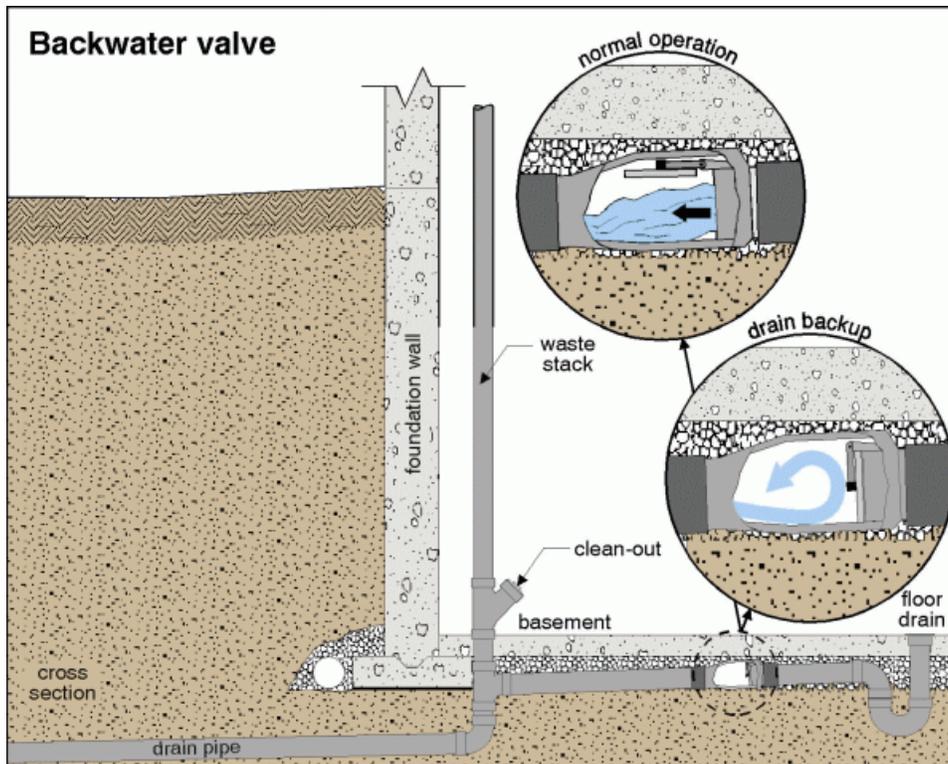
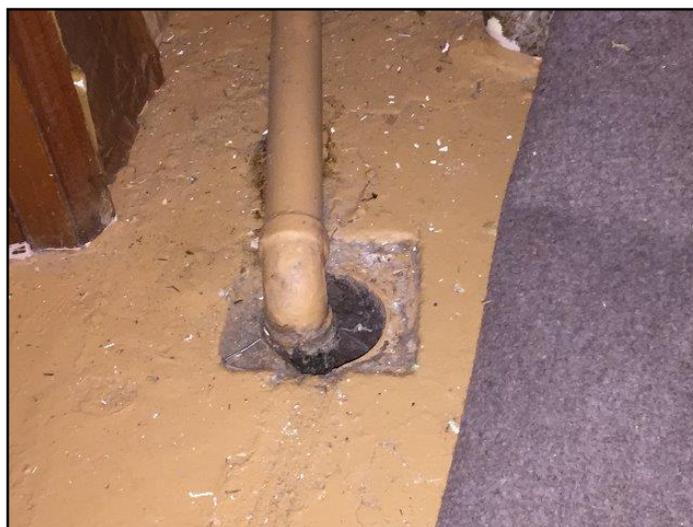
23. Condition: • [Backup](#)

Implication(s): Chance of water damage to contents, finishes and/or structure

24. Backup valve missing

Task: Improve
