**Tidal Culvert Removal and Habitat Restoration
Black Brook, Hantsport Nova Scotia**

October 2012

Tidal Culvert Removal and Habitat Restoration - summary Black Brook, Hantsport Nova Scotia

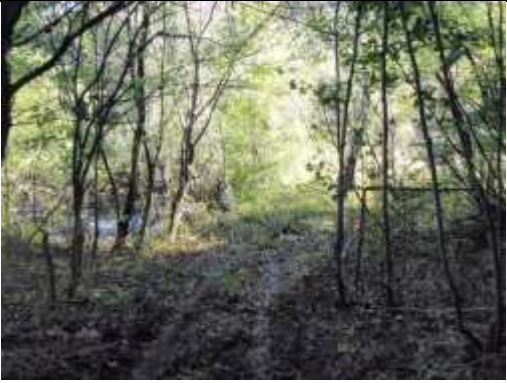
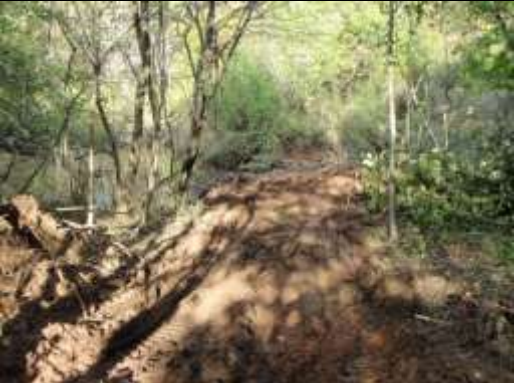
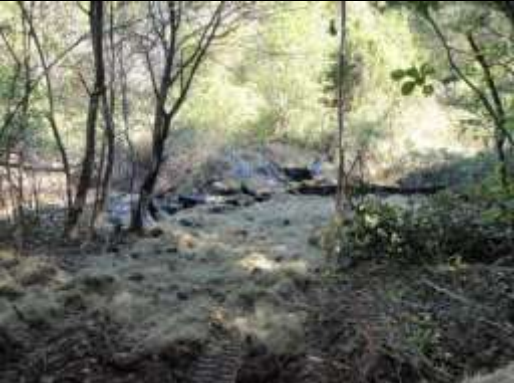
Location	Before (after removal of some road cover vegetation)	During	After
Looking northward along existing road surface to Black Brook and culvert crossing.

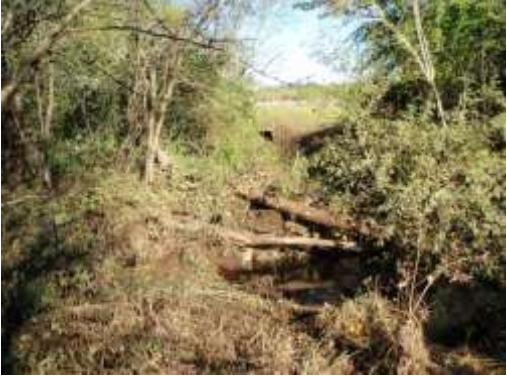
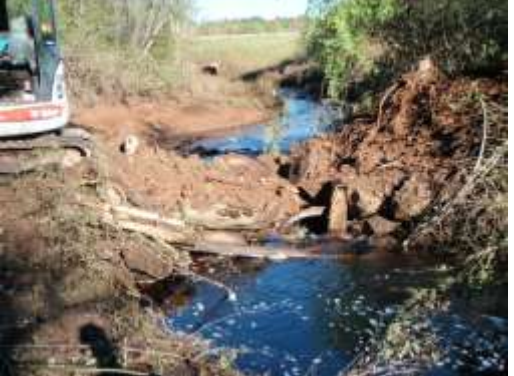
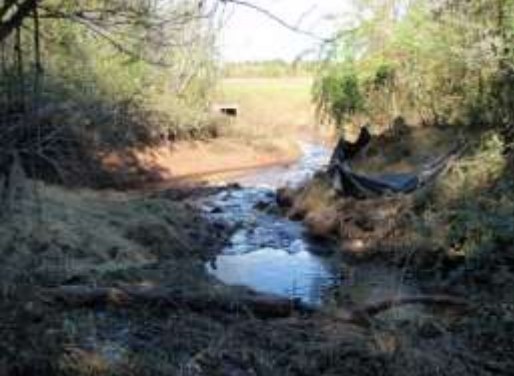
Looking northwestward toward Hantsport Connector, downstream view of culvert placement on Black Brook. Low Tide.

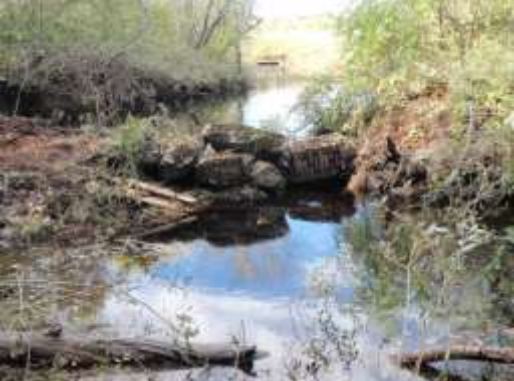
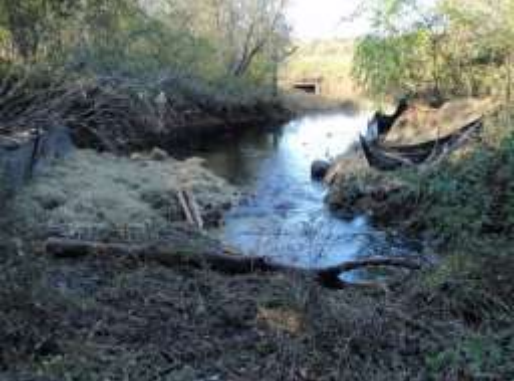
Looking northwestward toward Hantsport Connector, downstream view of culvert placement on Black Brook. High Tide.	Non available

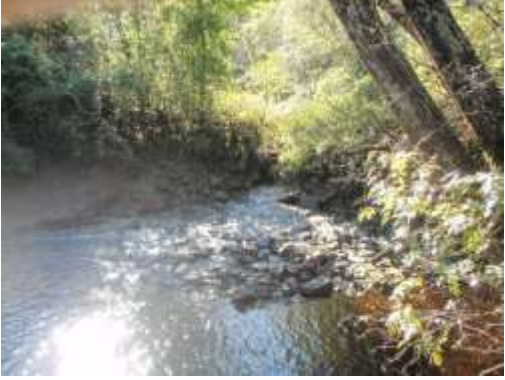
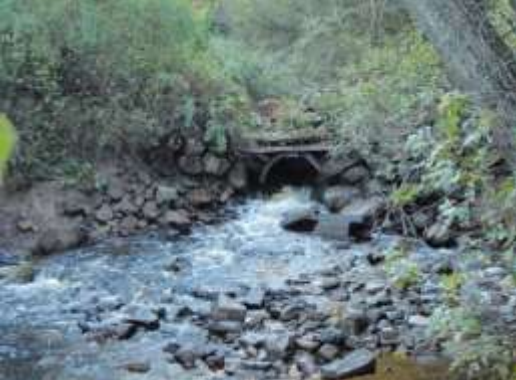
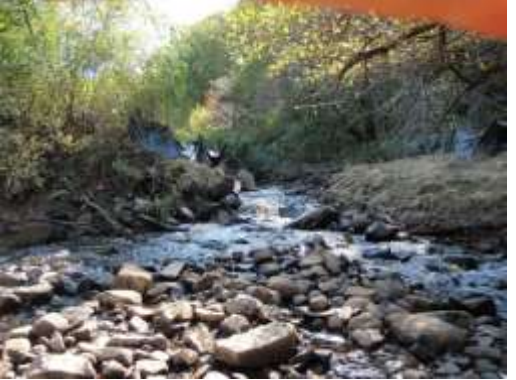
Location	Before (after removal of some road cover vegetation)	During	After
Looking southeastward, upstream view of culvert placement on Black Brook. Low Tide.

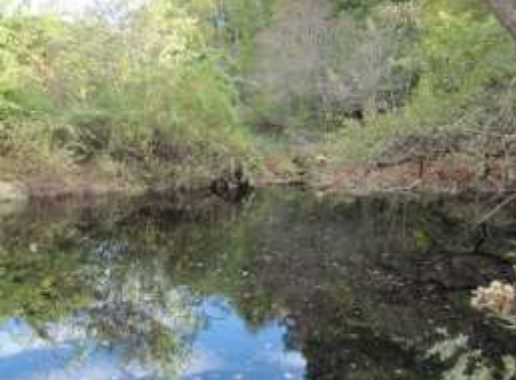
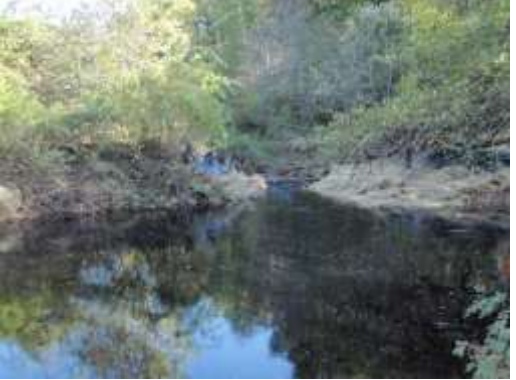
Looking southeastward, upstream view of culvert placement on Black Brook. High Tide.	None available

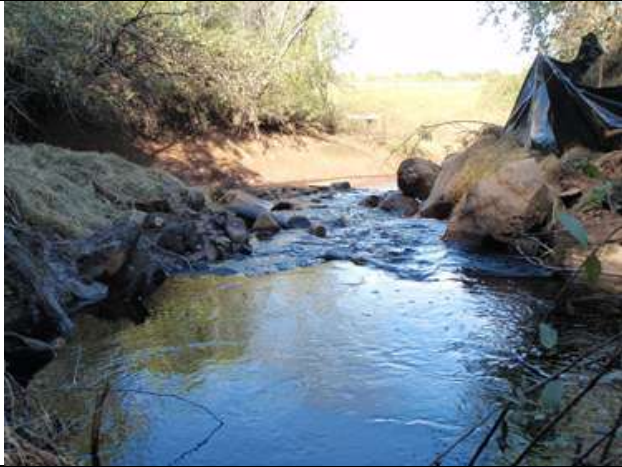
Water level downstream view of new channel, low tide

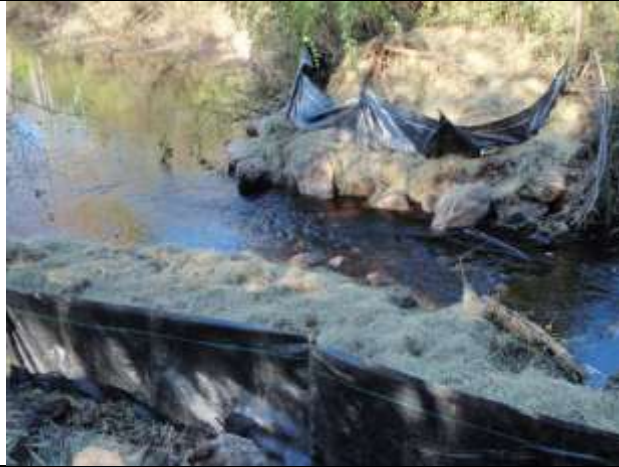
New channel during near high tide.

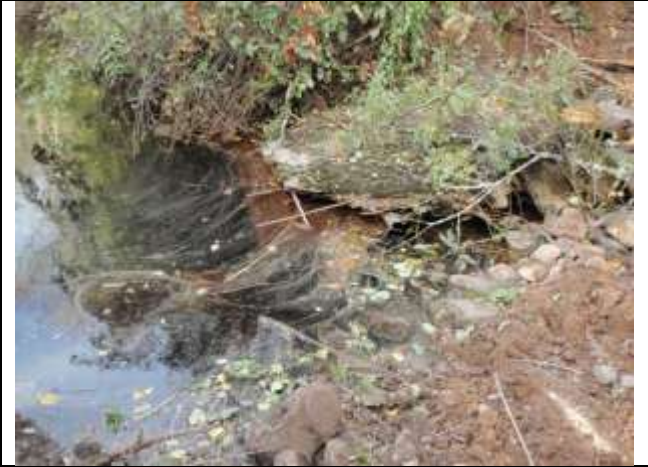
Submerged culvert during high tide.

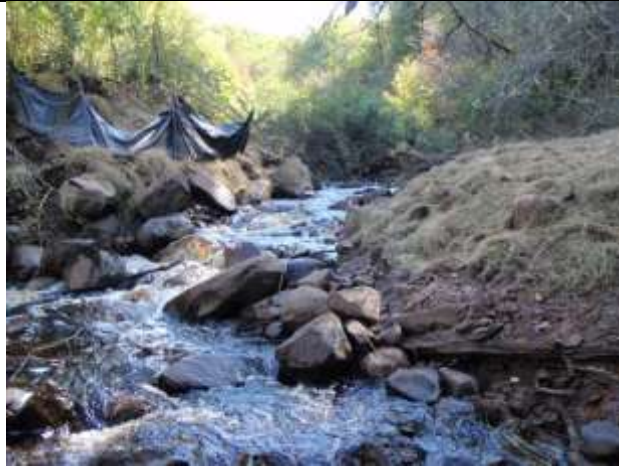
New channel looking upstream during low tide.
