Big Meadow Bog Hydrology Restoration: As Built Report

March 16, 2018
FINAL

Prepared by:
East Coast Aquatics Inc.
3 Middle St. Bridgetown, NS, B0S 1C0
(902) 665-4682
www.eastcoastaquatics.ca

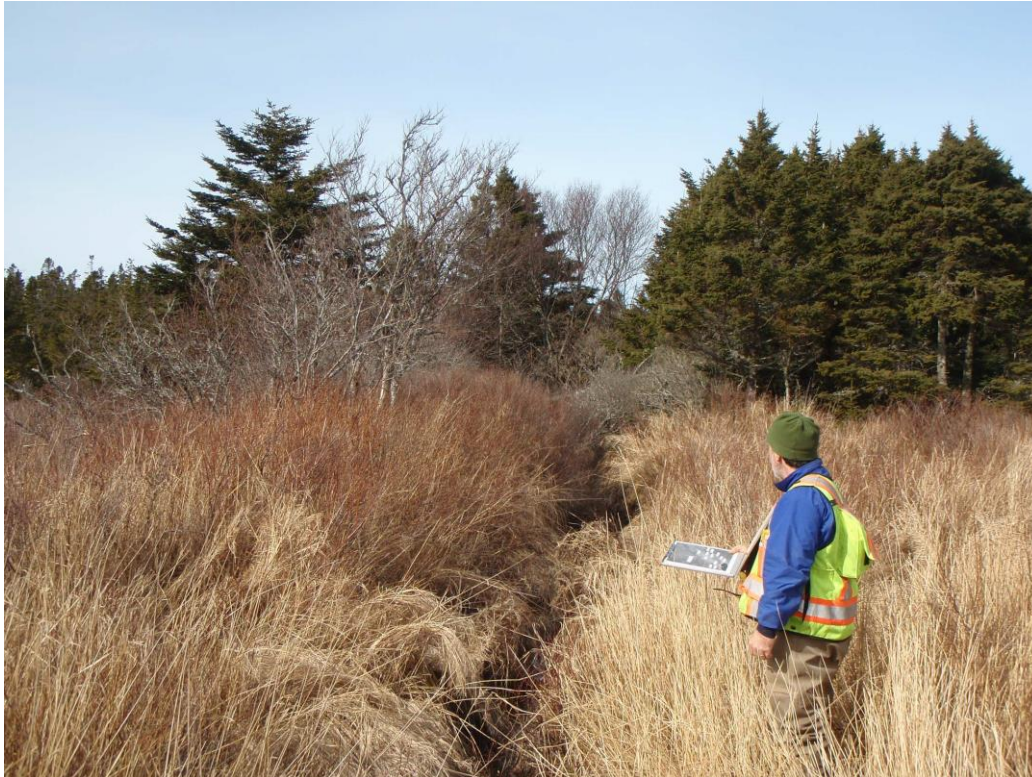
Figure 7: View landward from Big Pond along the southwest ditch prior to restoration, demonstrating the mature tree encroachment that existed pre-restoration.

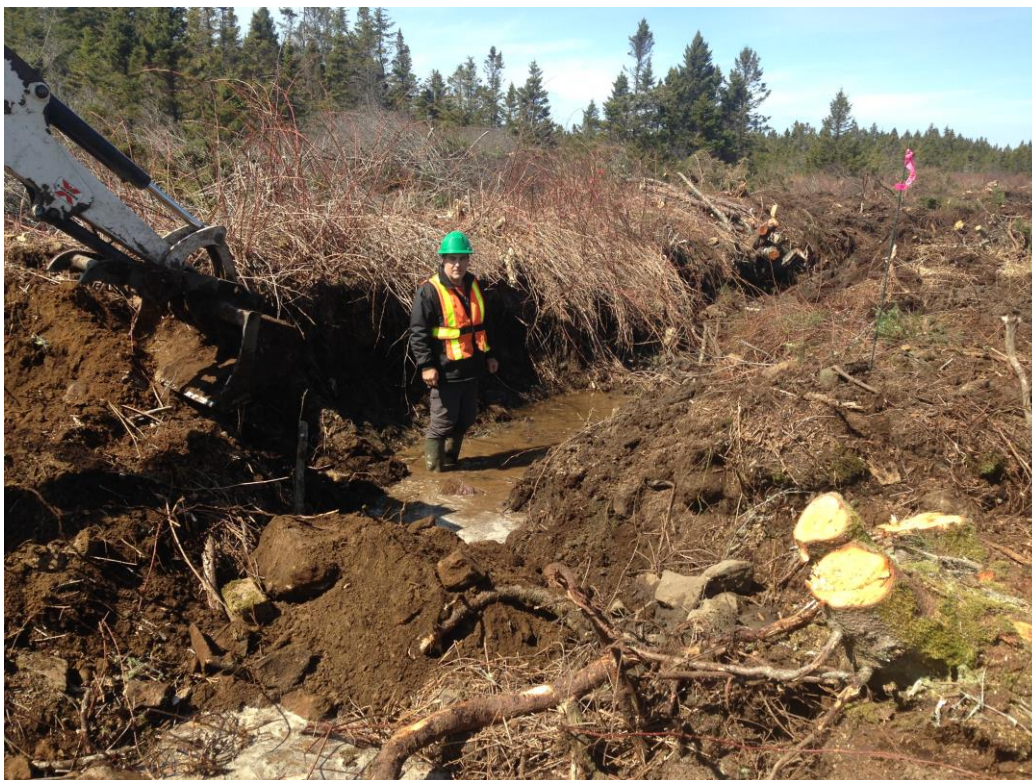
Figure 8: The mineral, rather than peat, nature of soils near big Pond are visible in this image, as is the relative depth of the Southwest ditch prior to remediation.

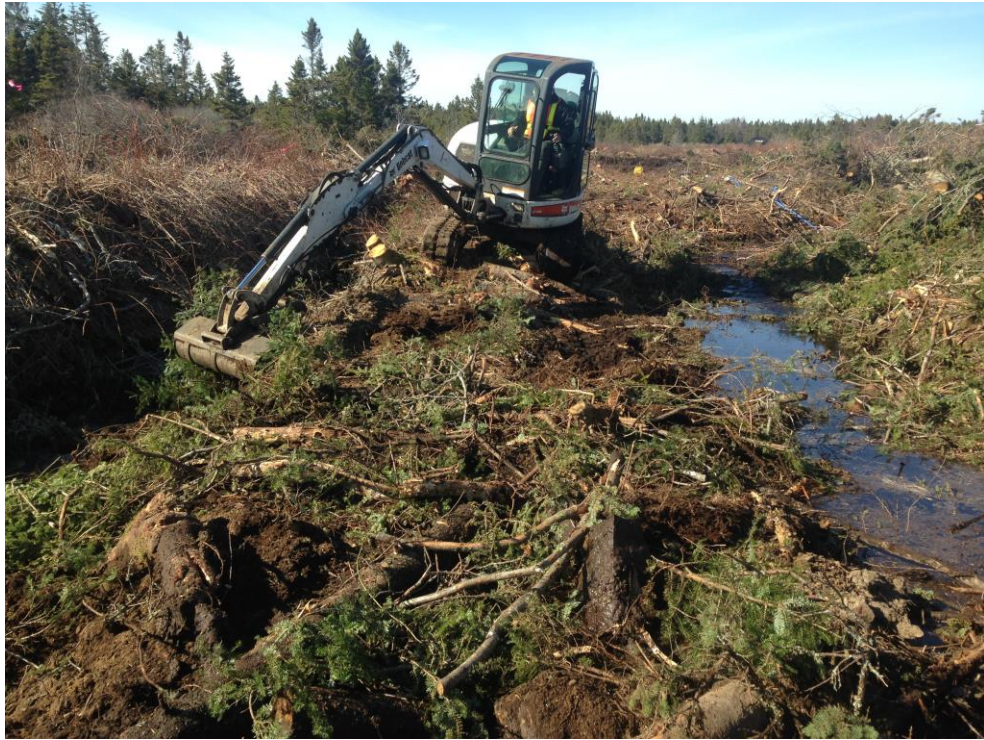
Figure 9: The natural lagg channel (photo right) was reactivated with stream flow following the initial upslope ditchblock installation, allowing the remaining ditch work (photo left) to be carried out "in the dry".

Following installation of the third ditchblock, all lagg channel discharge remained out of the ditch, instead flowing south along the reactivated natural lagg channel, that remained within the landscape, until it reached Big Pond (Figure 9 and 10). Mature tree growth that had been cut from the historic ditch spoil piles and adjacent to the ditch had extensive root systems that hindered efforts to build ditchblocks and recontour the ditch (Figure 11). Although the construction was successfully completed, surface disturbance was greater in this project area than other locations of BMB given the presence of roots, mineral nature of some soils, and lack of sod to be placed on top of restored areas. This may provide opportunities for weedy pioneering species to initially dominate colonization along the restored ditchline. Similarly, the high volume of cut slash on the ground in this project area may influence the plant colonization trajectory.

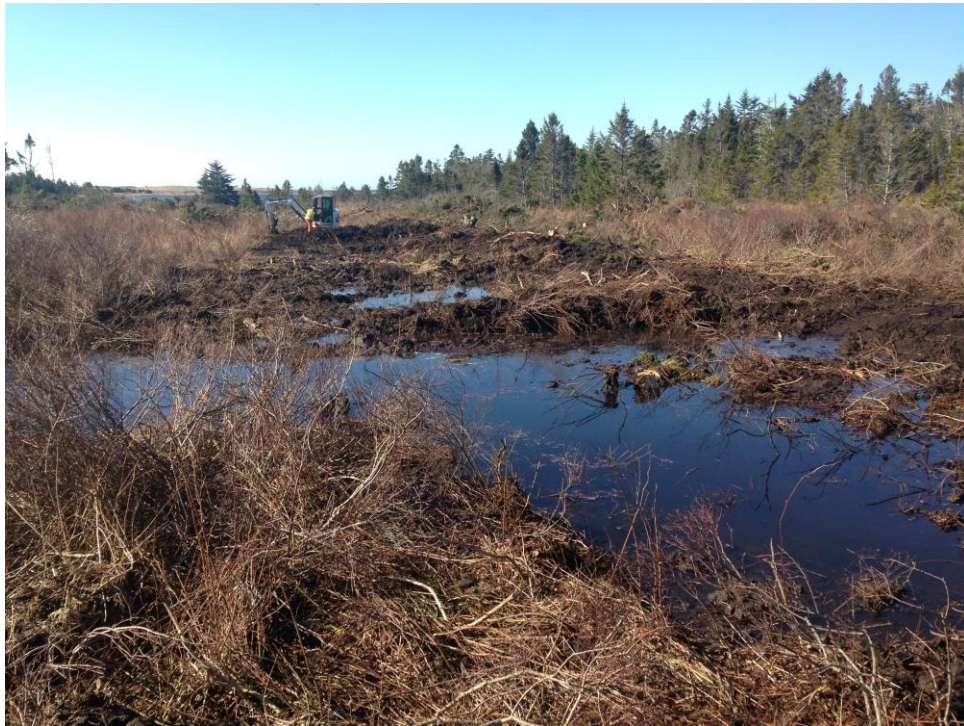
Figure 10: Following significant rain during initial construction, ditchblocks immediately impounded water and redirected sheet flows to the reactivated lagg channel rather than along the ditch.

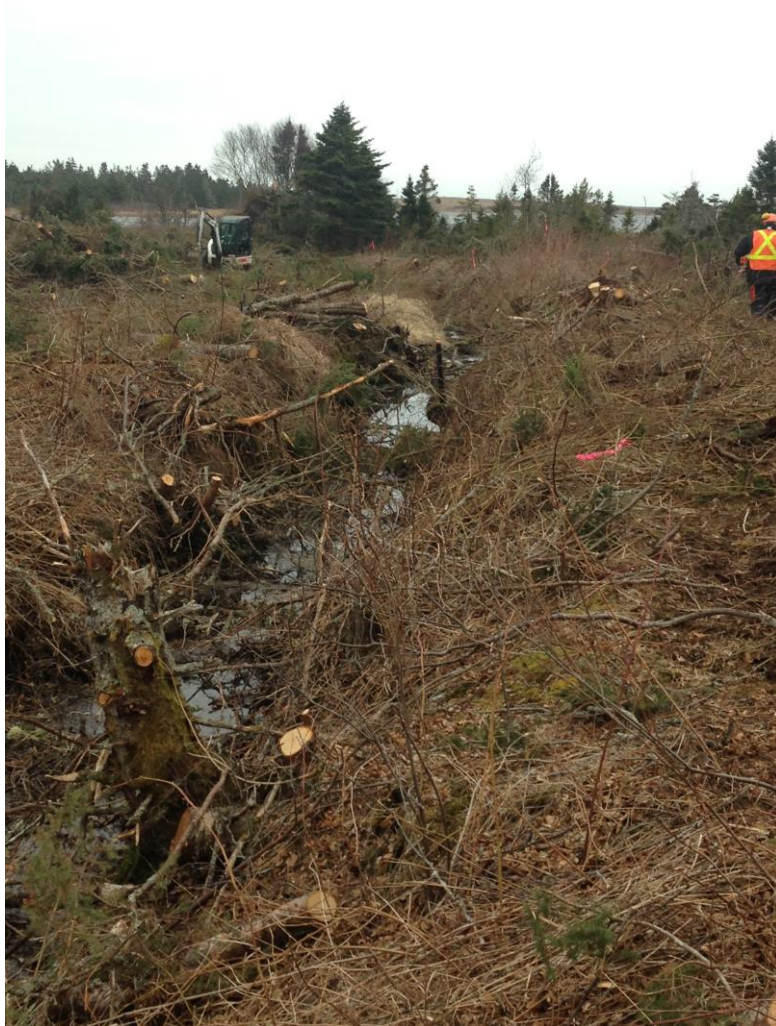
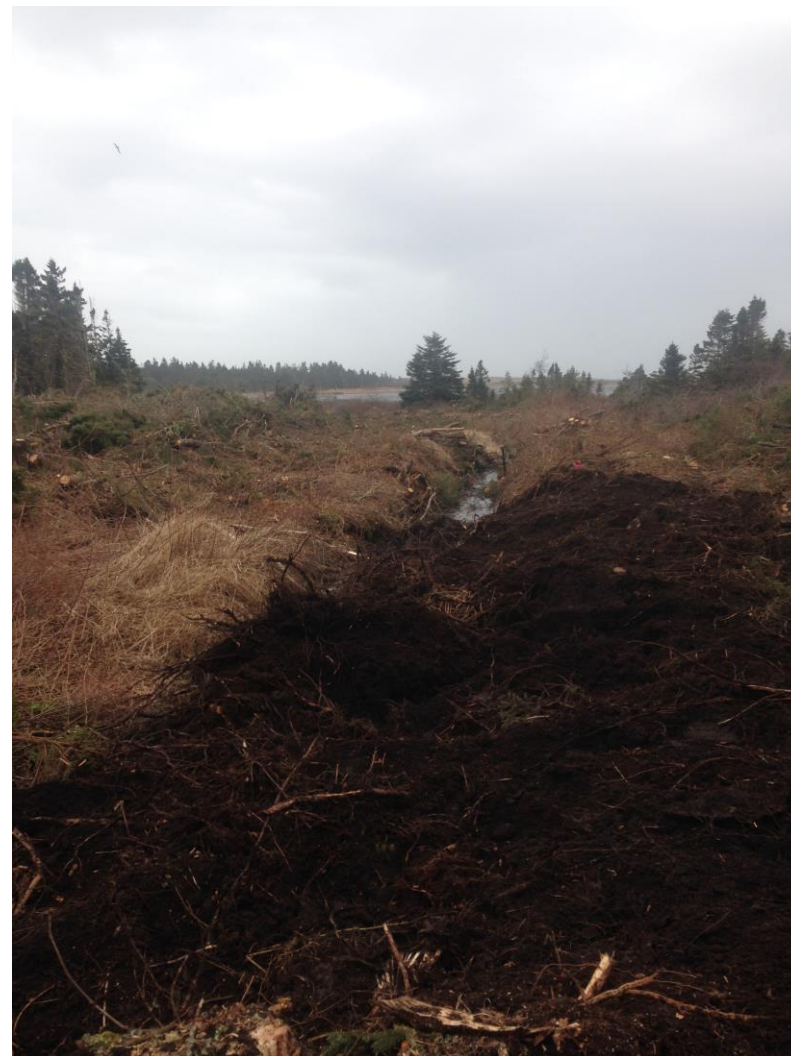
Figure 11: A view south along the southwest ditch toward Big Pond following tree cutting, and during clearing of the construction corridor along the brook (L) and following initial re-profiling activities (R).

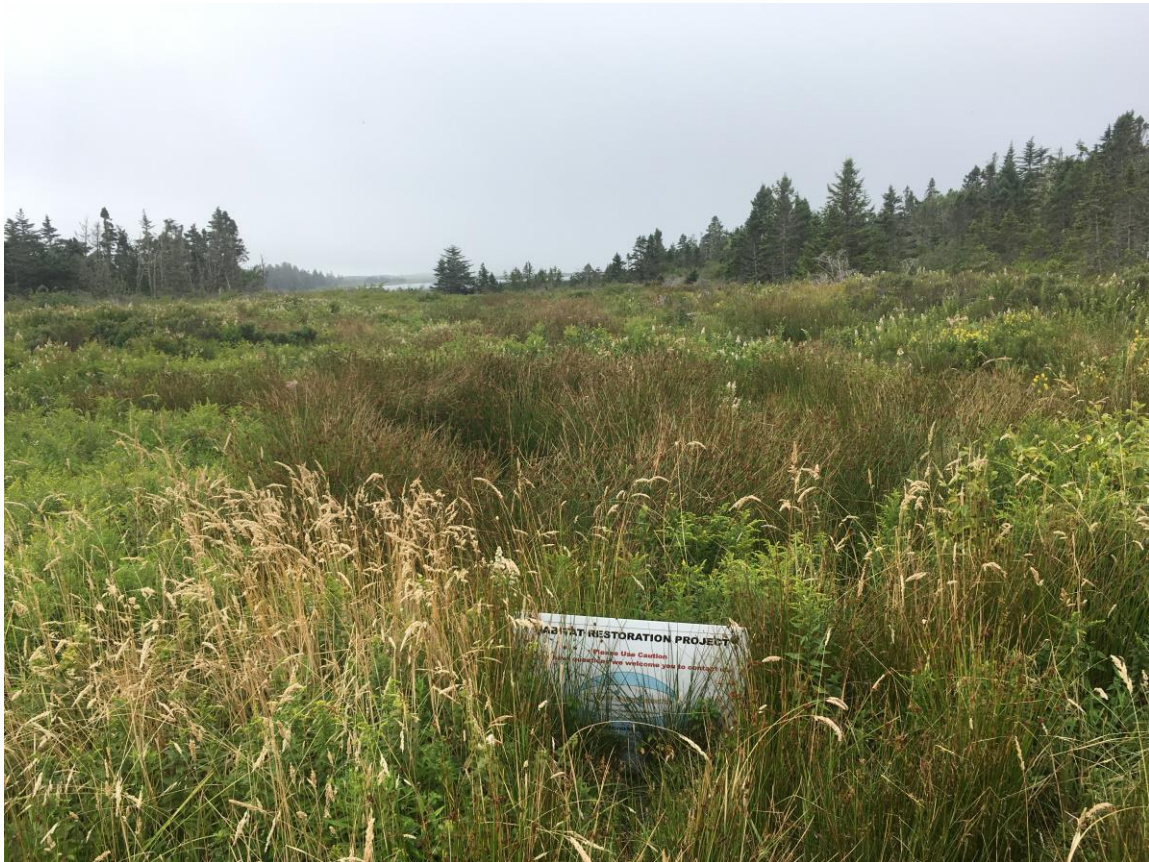
Figure 12: Approximately 16 months post restoration, the southwest ditch that is located on NCC lands was well vegetated with a diversity of herbaceous plants and mosses.

As the southwest ditch was completed (April 2016) a year before any other restoration work was initiated (May 2017), some initial observations of hydrological restoration implications were observed. This included the relatively rapid colonization of the site with herbaceous wetland species growth (see Figure 12), indicators of plant stress (discoloration of foliage, dieback) within the non-typical community that had colonized the site over the past number of decades, visual presence of surface water at ditchblock sites and along the re-activated lagg channel, and initial moss colonization of the bare peat areas that had resulted from construction.

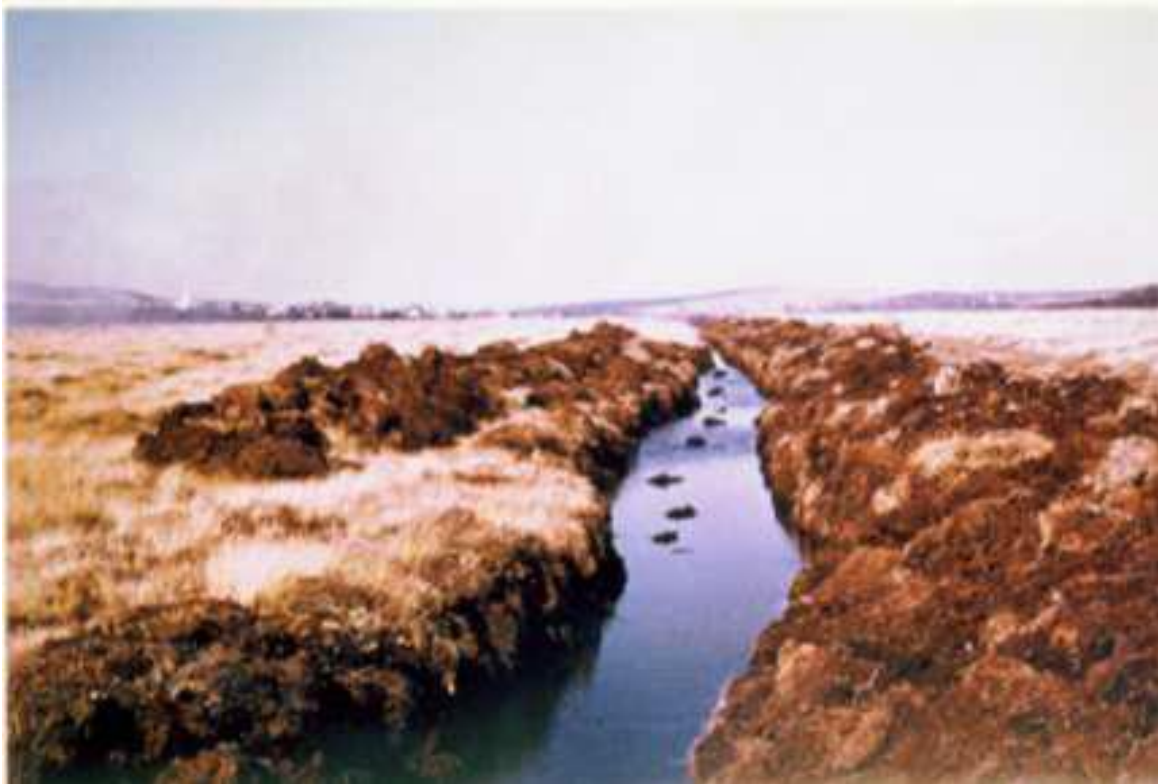
Figure 13: A northward view of Big Meadow Bog central ditch when it was freshly "ditched" in 1958 or 1959 (Source: LaRue and Toms 2013). Note the high water table within the central ditch, a state never observed during the design and restoration period (2015-2017) within the central ditch.

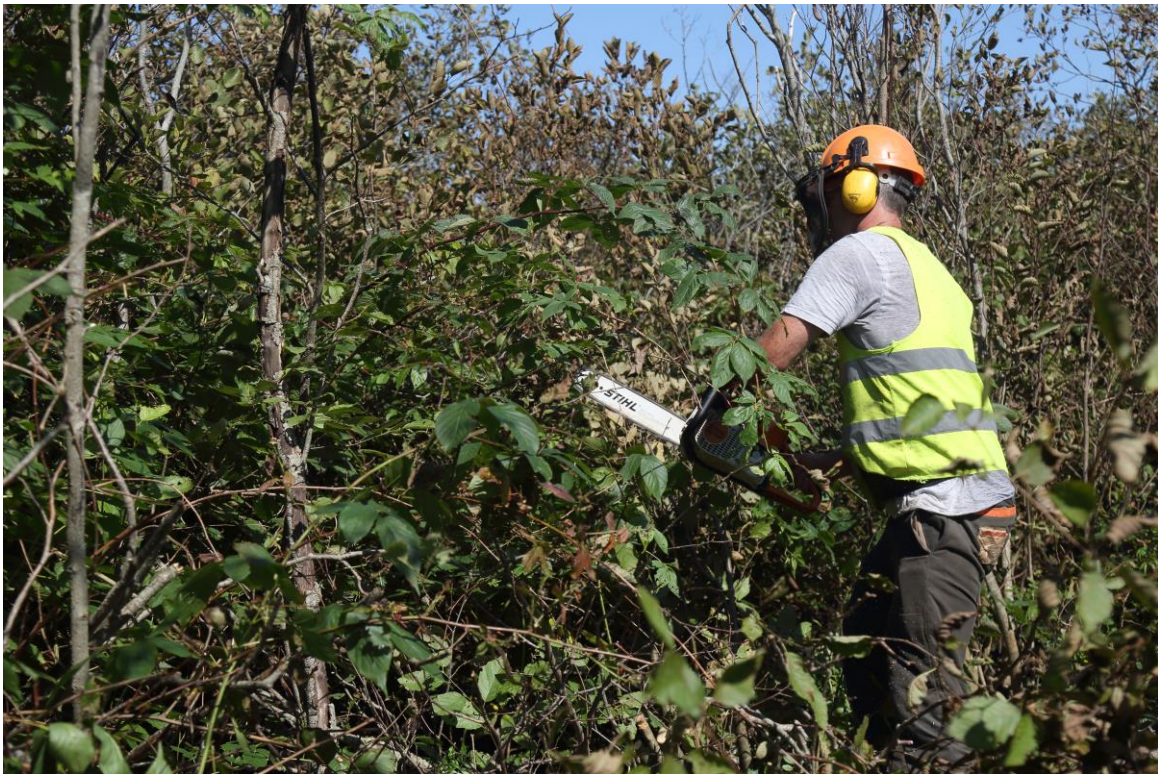
Figure 14: Dense tree/tall shrub growth along historic ditch lines had to be cut prior to restoration to gain machine access. Here, an alder stand in the north confluence is cleared.

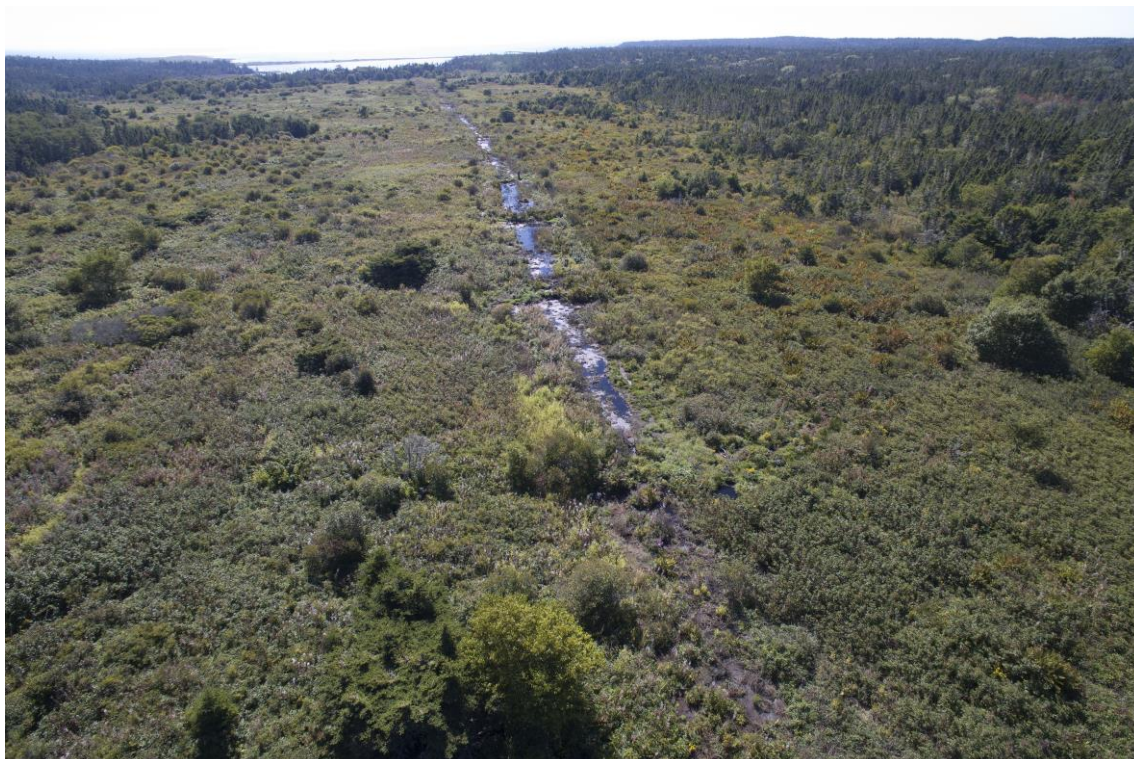
Figure 15: This August 2017 view of the central ditch, recently restored with ditchblocks and re-profiling, depicts the shallow water microhabitats post restoration. The image is take from near the middle of Big Meadow Bog looking south to Big Pond (Photo credit: Mike Dembeck photography mikedembeck.com).

Re-profiling ditch walls has the advantage of addressing the hazard of deep-water while providing a range of aquatic micro habitats (~0.5 m to 0 m water depths) and ditch wall stability. Immediately following restoration activities these small bodies of surface water were visible along the south central ditch (Figure 15), but generally were absent from the north central ditch (Figure 16). Overall the north central appeared drier throughout construction, despite low ditch water discharge occurring. However, this could have been, at least in part, due to the late seasonal timing of construction in the north. The south water table remained visible in surface depressions even during the September work period, having been charged by earlier season precipitation and moisture levels.

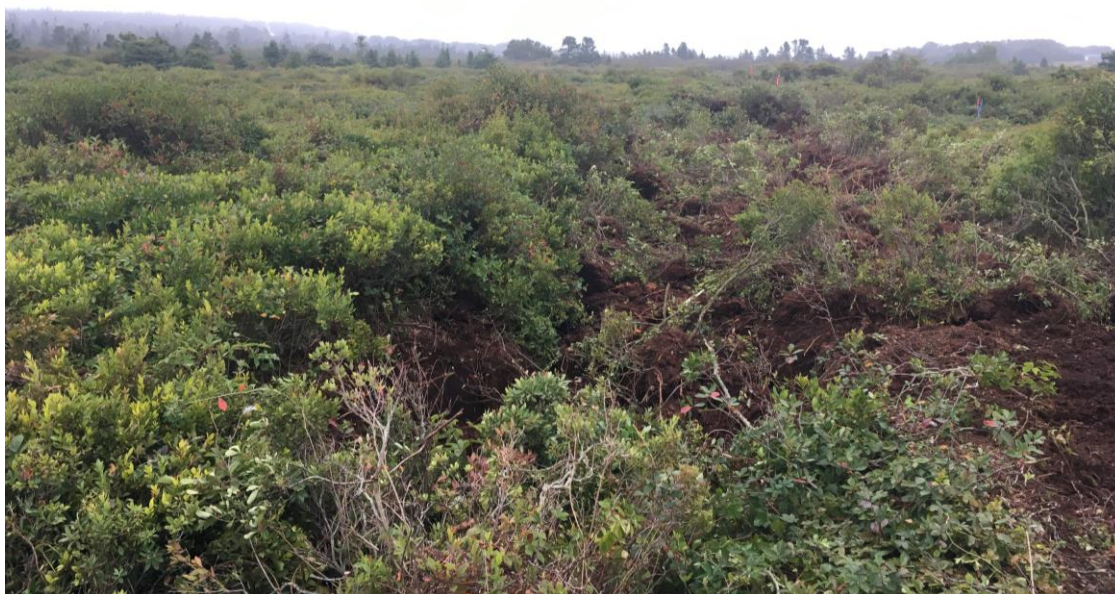
Figure 16: A northward view of Big Meadow Bog central ditch when it was freshly restored in September 2017, having been recontoured and ditchblocks installed. This view approximates the 1958 post ditching view of Figure 13.

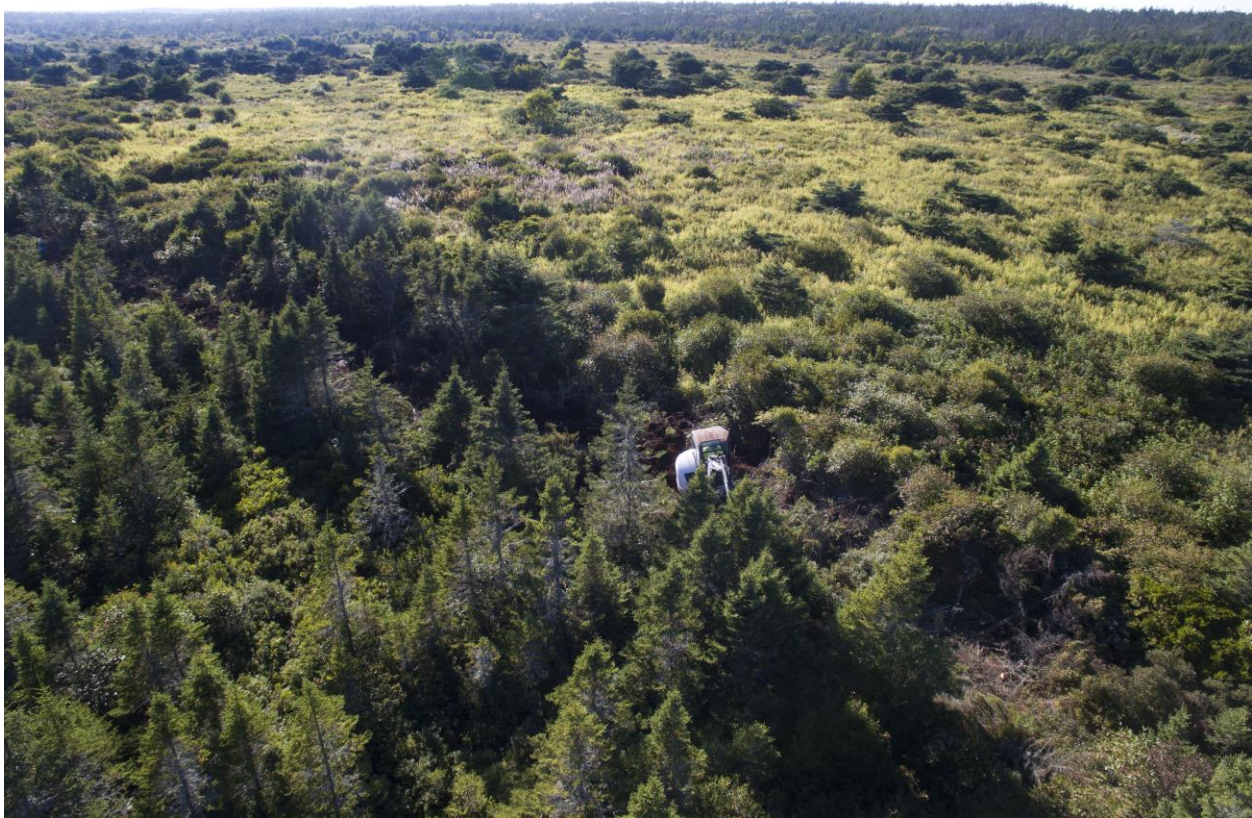
Figure 17: An excavator works in a recently cut corridor of trees along the north east ditch. The view is south westward across Big Meadow Bog and shows the scattered encroachment of larger trees across the main bog that would be felled as a final step in the restoration process. (Photo credit: Mike Dembeck photography mikedembeck.com)

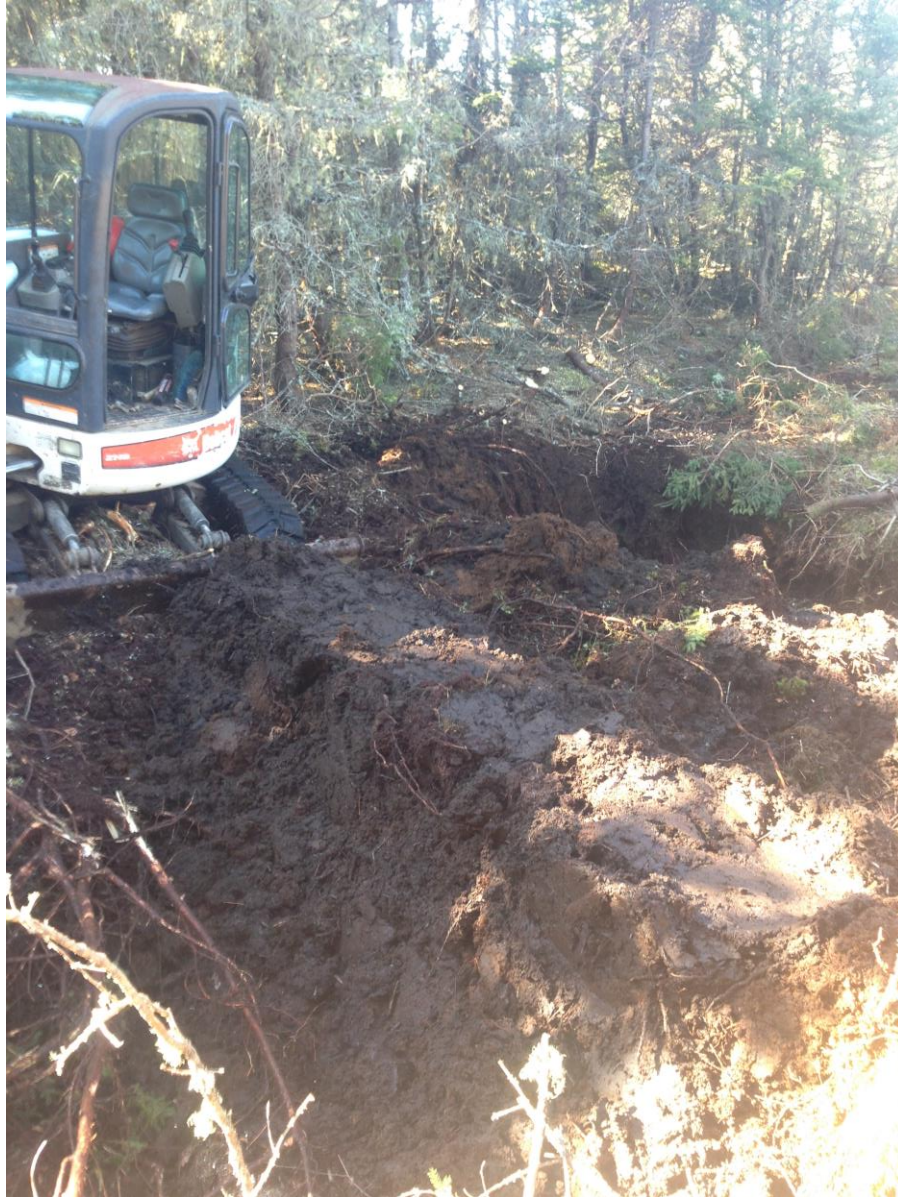
Figure 19: A ditchblock nears completion on the southeast ditch. The compacted peat core is visible, waiting to be topped with available live "sod" that will promote quick growth and stability.

The southeast ditch was found to have an armored substrate of cobble and rock along nearly its entire length, reflecting the thinner layer of peat along the lagg channel as compared to along the central ditch. The largest stones within the southeast ditch were ~2m in diameter, although most were 0.2 to 0.5m. These materials were excluded in construction of ditchblocks, and adequate peat could be found to construct all the ditchblocks on the east (see Figures 19 and 20). However, mineral and stone materials were used as available in the ditch between the ditchblocks as part of the re-profiling.

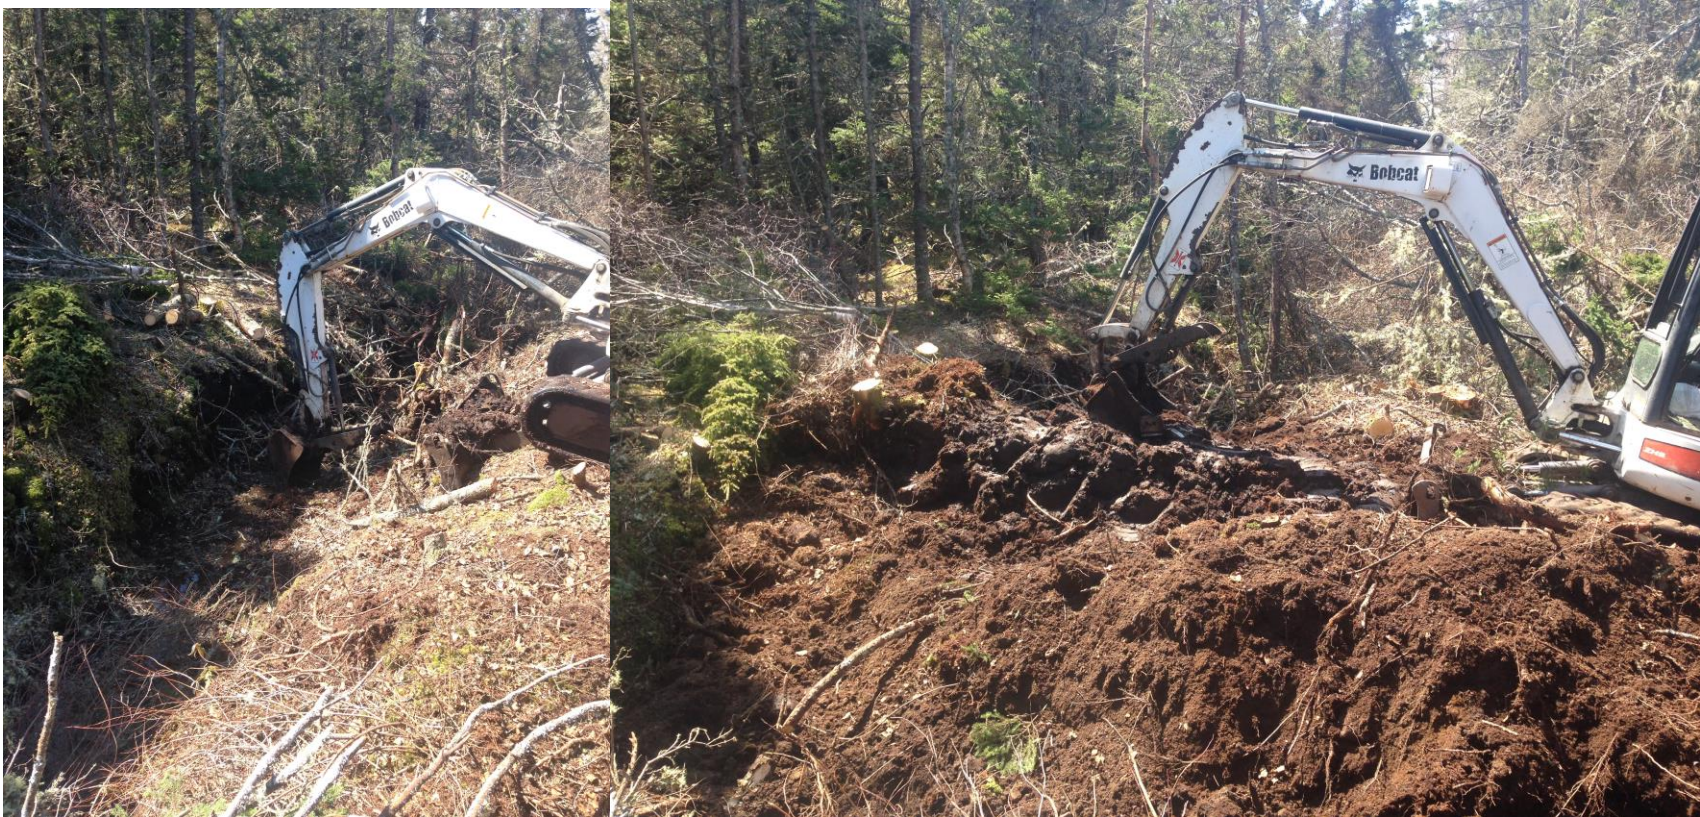
Figure 20: A before (L) and after (R) of ditchblock construction on the southeast ditch in a heavily forested stretch. Note that ditch has become dry from construction of upslope ditchblocks, allowing work to occur “in the dry”. In the nearly completed photo (R), the ditchblock of wet catotelmic peat under the excavator buck is being compacted with an initial sod being placed on top of the far end of the ditchblock. Note the dry desiccated shallow peat piled in the image foreground that has been removed to allow access to deeper wet peat used in construction.

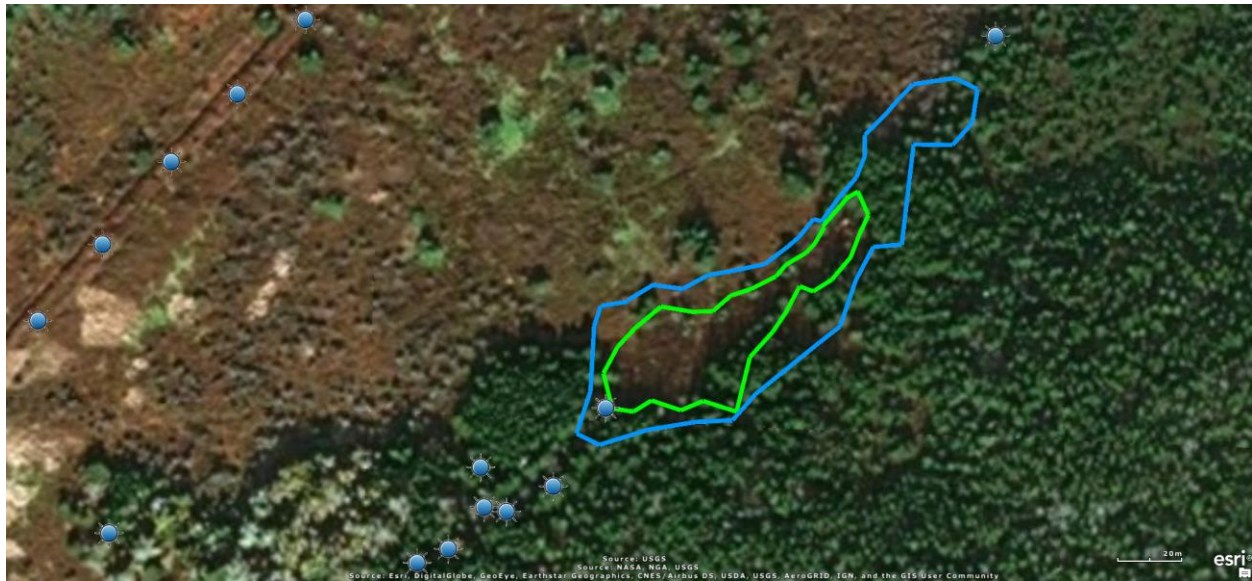
Figure 21: The Big Lily Pond on the southeast ditch had not held water in over 50 years prior to restoration at BMB. Following installation of ditchblocks (blue circles) the open water area recharged to 1950m² by May 2017 (green line) and over 4550m² by February 2018 (blue line).

Following the initiation of restoration of the southeast ditch, the “Big Lily Pond” immediately began to capture surface water within the landscape depression of the former pond that had been dry for more than 50 years. The pond had been drained in two directions, north and south, by the east ditch. Within five months of the restoration construction being completed, the open water surface area of Big Lily Pond had grown to 4550m² (see Figure 15) and depths of >0.75m were measured at the southern end.

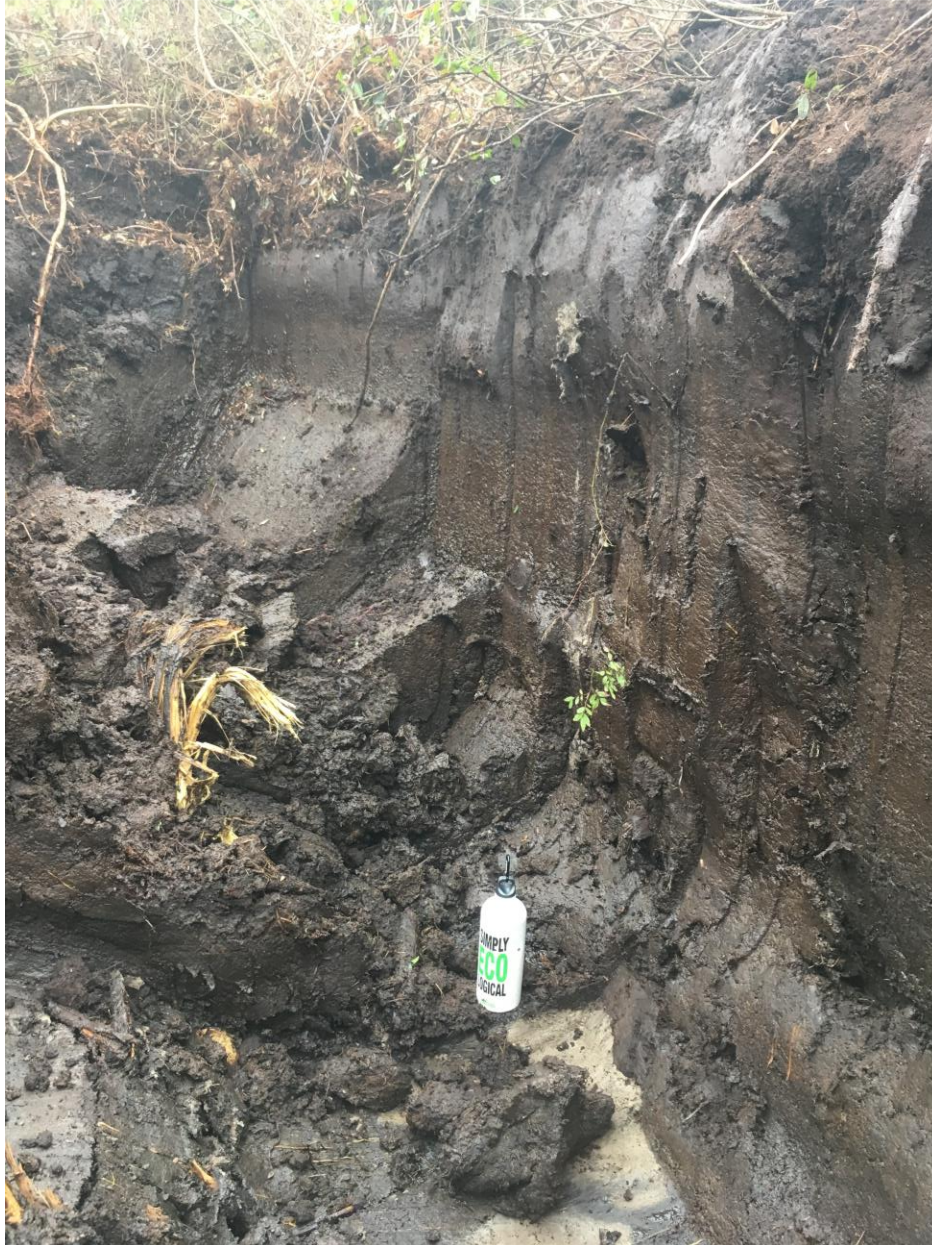
Figure 22: This image of a ditch block borrow pit area in along the northeast ditch shows a peat layer of approximately 0.8m underlain by a light grey mineral soil, and pieces of wood within the peat matrix below approximately 0.5m.

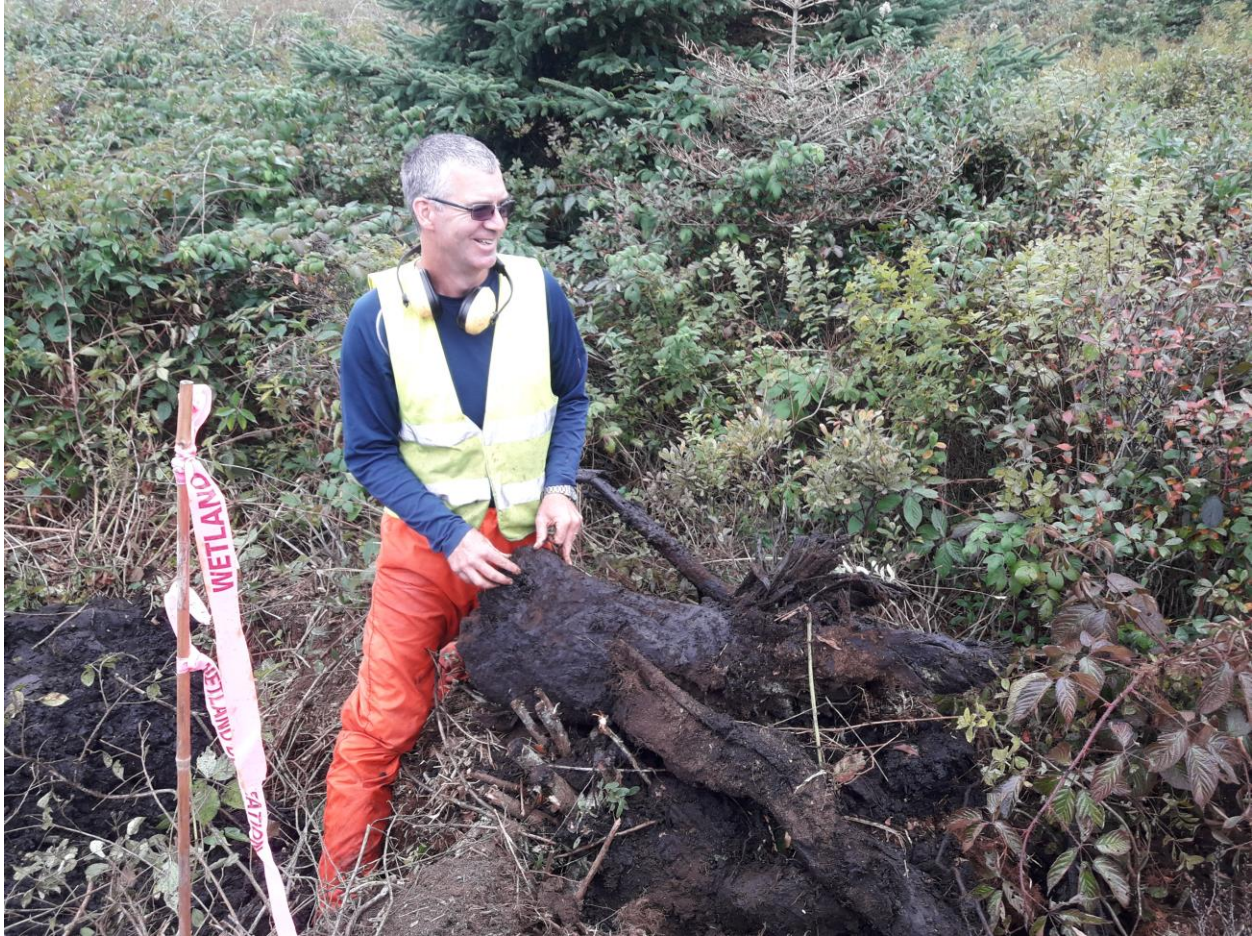
Figure 23: Evidence of an old forest strata was found across much of the northern half of Big Meadow Bog. Along the northeast ditch this large root ball was excavated from some 0.7m below the bog surface.

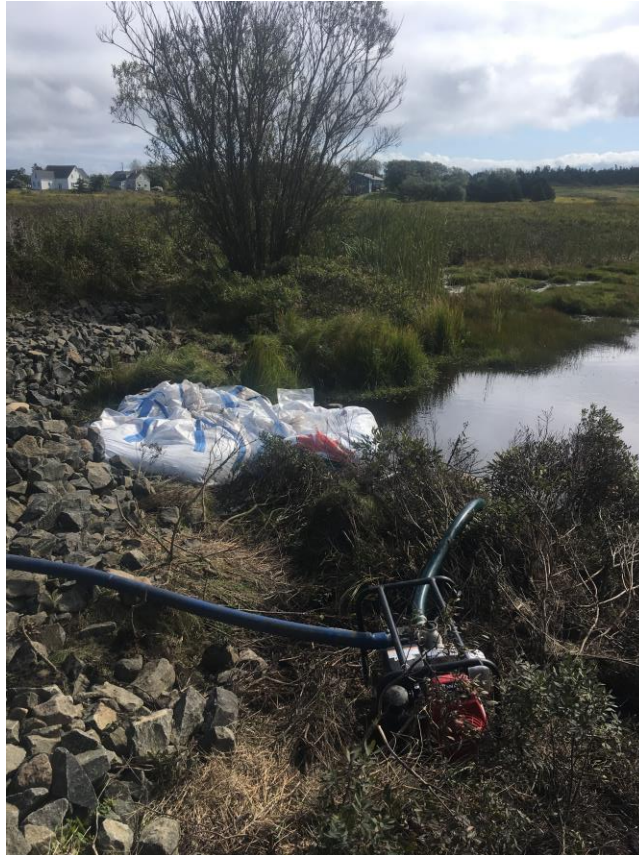
Figure 25: Cofferdam bags isolate the outflow from Jimmy's Pond, while a 2" pump was used to draw down the pond water level prior to restoration works.

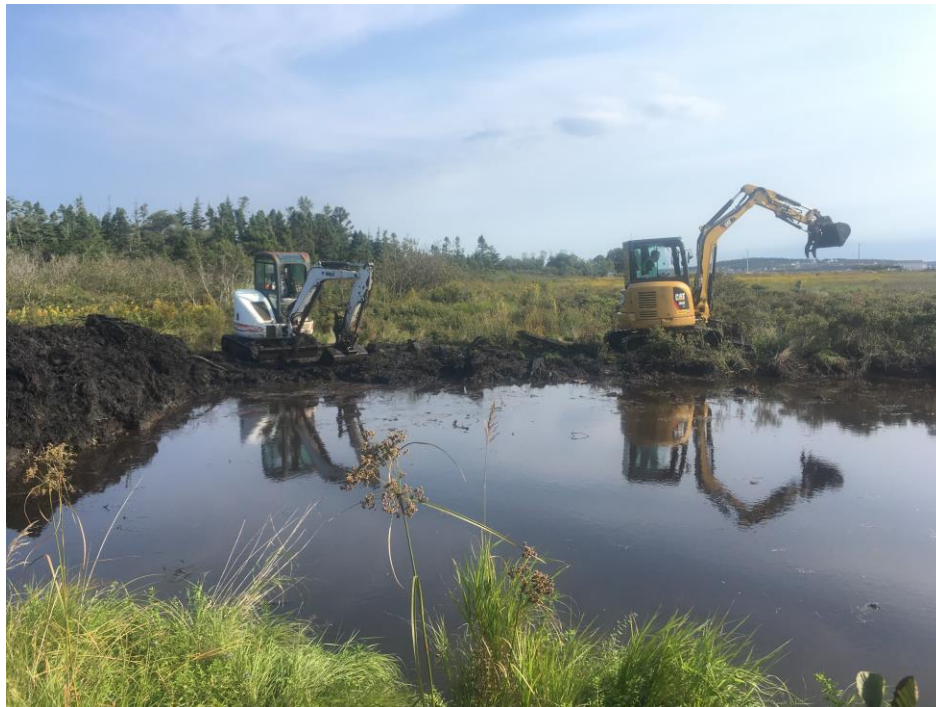
Figure 26: Compact excavators sit on timber cribbing to excavate the pond infill.

The second step in the pond restoration involved excavation of the infilled pond area on the western half of the pond (see Figure 26). Extensive use of timber cribbing was necessary to support the two compact excavators while the machines were working off the soft areas of infill. Material was excavated approximately 70 cm, or 50-60 cm below the pre-restoration water level, across the entire infill site. Nearly all the excavated spoils were moved to the spoil disposal area to the west of the pond, inside an area of silt fencing.

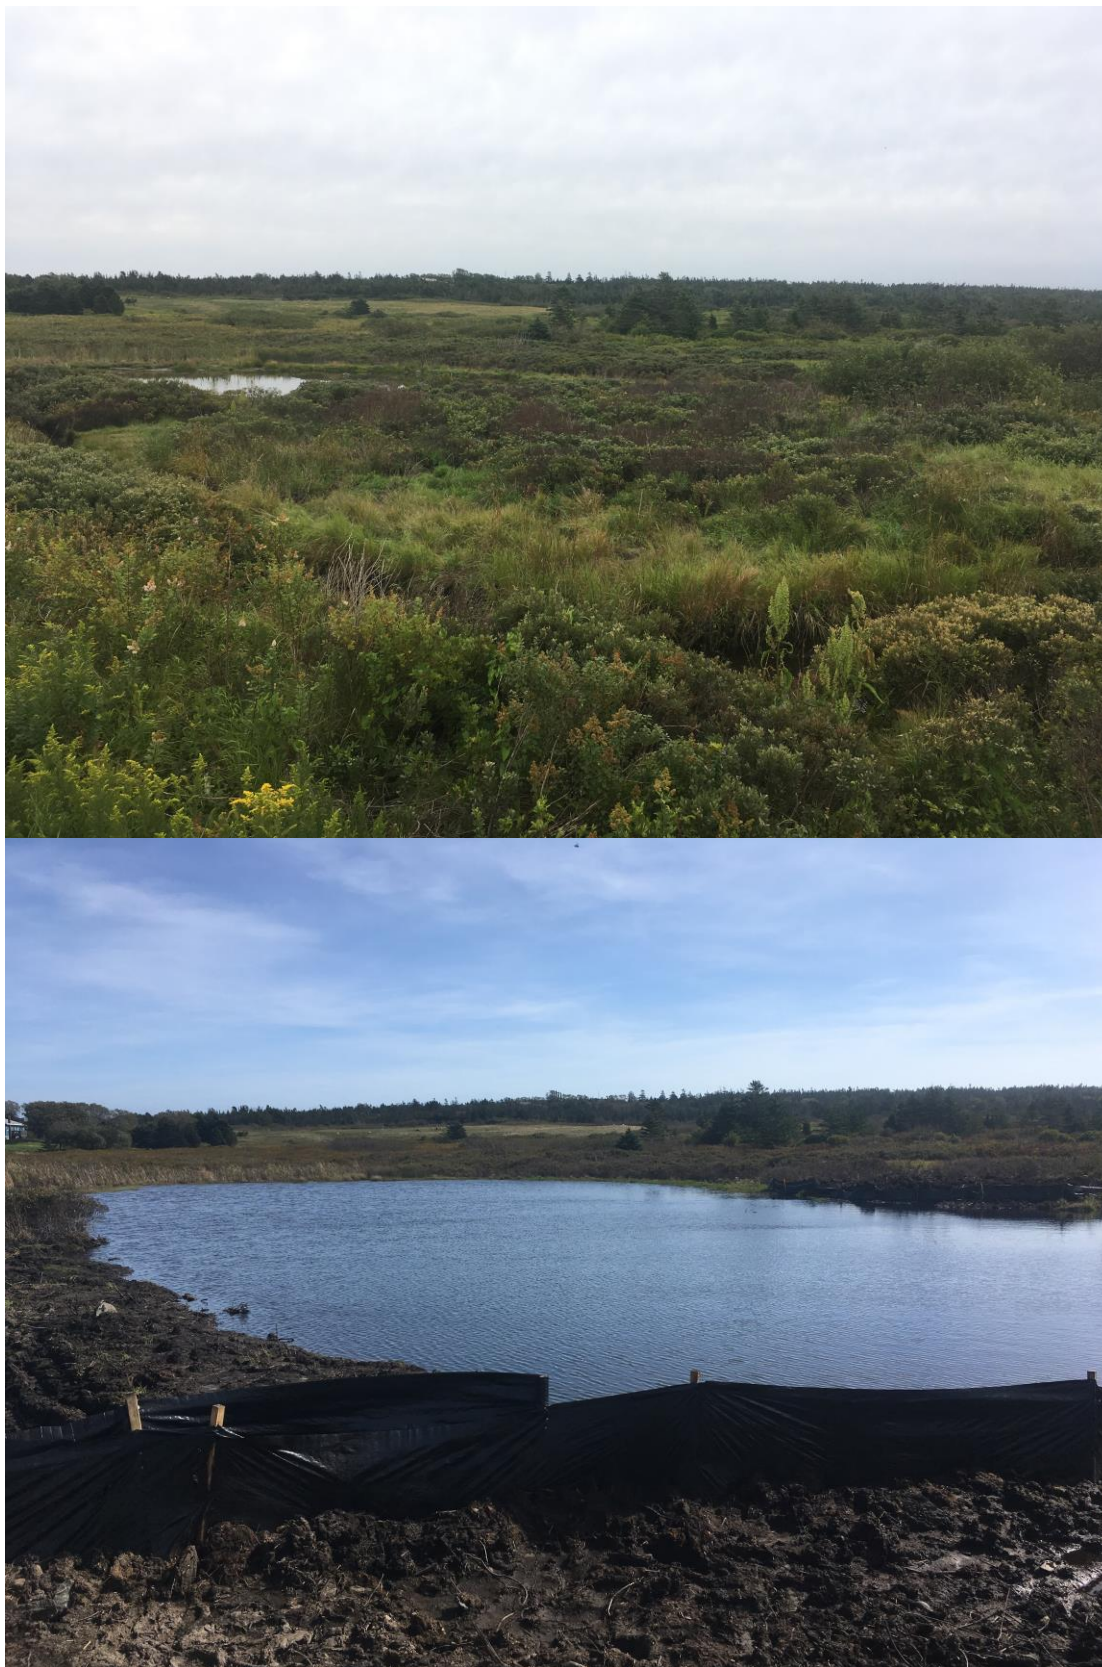
Figure 27: Distant trees provide reference for this pre (Aug 2017) and post (Sept 2017) restoration eastward view of the pond.

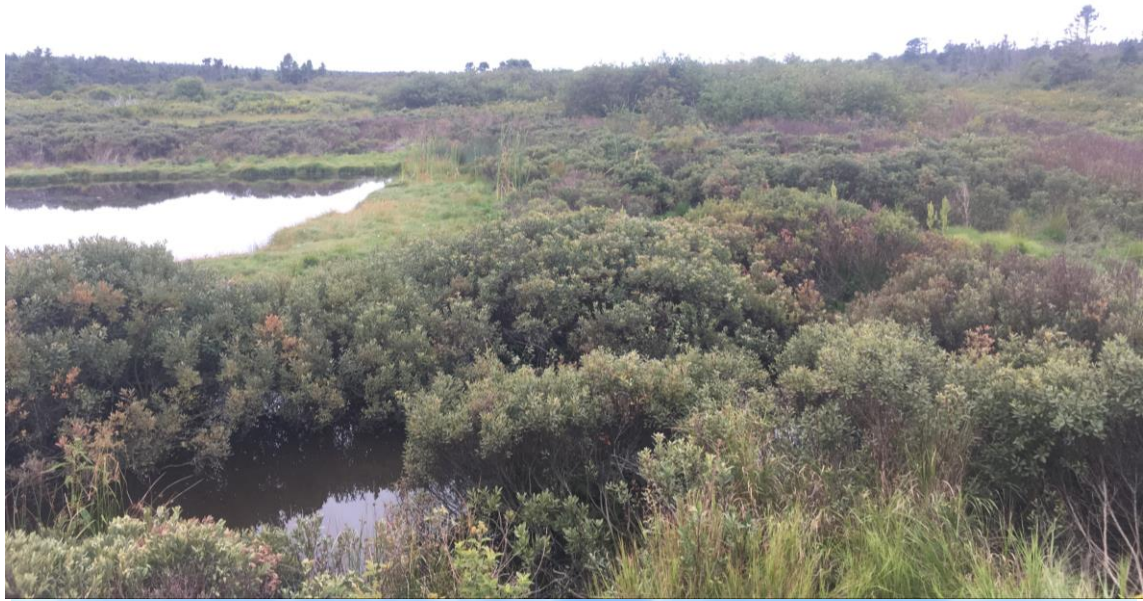
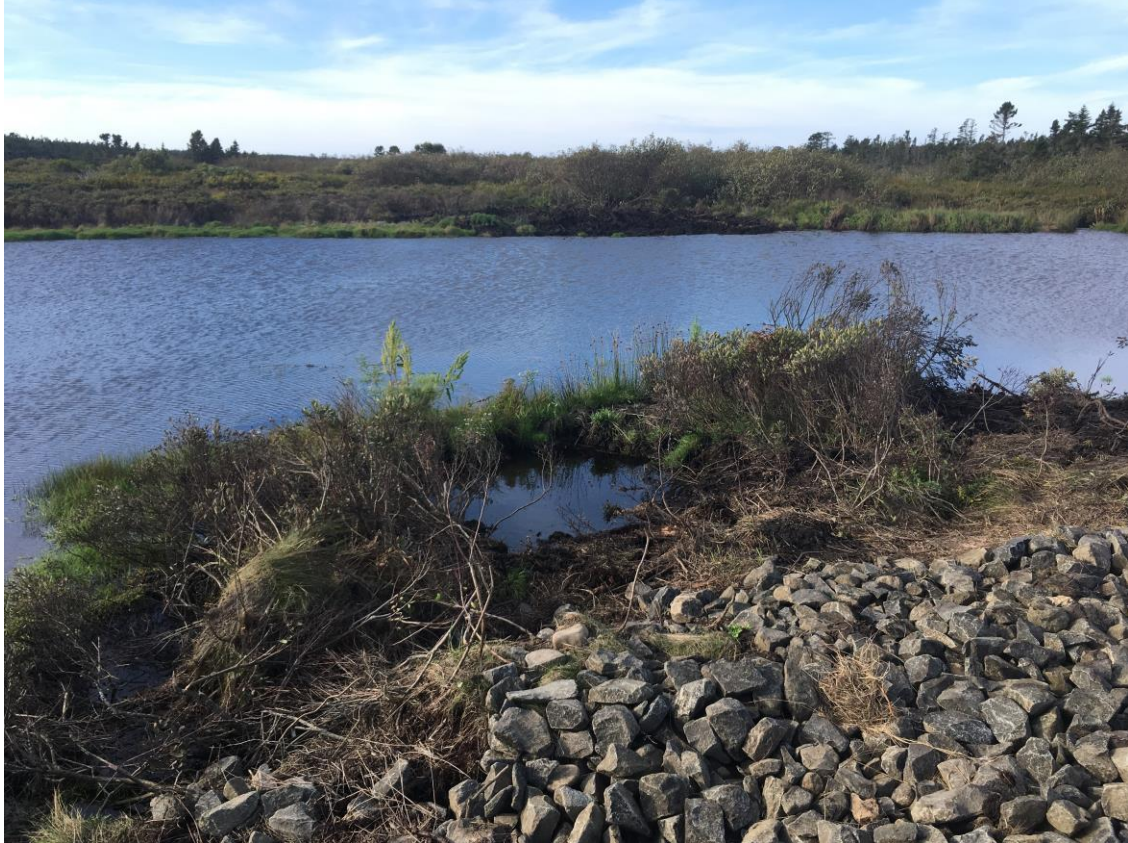
Figure 28: Distant trees provide reference for this pre (Aug 2017) and post (Sept 2017) restoration southward view of the pond toward Big Meadow Bog. Stone in the foreground is part of the restored outlet channel, which further raised the water level within the pond.
