Big Meadow Bog Hydrology Restoration: As Built Report

March 16, 2018
FINAL

Prepared by:
East Coast Aquatics Inc.
3 Middle St. Bridgetown, NS, B0S 1C0
(902) 665-4682
www.eastcoastaquatics.ca

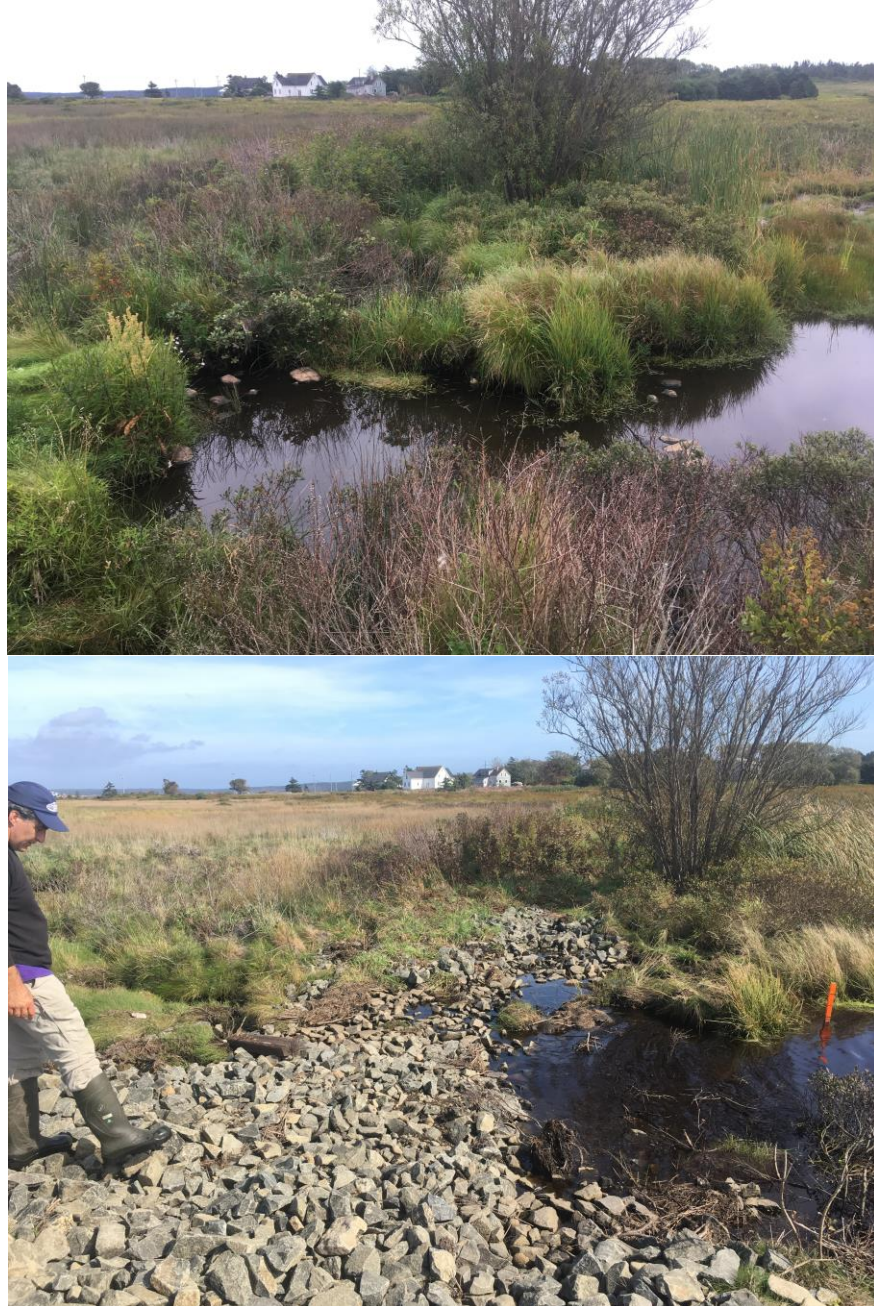
Figure 29: Pre and post restoration views of Jimmy's pond outlet channel. The outlet was raised .03-0.4 m and armoured for stability.

As shown in Figure 29, the final step in the pond restoration was the placement of a load of stone (4-12") to re-build the armoured outlet weir and raise the water level in the pond about 30-40 cm above the pre-restoration base flow level. The elevation of the outlet weir was established such as to not flood any of the marsh area south of the historic pond footprint, but to raise the pond water level to approximately that which occurred prior to partial failure of the outlet. The outlet invert was surveyed to remain lower than any area along the old secondary roadway that forms the northern boundary of the pond.

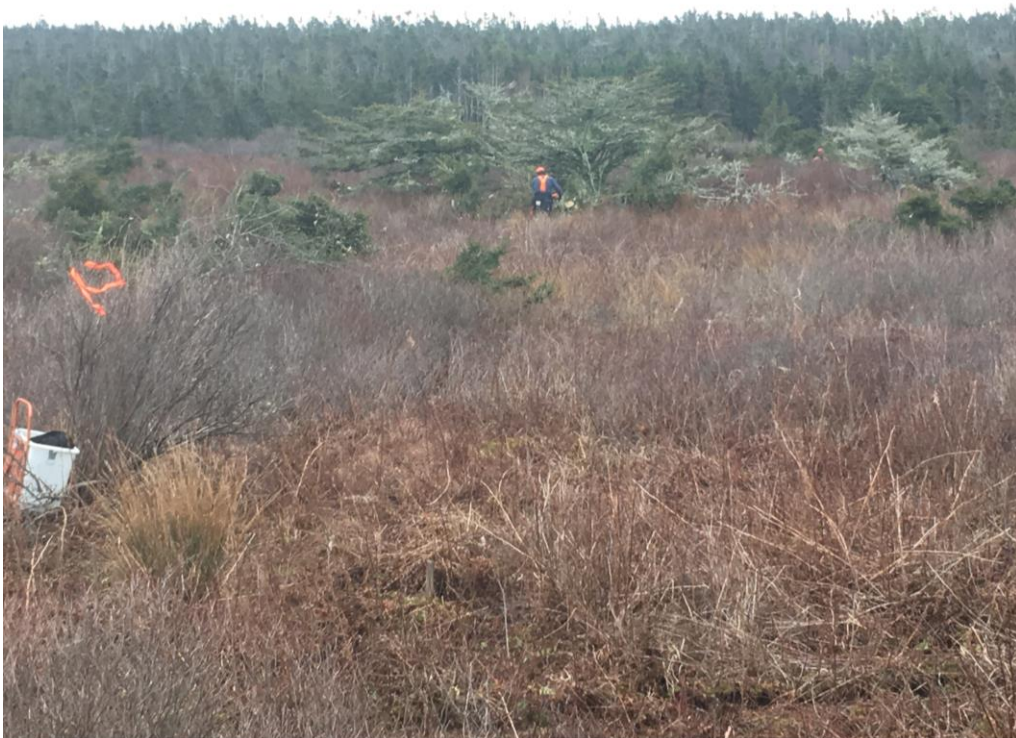
Figure 33: A crew fells trees and tall shrubs on central Big Meadow Bog. All sparse tree cover on the main bog was felled whereas only select areas of dense forest encroachment along the bog margins was cleared.

All wood felling was completed manually with chainsaws. Trees were partially limbed and stems typically bucked in 8ft lengths to facilitate the slash settling to the bog surface. None of the vegetation was removed from the site, piled on site, or burned. Instead it was left as it fell to eventually be reclaimed into the bog. Some effort was made to ensure that slash was left to cover any bare ground that may have existed under the trees, as a means of discouraging gull nesting.

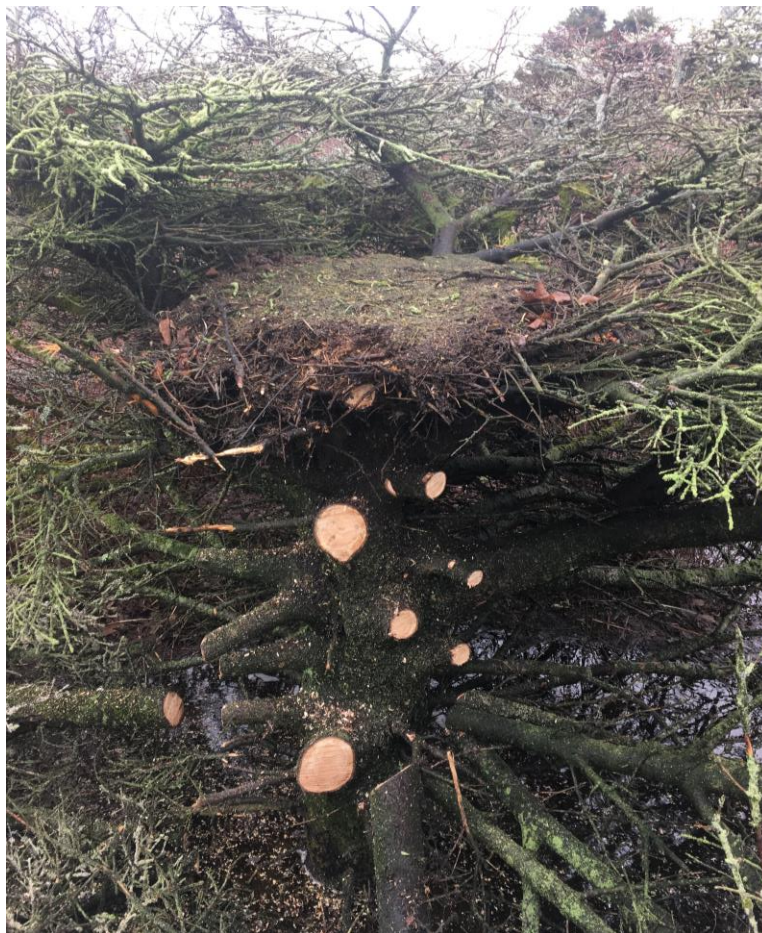
Figure 34: A roosting platform established by gulls deep inside a White spruce on Big Meadow Bog. Standing water surrounds the base of the tree following hydrological restoration.
