# **Salmon River Aquatic Resources Integrated Management Report**

**March 2002  
Final Report**

Michael A. Parker  
East Coast Aquatics  
P.O. Box 129  
Bridgetown, Nova Scotia  
B0S 1C0  
(902) 665-4682  
Project #0501

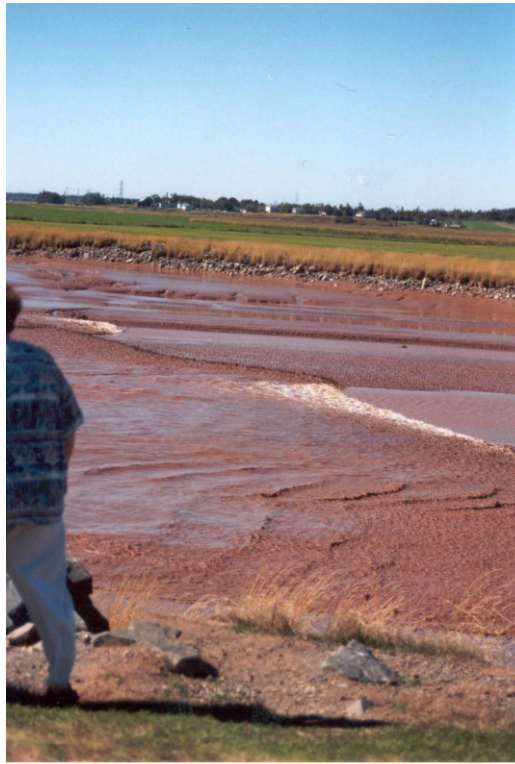
**Photo 1:** A tidal bore (moving from l to r) makes its way up the Salmon River near the highway 102 crossing. The tides in the Bay of Fundy come in with such surge that an upstream wave is created.

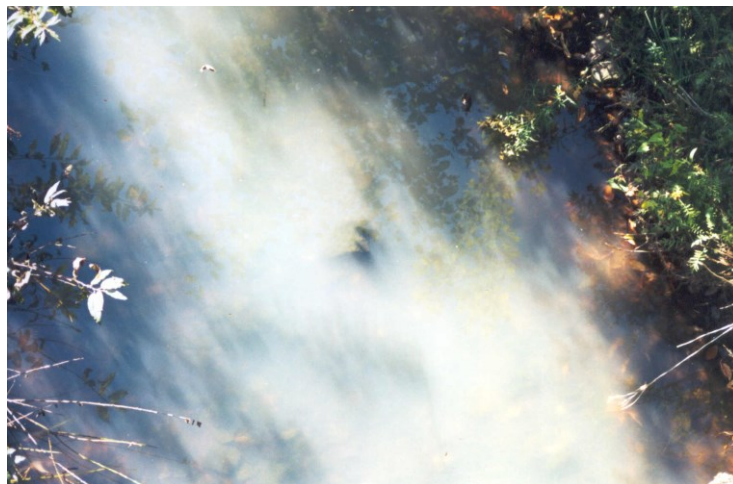
**Photo 2:** A milky suspension clouds Lepper Brook on October 03, 2001, at the railway bridge in Truro. Source is unknown.

The Lepper Brook drainage area contains the Town of Truro reservoir. As such, this basin should be carefully managed as an entity unto itself, possibly with standards separate from the remainder of the watershed. This action would ensure that both water quality and quantity are not affected. Both logging and other development take place in the Lepper Brook basin. Photo 2 documents a milky suspension in the lower brook in October of 2001, observed by chance by the author.

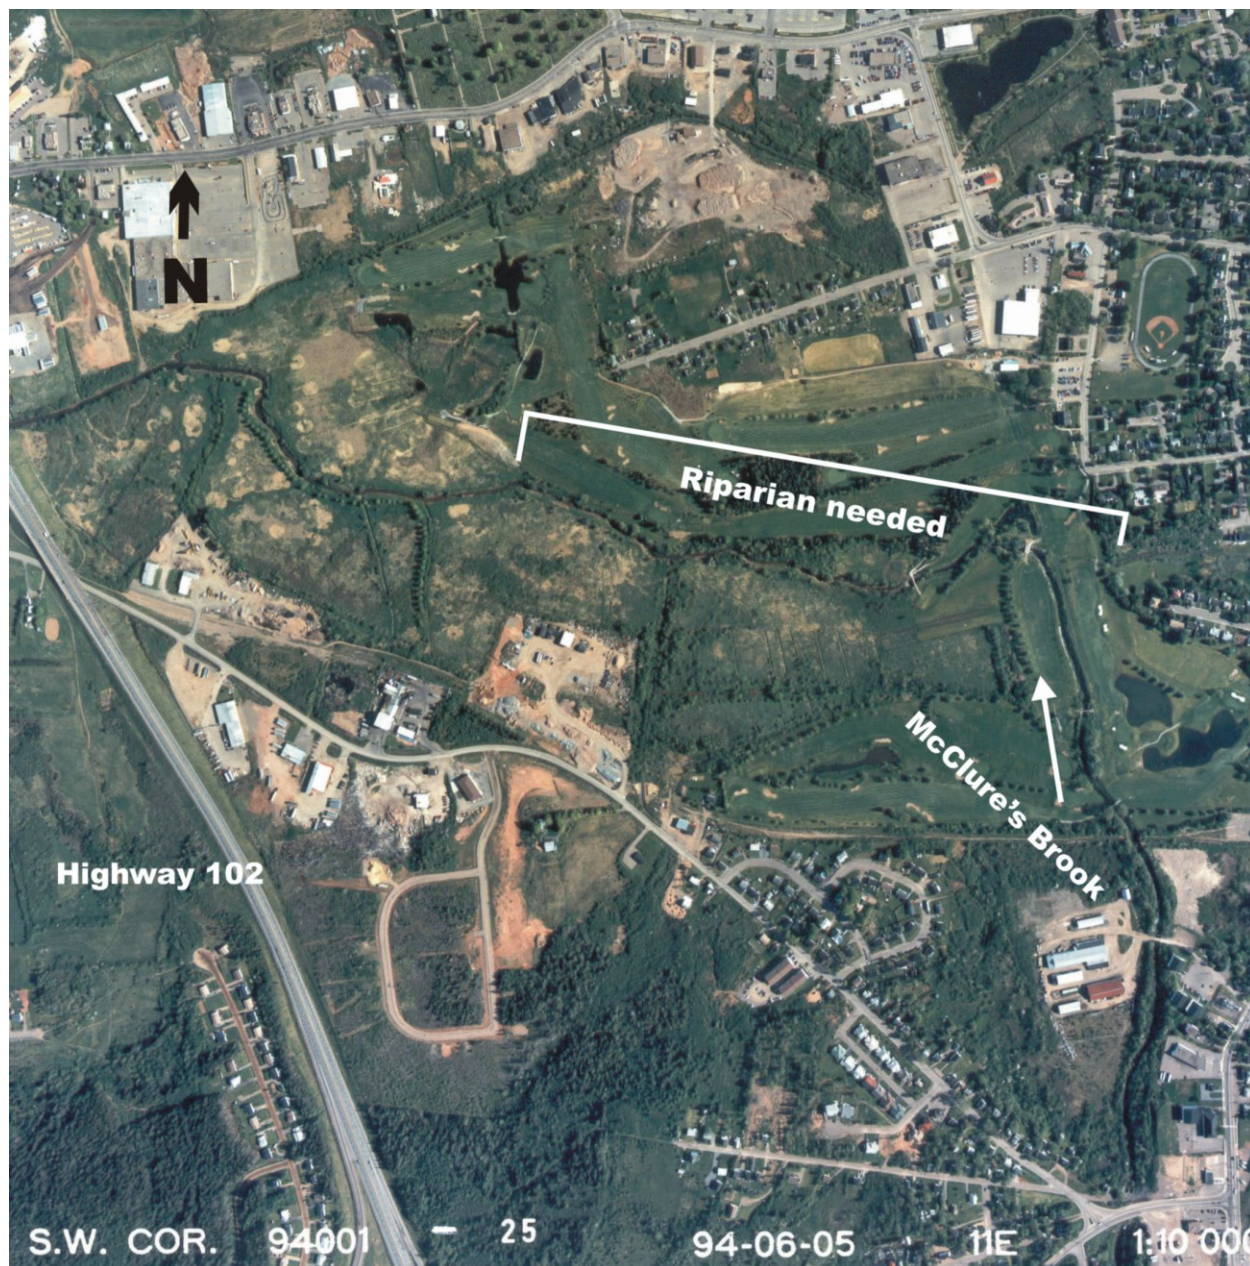
**Figure 5:** The golf course on McClure's Brook is a potential source of thermal warming because of the lack of riparian, and several ponds that may drain into the brook. As well, partnering with course management should be undertaken to ensure fertilizers are not used in a manner that would affect the brook, creating algal blooms and consuming stream oxygen.

Several site specific recommendations have been made in Table 12. However, some management activities are at this point limited, awaiting the results of a more exploratory water sampling program that would move sample locations around the watershed to help locate sources of water contamination or quality issues, or that would simply be used to provide information from smaller tributaries for which current water quality is not known. Dissolved oxygen (DO<sub>2</sub>), fecal and total coliforms, temperature (long term data logging through summer highs), and total suspended solids (TSS) should be the base parameters to be evaluated. Each site should be tested at least twice to help account for variation, and should be tested at the time of greatest potential impact, such as spring flood and summer low flows (post rain events if possible). If testing does not reveal water quality issues at the anticipated worst times, then we have greater confidence water quality issues do not exist at the sampled location. This sampling will produce results for several watershed locations, defining issues of water temperature and fecal coliform contamination. The results of exploratory sampling for fecal coliform should be used to determine if irrigation and livestock watering are permissible (see Appendix C for guidelines) in various areas of the watershed. It will also help to confirm sources of fecal contamination so that partnerships may be developed with relevant landowners to address source problems. Low dissolved oxygen results would add further priority to a critical site. Summer temperature data will quantify thermal warming impacts and determine the need for higher priority of riparian planting, as well as protection for cool water refuge areas (see Figure 5).

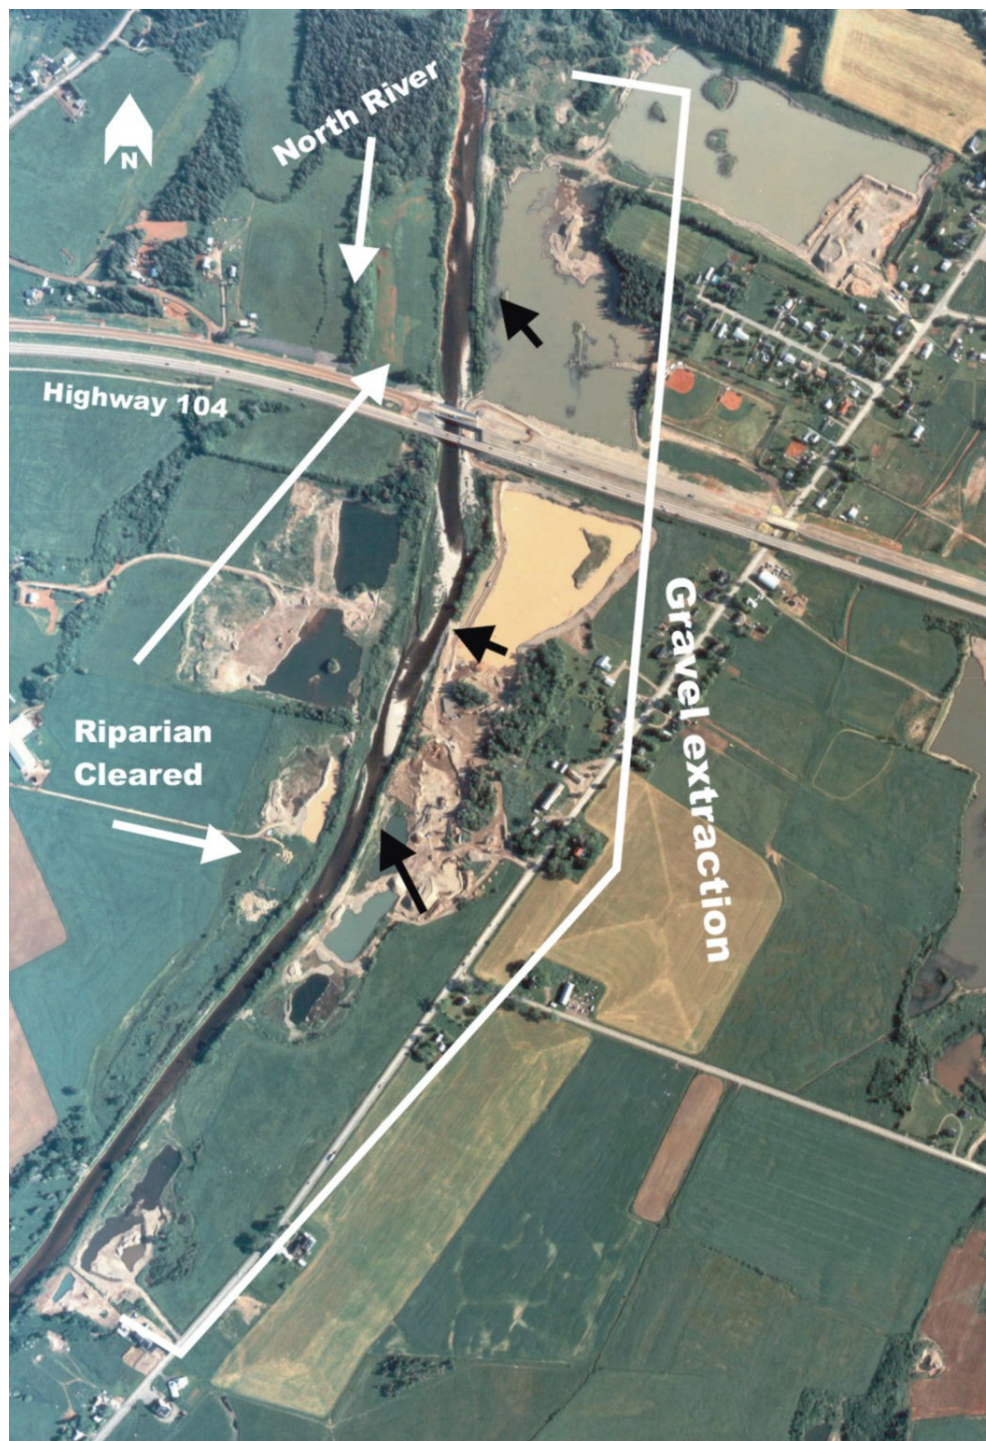
**Figure 8:** Numerous gravel extraction operations exist immediately adjacent to both sides of the lower North River near Highway 104. Resulting ponds exhibit suspended sediments. Thermal warming and sedimentation may be an issue if these channels drain directly to the river. The North River has been channelized all along this reach (see also Photo 3), and completely lacks habitat diversity.

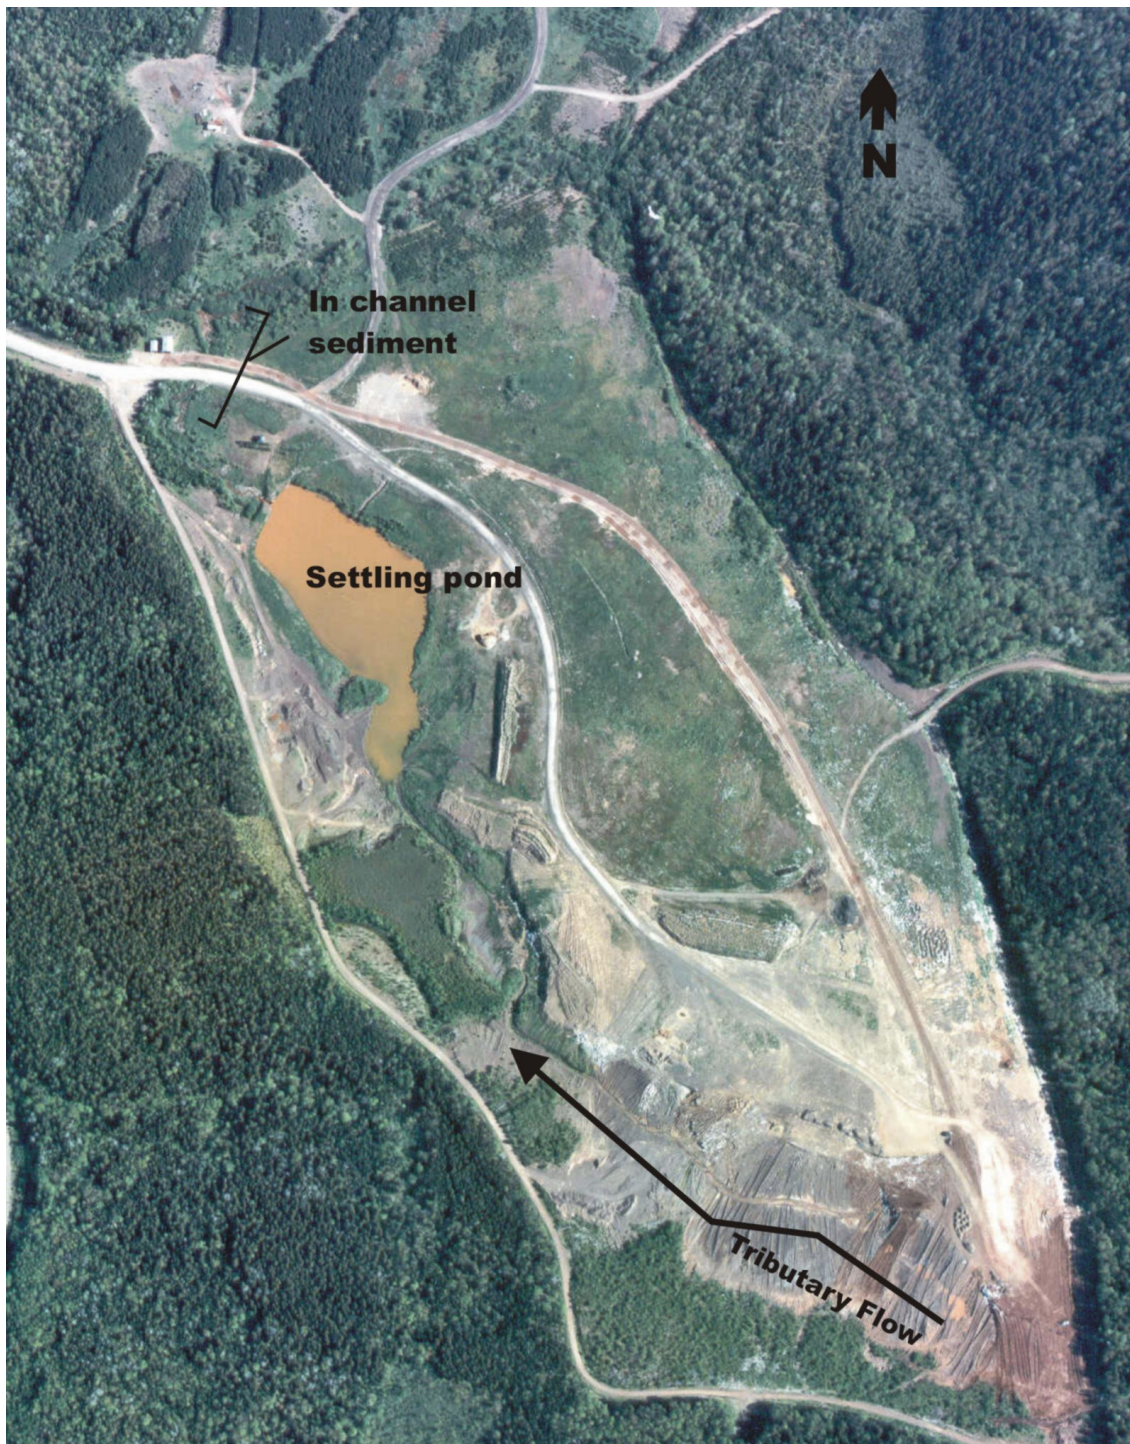
**Figure 9:** This small unnamed tributary to McClure's brook is the location of the Town of Truro dump. The settling pond appears inadequate based on visible sediments in the channel below the pond. There is good stream habitat and riparian for some distance downstream.

There is a Town dump site on a small tributary to McClure's brook (see Figure 9) that appears to be a sediment source. Although a settling pond exists, the existence of downstream sediment bars would indicate the pond is inadequate. There is also significant potential for leachate from the dump to directly enter the watercourse.

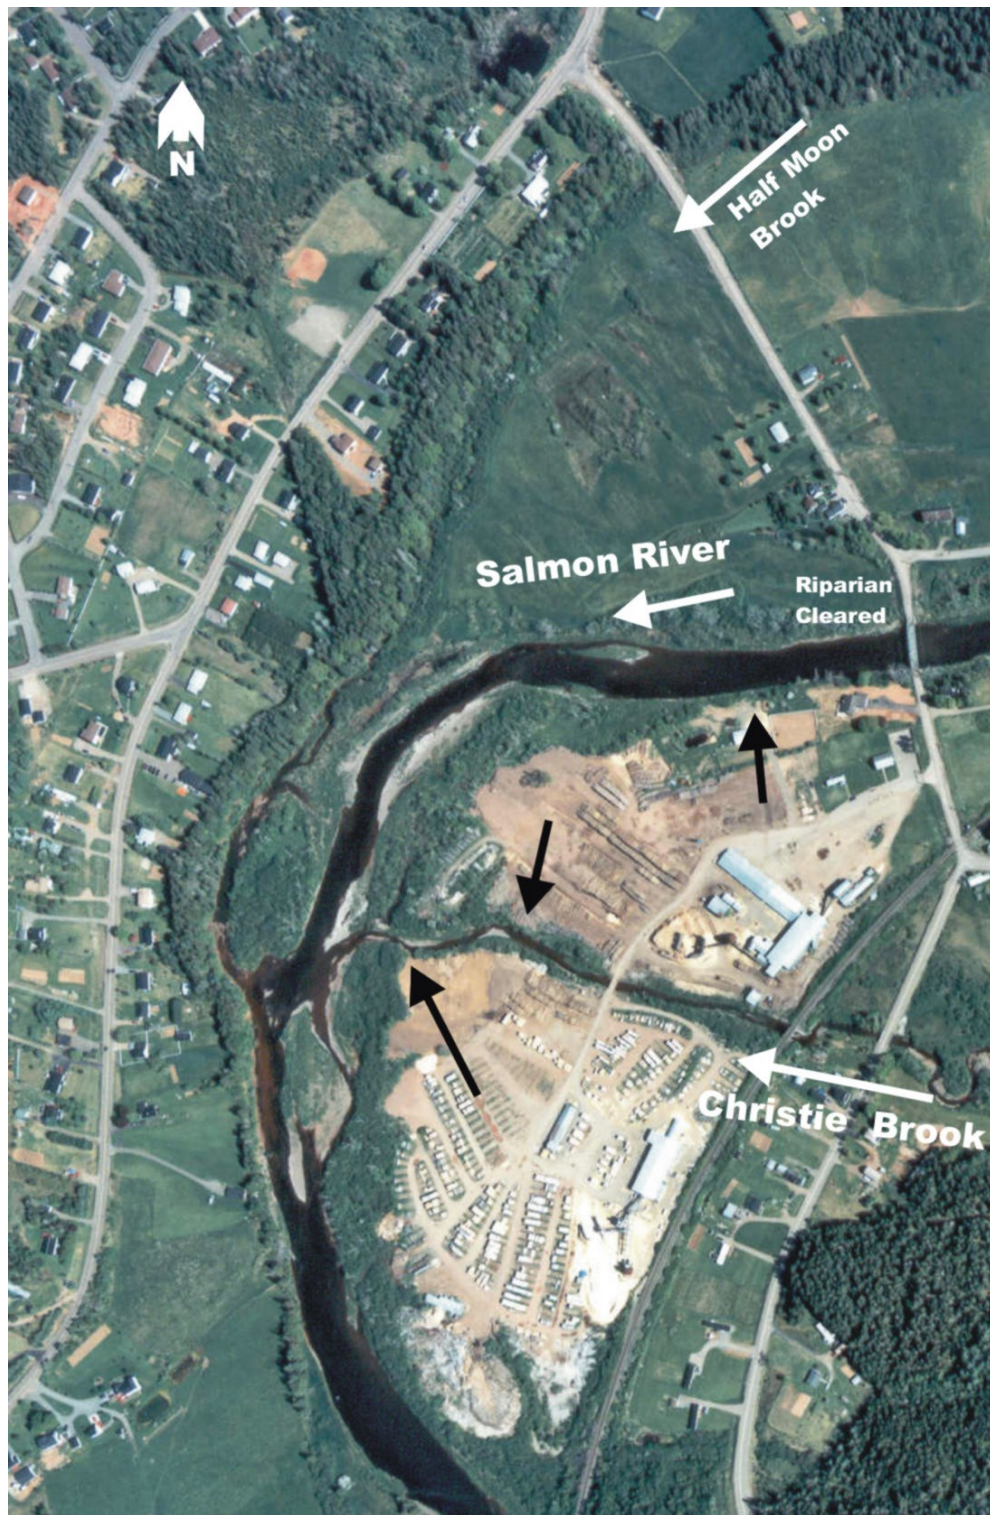
**Figure 10:** A lumber yard at the confluence of Christie Brook and Salmon River encroaches both systems. As the yard is likely a high traffic area, the potential is great for sediment runoff to the streams through the minimal riparian.

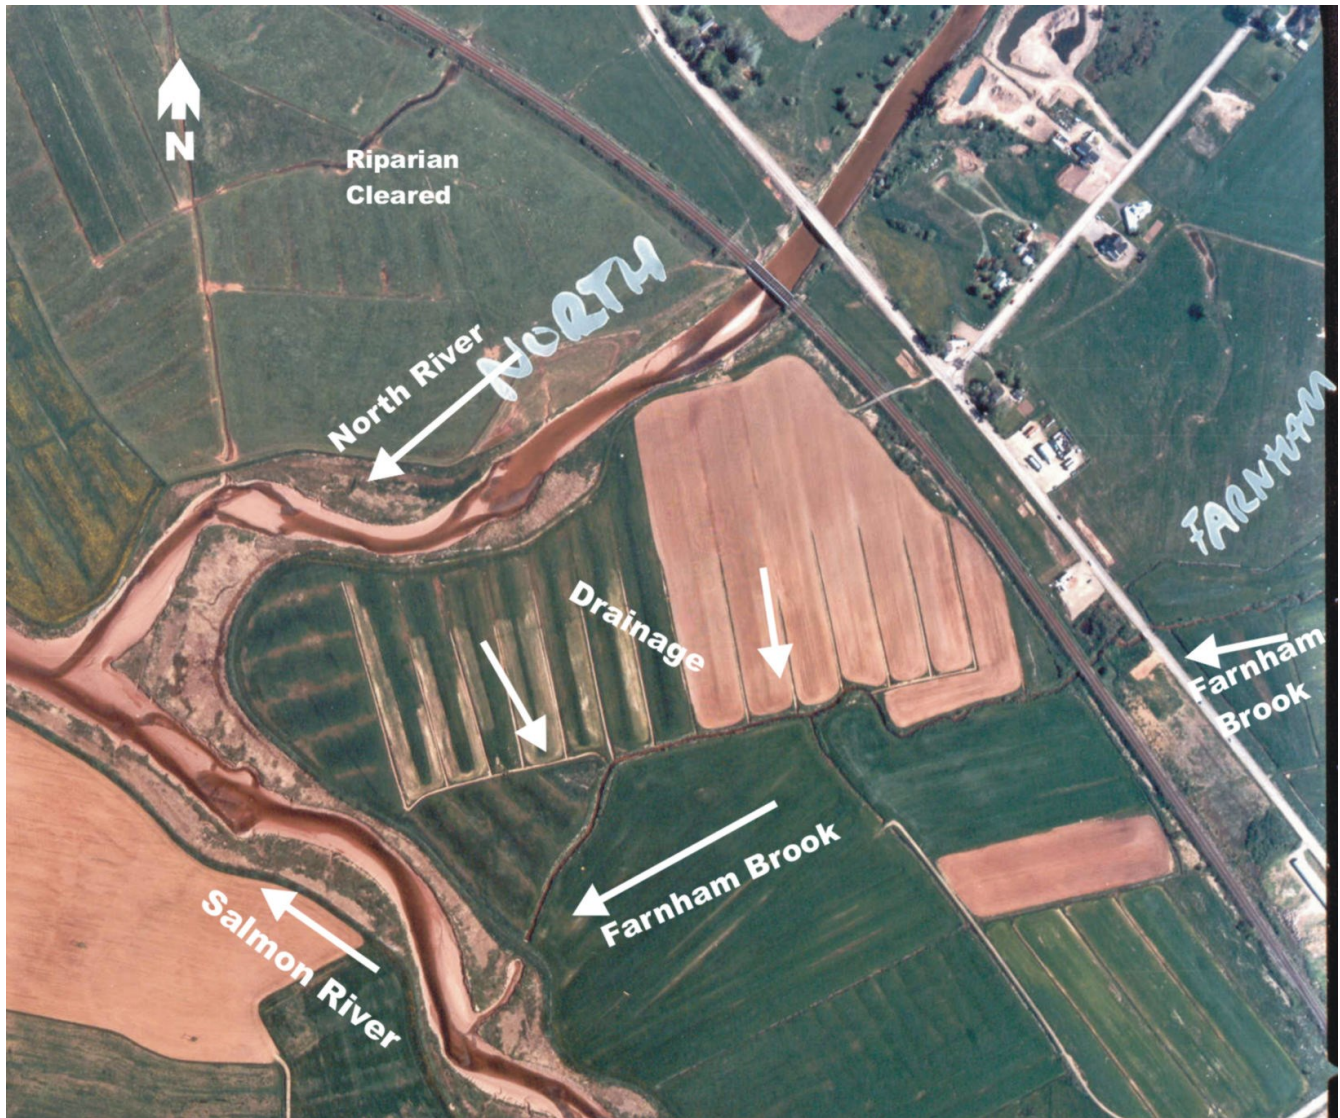
**Figure 11:** Fourteen ditches drain a field directly to lower Farnham Brook, and are a likely source of sediment. Almost all riparian is lacking from the confluence with the Salmon River upstream to Farnham Road.

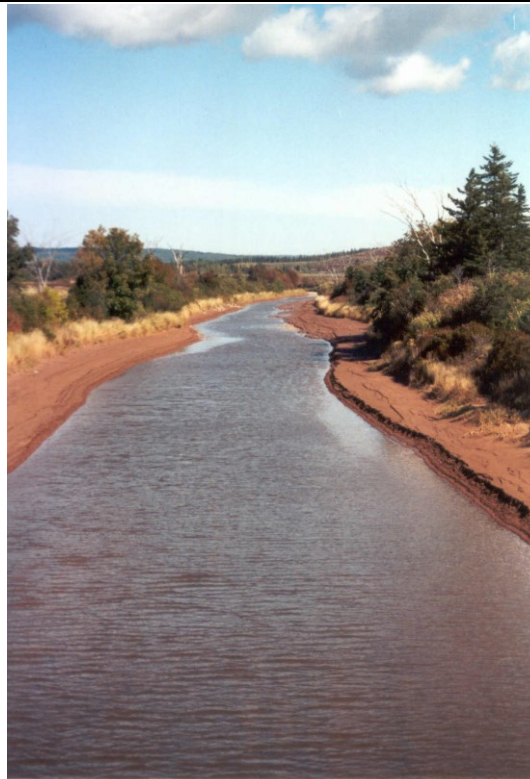
**Photo 3:** The North River looking upstream from near the confluence with the Salmon River. The channel has been straightened, bermed, and stripped of all significant riparian growth. Lack of in-stream complexity is apparent.

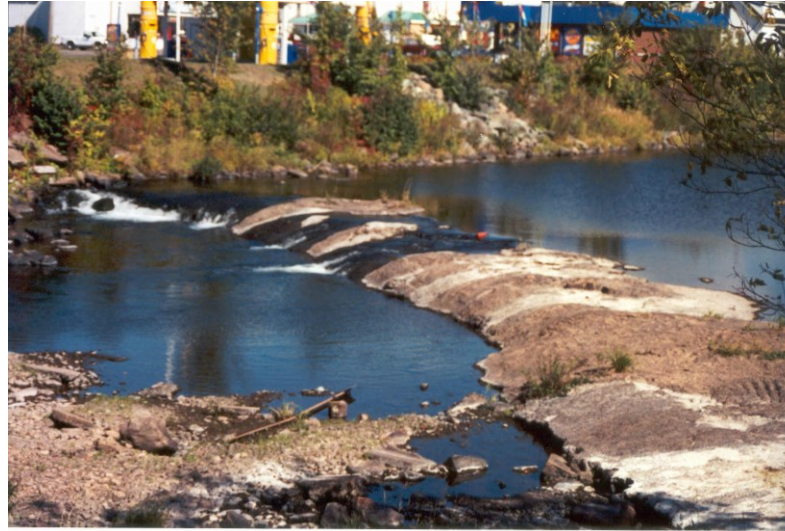
**Photo 4:** A cement cap helps protect a pipeline crossing of the Salmon River at Truro. At low flows, such as in the photo, it could inhibit some fish passage.

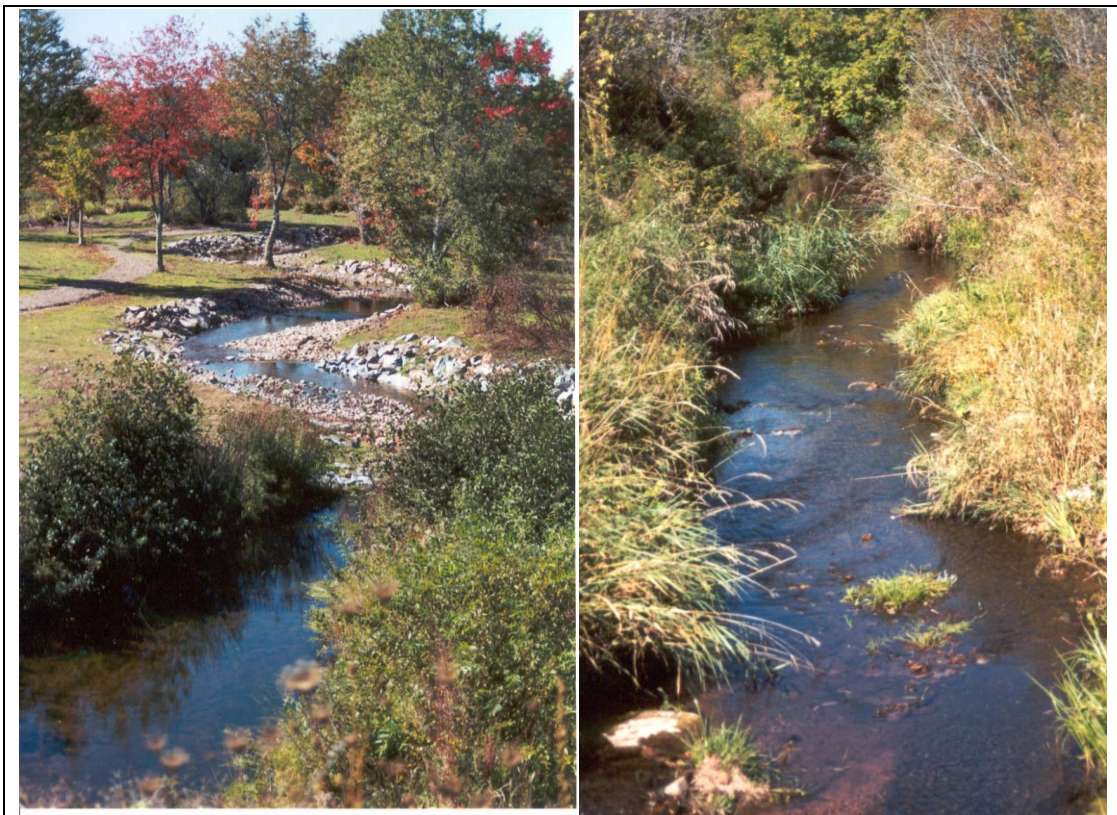
**Photo 5:** Two photos of Farnham Brook. The one on the left shows recent stream improvements conducted below Vimy Rd. The right photo shows an up stream stretch with good riparian function, although the channel lacks structure and complexity.

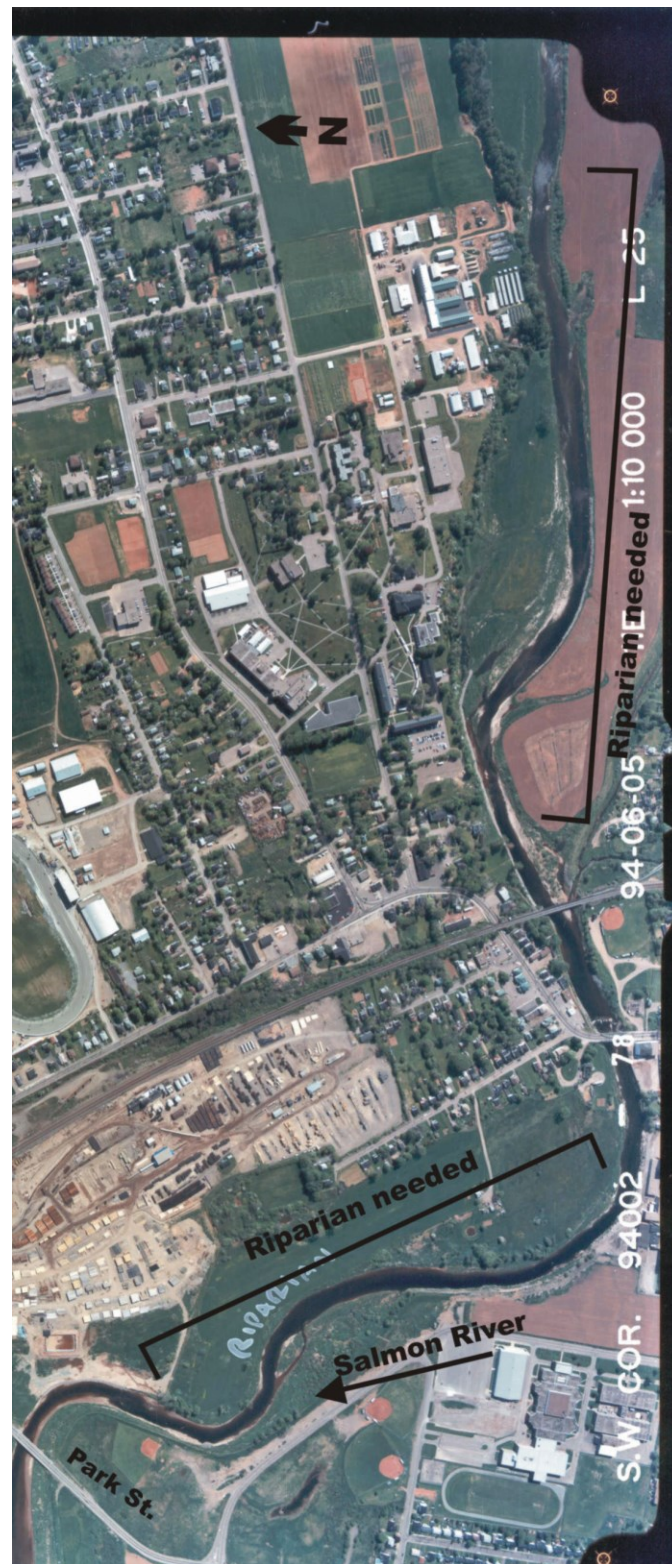
**Figure 12:** The riparian corridor along the Salmon River is lacking for 3km through Truro, along both banks of the river. It appears likely there are only a couple of landowners with whom to address this high priority issue.

Riparian functions of the lower reaches of the Salmon River (see Figure 12), and all the tributaries entering these lower reaches (see Figure 13), have been severely impaired. Table 12 outlines, at a great underestimate, more than 24 km of river channel that is almost completely devoid of riparian vegetation and function. Stretches of river up to 3 km long have little or no riparian areas. The severely degraded, or lacking, riparian functions makes restoration the second most important priority for this watershed behind water quality. It is also the single most important long term IMP issue to address for the future health of the aquatic ecosystem, because of the length of time necessary to establish a fully functional riparian area in a location where none currently exists.

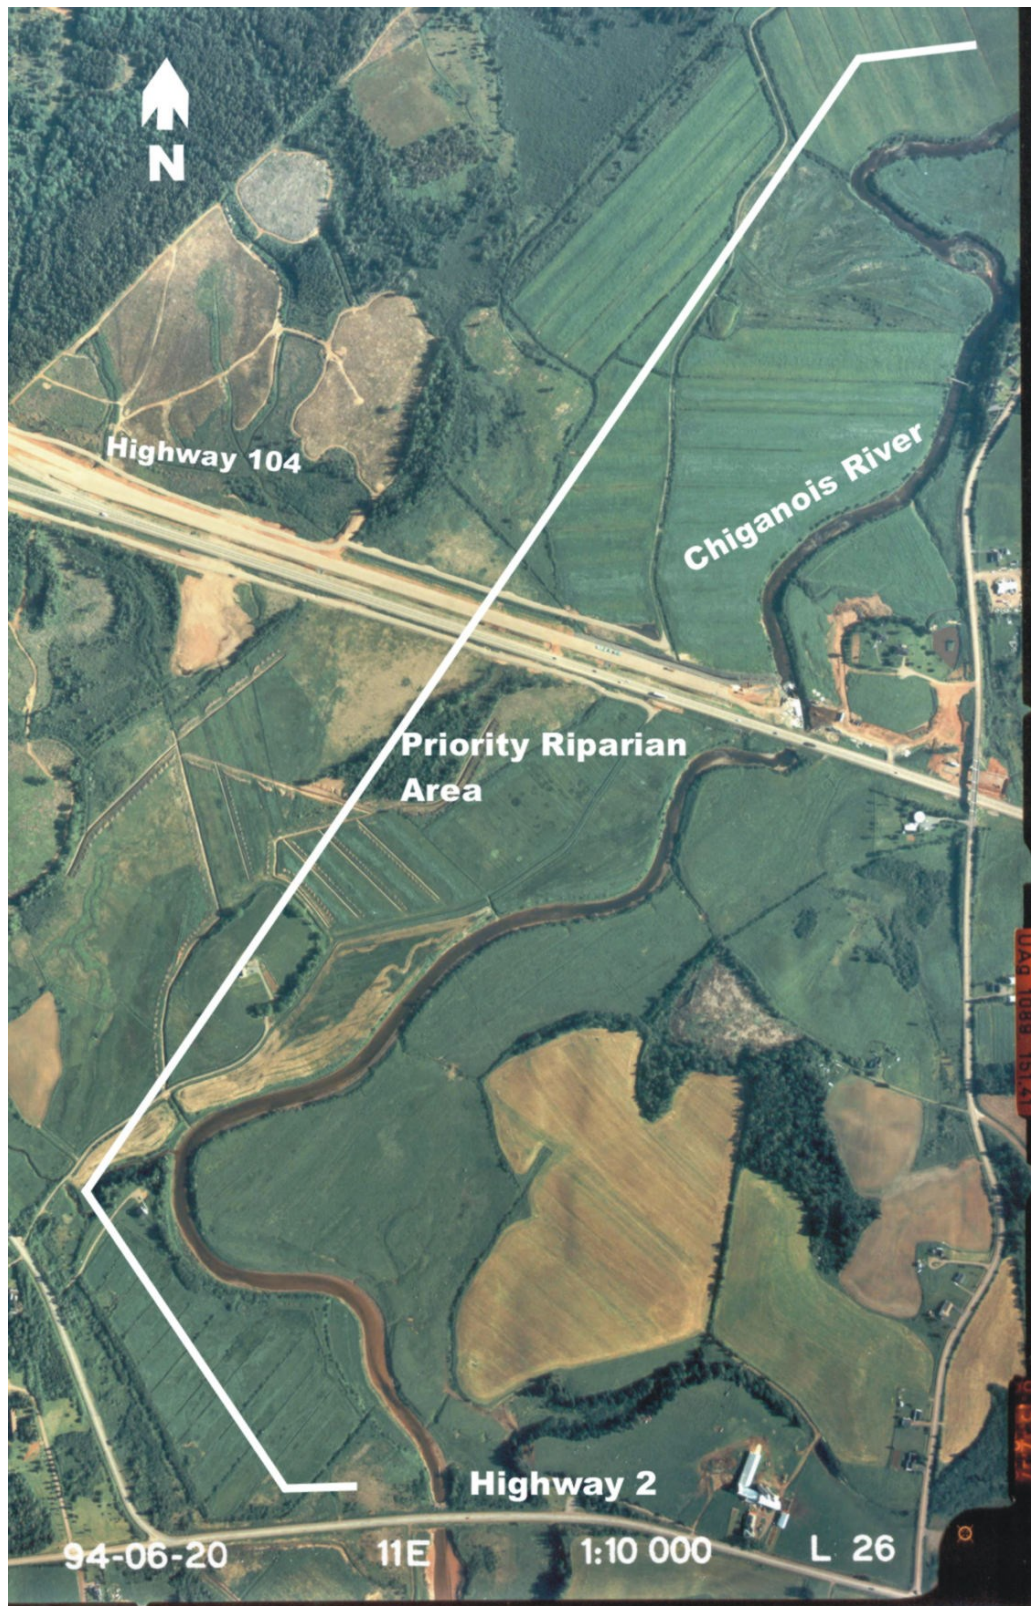
**Figure 13:** Over 3.5 km of the lower Chiganois River has no mature riparian vegetation. The resulting lack of habitat complexity is apparent, and other functions of the riparian are severely impaired. The importance of this reach makes it a high priority for extensive riparian restoration.
