**PRE-DEMOLITION  
HAZARDOUS BUILDING MATERIALS ASSESSMENT  
FORMER CONSTRUCTION CAMP SITES  
BAY D'ESPOIR – AVALON TRANSMISSION LINE (TL202/TL206)  
NEWFOUNDLAND AND LABRADOR**

**Newfoundland and Labrador Hydro,  
a Nalcor Energy Company**  
Hydro Place, 500 Columbus Drive  
PO Box 12400  
St. John's, NL A1B 4K7

April 2019

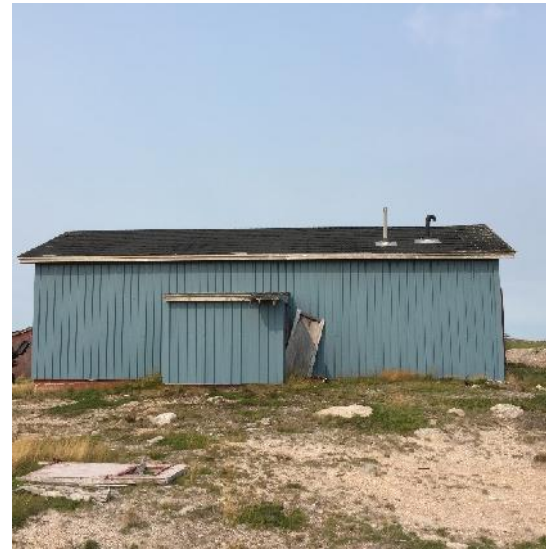
It is important to note that, due to height constraints, no samples of building materials around roof penetrations (e.g., caulking or sealants around vents or electrical conduit) or roof seams were collected for analysis (refer to Photo 6, Appendix B2).

Photo 6: View of the accommodations cabin at Camp #1 site, looking northeast (Note: attached generator shed).

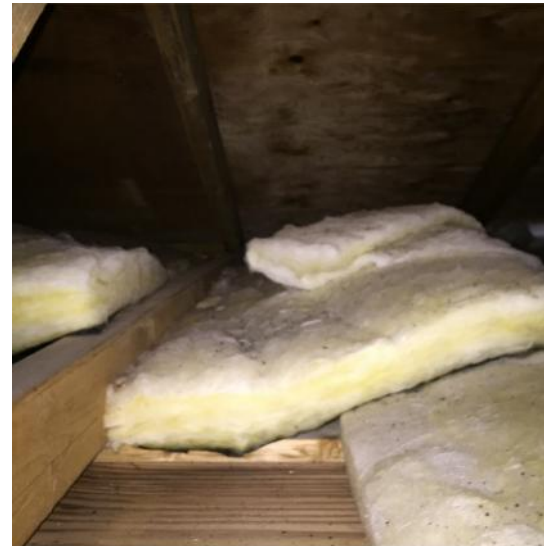
During the Pre-Demolition HBMA site visit, fiberglass batt insulation was observed in the attic and walls of the accommodations cabin (refer to Photos 12, 17 and 18, Appendix B2). Thermal system insulation was not observed at Camp #1.

Visual indicators suggesting the potential presence of UFFI were not observed at Camp #1. The nature of the insulation in the walls and ceilings throughout the accommodations cabin consisted of fiberglass batt insulation (refer to Photos 12, 17 and 18, Appendix B2).

Photo 12: View of the attic inside the accommodations cabin at Camp #1  
(Note: attic hatch in the ceiling of Room 1).

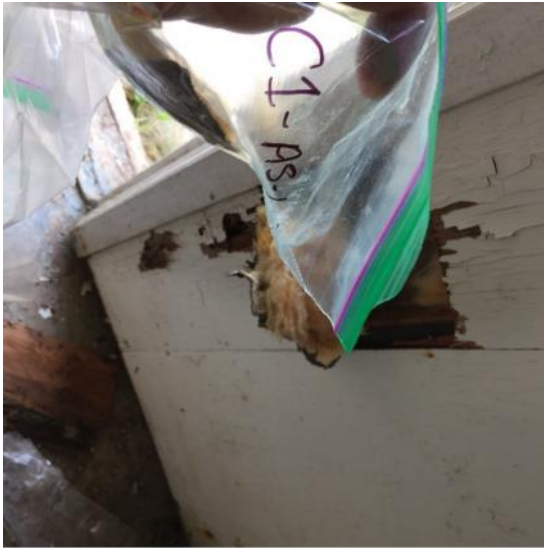
Photo 17: View of bulk material sample C1-AS-1, black paper backing and pink fibreglass insulation, cabin interior.

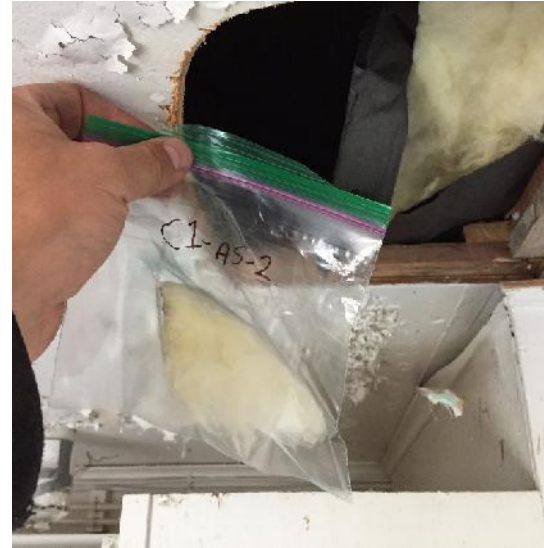
Photo 18: View of bulk material sample C1-AS-2, black paper backing and yellow fibreglass insulation, cabin interior.

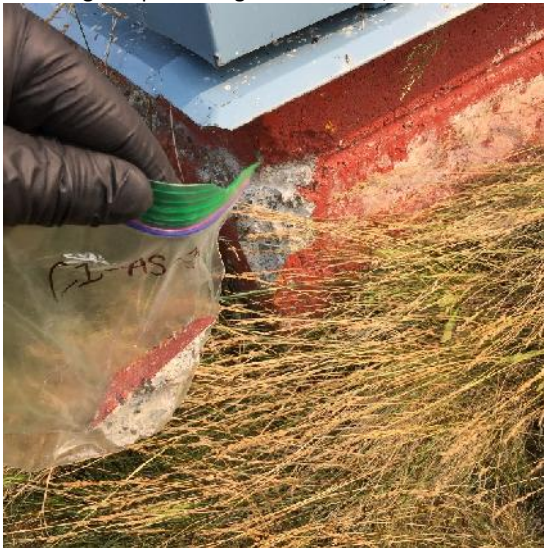
During the Pre-Demolition HBMA site visit, one (1) sample of concrete (C1-AS-3) was collected from the concrete foundation of the accommodations cabin and one (1) sample of concrete block and mortar (C1-AS-4) was collected from the foundation of the accommodations cabin and analyzed for asbestos content (refer to Photos 19 and 20, Appendix B2). Asbestos was not detected in the concrete and concrete block and mortar samples analyzed.

Photo 19: View of bulk material sample C1-AS-3, concrete, cabin exterior.

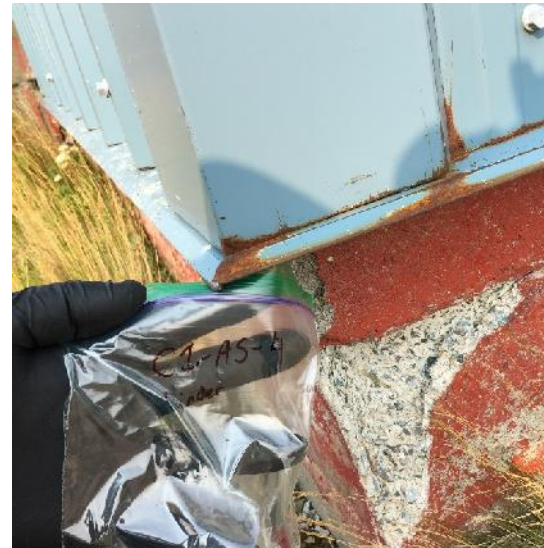
Photo 20: View of bulk material sample C1-AS-4, concrete block and mortar, cabin exterior.

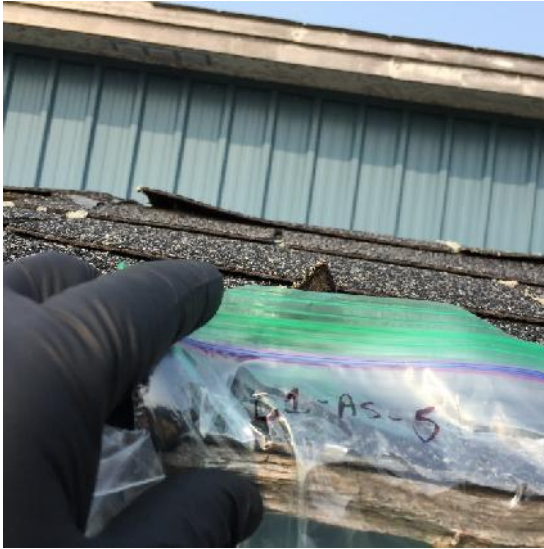
During the Pre-Demolition HBMA site visit, one (1) sample of black asphalt shingle and tar (C1-AS-5) was collected from the roof of the accommodations cabin and one (1) sample of black asphalt shingle and tar (C1-PP-AS-1) was collected from the roof of the outhouse and analyzed for asbestos content (refer to Photos 21 and 22, Appendix B2). Asbestos was not detected in the roofing product samples analyzed.

Photo 21: View of bulk material sample C1-AS-5, black shingle and tar, cabin exterior.

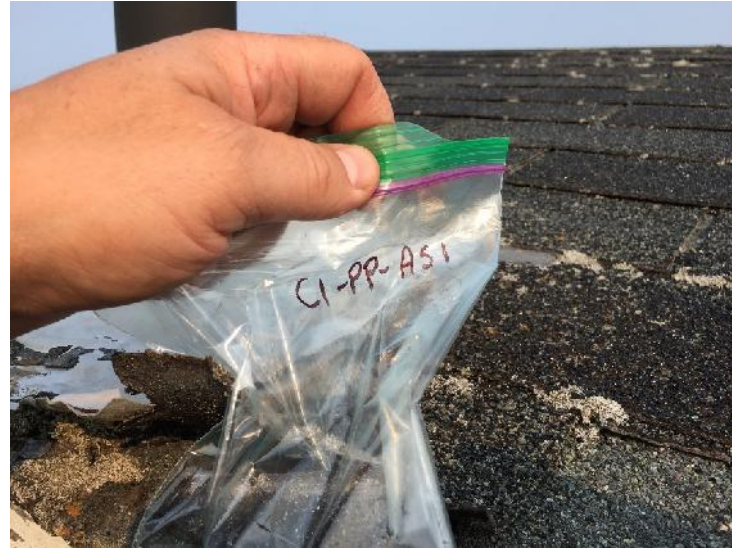
Photo 22: View of bulk material sample C1-PP-AS1, black shingle and tar, outhouse exterior.

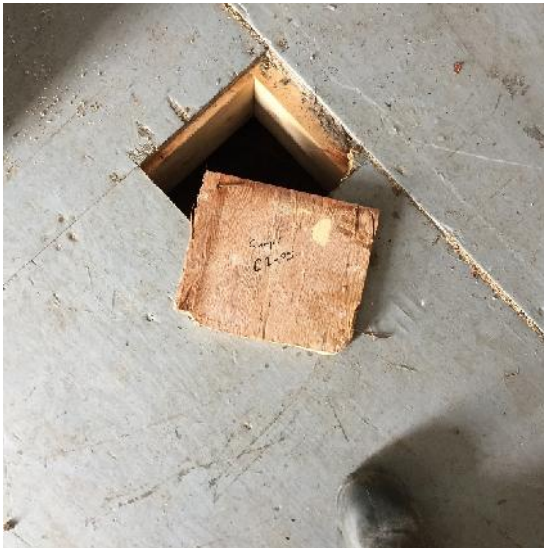
During the Pre-Demolition HBMA site visit, six (6) samples (C1-PS1 to C1-PS6) were collected from painted surfaces of the accommodations cabin and three (3) samples (C1-PP-PS1 to C1-PP-PS3) were collected from painted surfaces of the outhouse and analyzed for lead, mercury and PCB content (refer to Photos 23 to 31, Appendix B2). Paint sample descriptions and lead, mercury and PCBs analytical results are summarized in Tables C2-2 to C2-4, Appendix C2. Sample locations and analytical results are graphically illustrated in Figure 2.1, Appendix A2.

Photo 23: View of paint sample C1-PS1, floor, cabin interior.

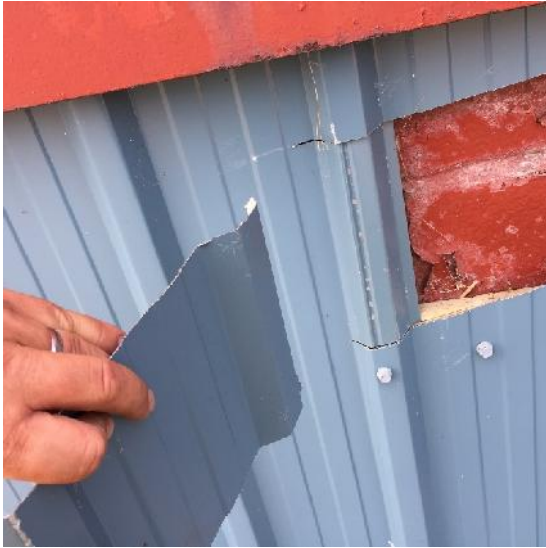
Photo 25: View of paint sample C1-PS3, wall, cabin exterior.

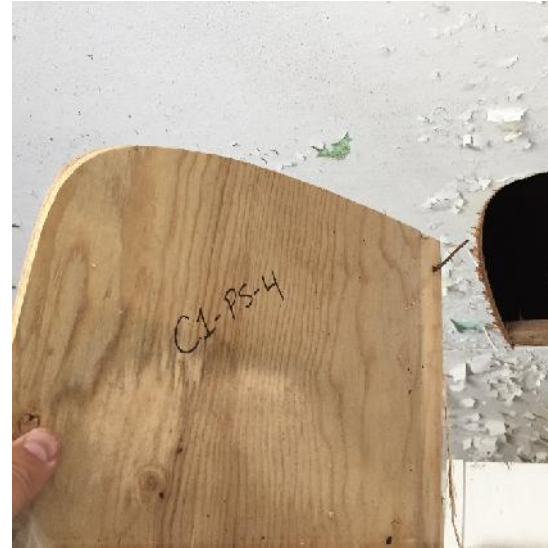
Photo 26: View of paint sample C1-PS4, ceiling, cabin interior.

| Sample ID | Room No. | Room Description | Photo No. | Sample Location | Substrate | Sample Description | RDL (mg/kg) | Lead (mg/kg) |
|---|---|---|---|---|---|---|---|---|
| C1-PS4 | 1 | Kitchen | 26 | Ceiling | Plywood | White on green on plywood (sample includes loose paint and paint on wood) | 5.0 | <b><u>194</u></b> |

| Sample ID | Room No. | Room Description | Photo No. | Sample Location | Substrate | Sample Description | RDL<br>(mg/kg) | Mercury<br>(mg/kg) |
|---|---|---|---|---|---|---|---|---|
| C1-PS4 | 1 | Kitchen | 26 | Ceiling | Plywood | White on green on plywood (sample includes loose paint and paint on wood) | 0.05 | 1.8 |

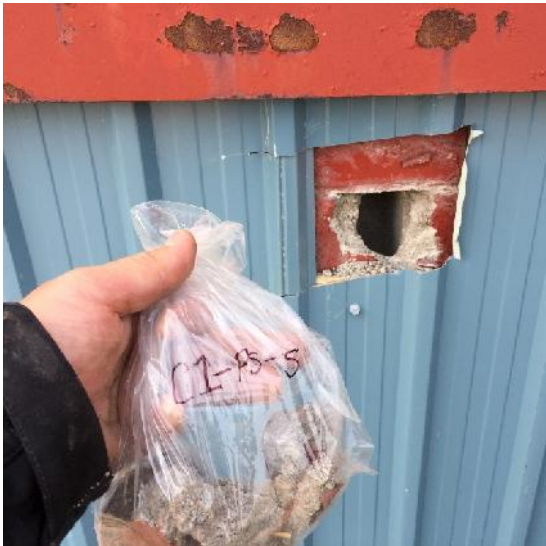
Photo 27: View of paint sample C1-PS5, wall, cabin exterior.

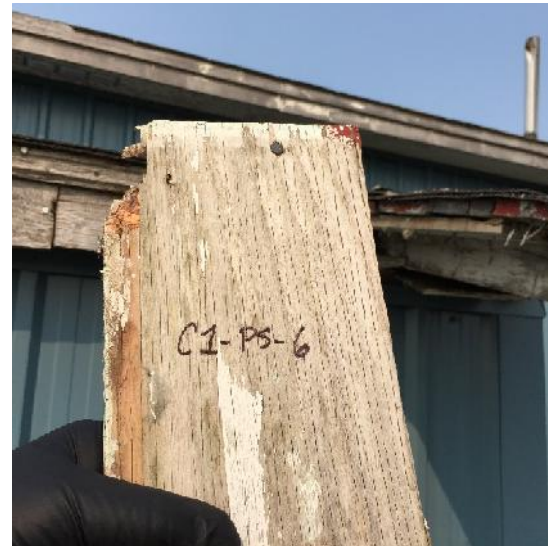
Photo 28: View of paint sample C1-PS6, wall, cabin exterior.

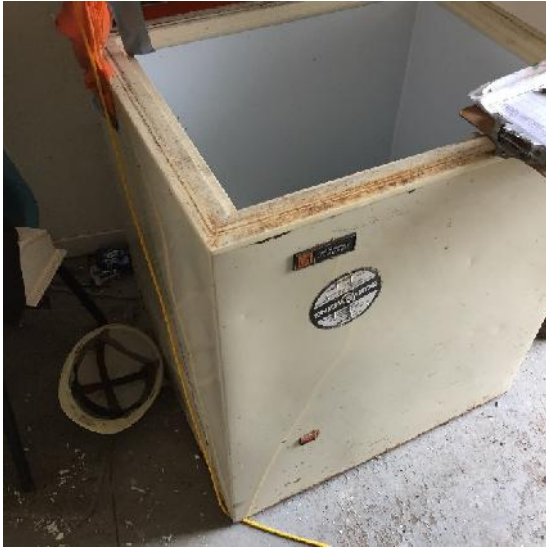
Photo 33: View of freezer inside the accomodations cabin, containing R12 refridgerant.

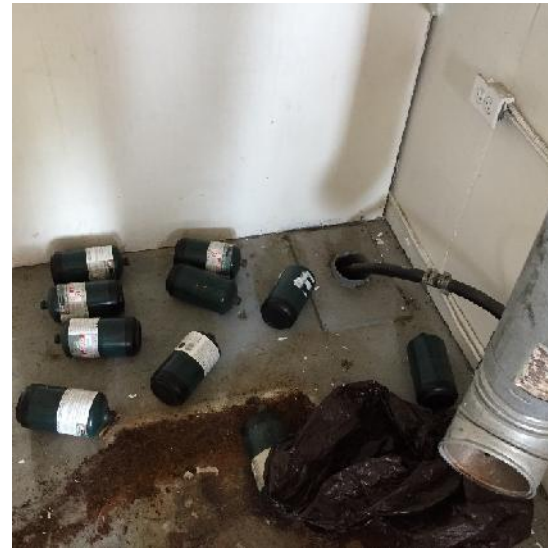
Photo 36: View of propane canisters located on the interior of the accomodations cabin.

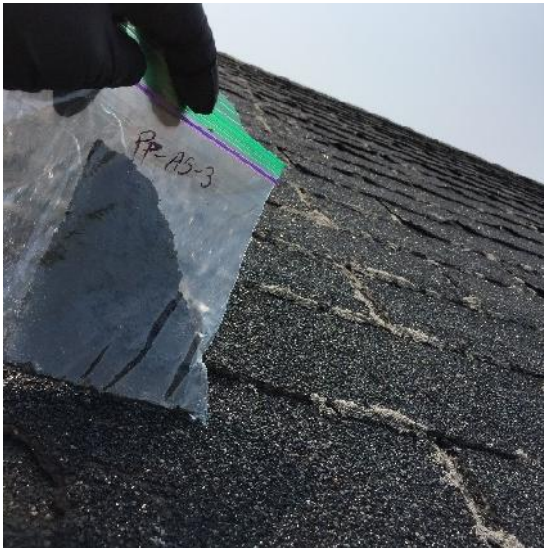
During the Pre-Demolition HBMA site visit, one (1) sample of black asphalt shingle (PP-AS-3) was collected from the roof of the accommodations cabin and one (1) sample of black asphalt shingle and tar (PP-PP-AS-1) was collected from the roof of the outhouse and analyzed for asbestos content (refer to Photos 19 and 22, Appendix B3). Asbestos was detected in PP-AS-3 containing 2.2 % chrysotile asbestos and in PP-PP-AS1 containing 1.1% chrysotile asbestos. According to the NL asbestos abatement regulations (Reg. 111/98), both materials are considered asbestos-containing materials.

Photo 19: View of bulk material sample PP-AS-3, black shingle, cabin exterior. **2.2 % Crysotile Asbestos**

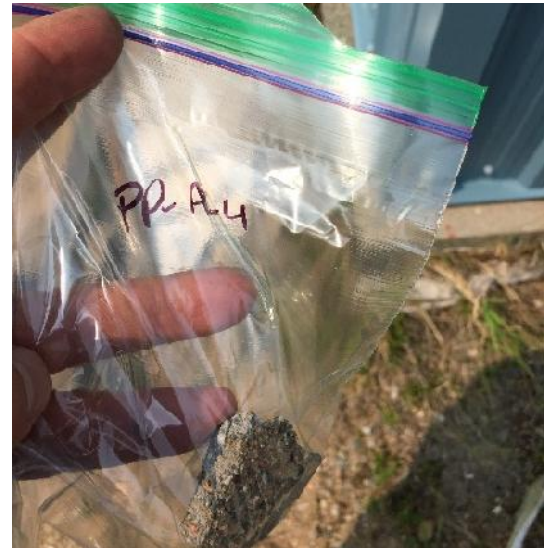
During the Pre-Demolition HBMA site visit, one (1) sample of concrete (PP-AS-4) was collected from the concrete foundation footing of the accommodation cabin and one (1) sample of concrete block and mortar (PP-AS-5) was collected from the exterior wall of the accommodation cabin and analyzed for asbestos content (refer to Photos 20 and 21, Appendix B3). Asbestos was not detected in the concrete or the concrete block and mortar samples analyzed.

Photo 20: View of bulk material sample PP-AS-4, concrete, cabin exterior.

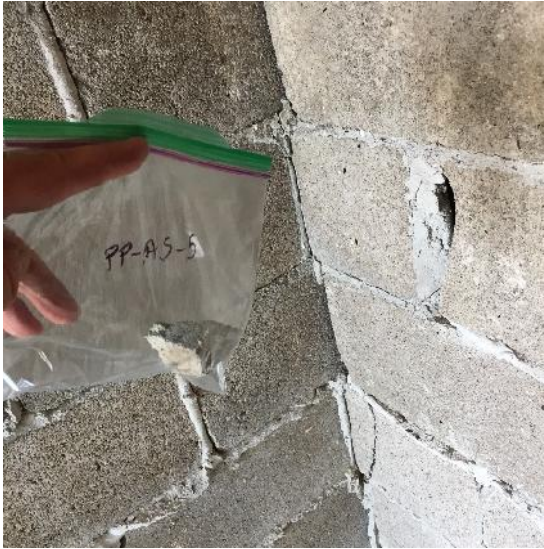
Photo 21: View of bulk material sample PP-AS-5, concrete block and mortar, cabin exterior.

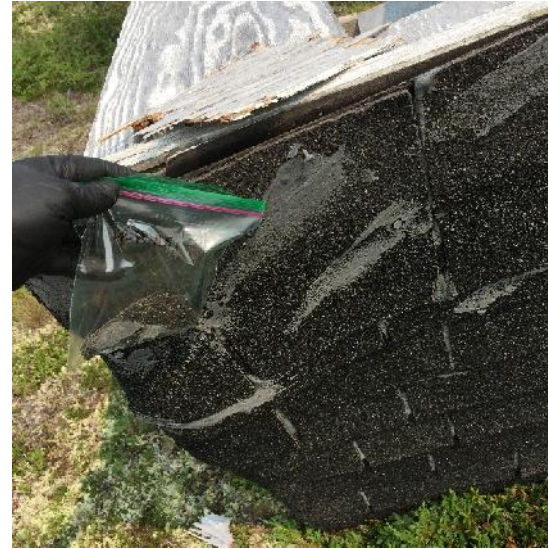
Photo 22: View of bulk material sample PP-PP-AS1, black shingle and tar, outhouse exterior. **1.1 % Cryotile Asbestos**

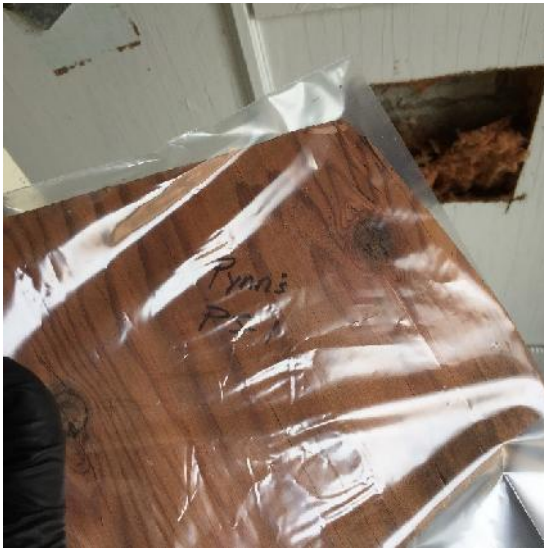
During the Pre-Demolition HBMA site visit, six (6) samples (PP-PS1 to PP-PS6) were collected from painted surfaces of the accommodations cabin and one (1) sample (PP-PP-PS1) was collected from the painted surfaces of the outhouse and analyzed for lead, mercury and PCB content (refer to Photos 23 to 29, Appendix B3). Paint sample descriptions and lead, mercury and PCBs analytical results are summarized in Tables C3-2 to C3-4, Appendix C3. Sample locations and analytical results are graphically illustrated in Figure 3.1, Appendix A3.

concentration (10, 400 mg/kg) above both the Federal HPA criterion of 90 mg/kg and the former Federal HPA criterion of 5,000 mg/kg (refer to Photo 28, Appendix B3). Two (2) paint samples (PP-PS1 and PP-PS3) contained lead at concentrations above the Federal HPA criterion of 90 mg/kg and below the former Federal HPA criterion of 5,000 mg/kg (refer to Photos 23 and 25, Appendix B2). The concentrations of lead in the other four (4) samples were below the Federal HPA criterion (90 mg/kg).

Photo 23: View of paint sample PP-PS1, floor, cabin interior.

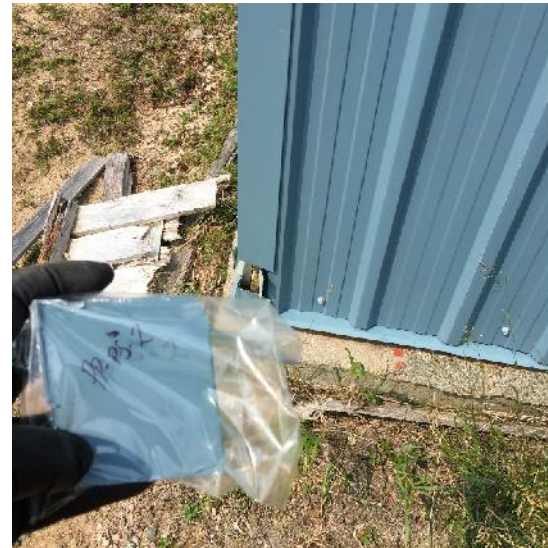
Photo 24: View of paint sample PP-PS2, wall, cabin exterior.

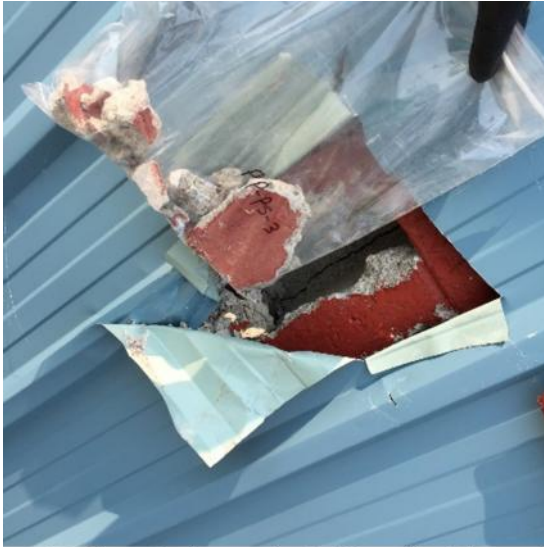
Photo 25: View of paint sample PP-PS3, wall, cabin exterior.

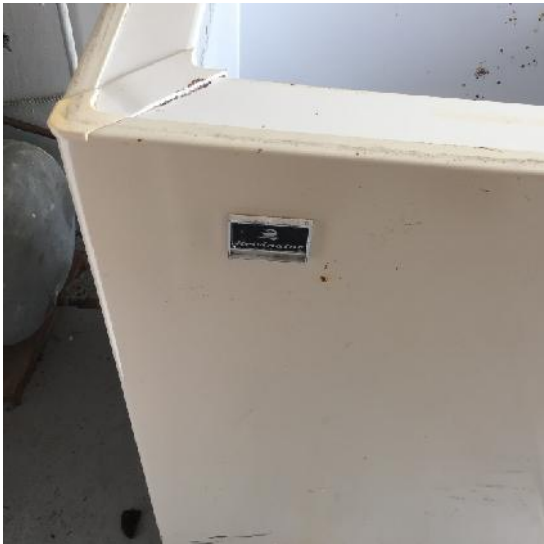
Photo 30: View of bulk mould sample PP-MS1, wall of cabin interior.

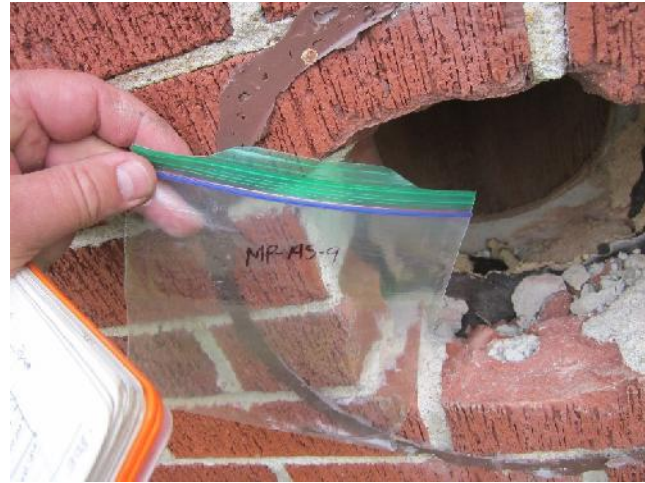
During the Pre-Demolition HBMA site visit, one (1) sample of red sealant (MP-AS9) was collected from around the brick on the accommodations cabin and one (1) sample of white caulking (MP-AS10) was collected from the vent on the exterior of the accommodations building and analyzed for asbestos content (refer to Photos 22 and 23, Appendix B6). Asbestos was not detected in the white caulking sample (MP-AS) collected from the accommodations cabin.

Photo 22: View of bulk material sample MP-AS9, red sealant, cabin exterior.

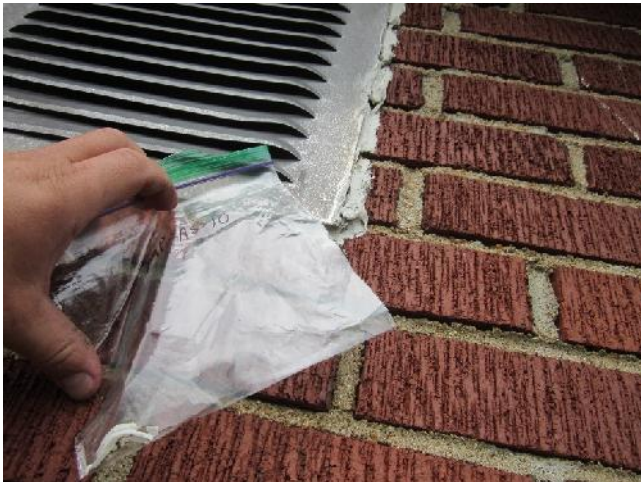
Photo 23: View of bulk material sample MP-AS10, white caulking, cabin exterior.

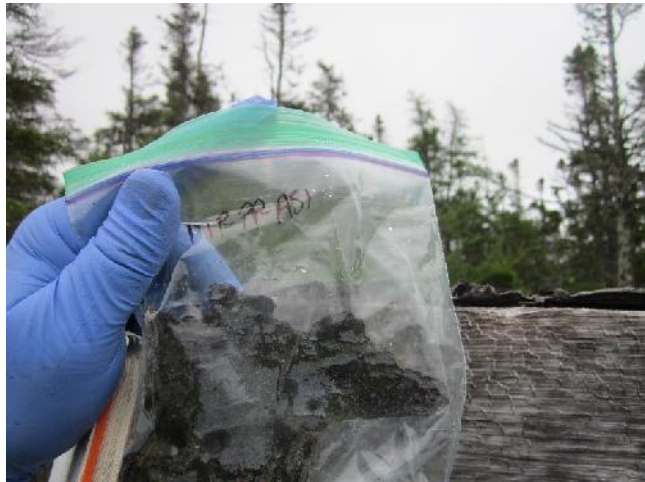
During the Pre-Demolition HBMA site visit, one (1) sample of black shingle and tar (MP-AS8) was collected from the roof of the accommodations cabin and one (1) sample of black shingle and tar (MP-PP-AS1) was collected from the roof of the outhouse and analyzed for asbestos content (refer to Photos 21 to 24, Appendix B4). Asbestos was not detected in the roofing samples collected from the accommodations cabin and outhouse.

Photo 24: View of bulk material sample MP-PP-AS1, black shingle and tar, cabin exterior.

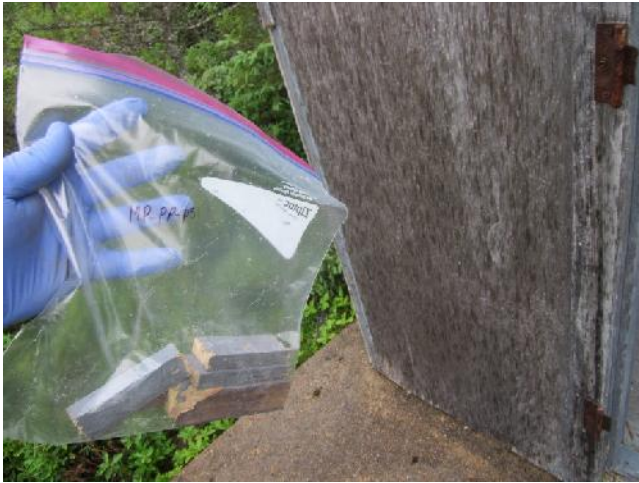
Photo 29: View of paint sample MP-PP-PS1, grey, outhouse exterior.

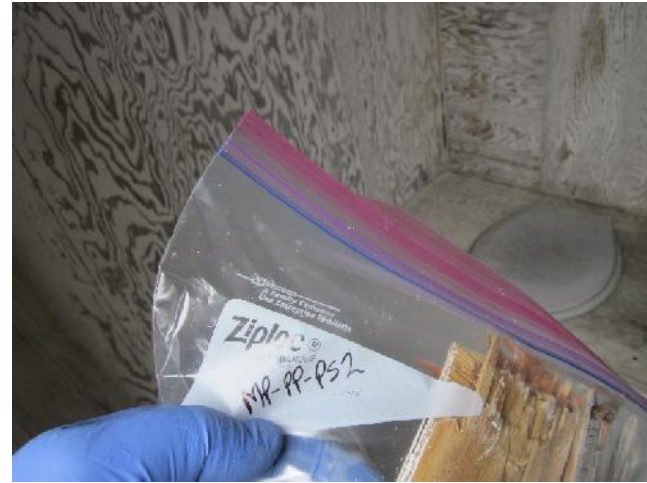
Photo 30: View of paint sample MP-PP-PS2, white, outhouse interior.

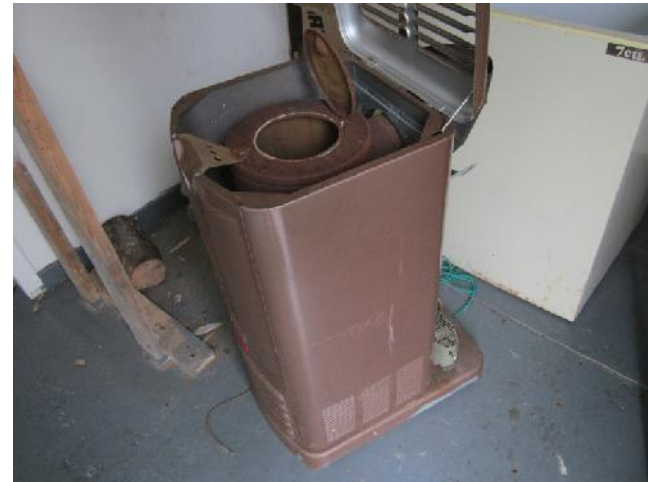
Photo 32: View of oil fired heater, cabin interior.

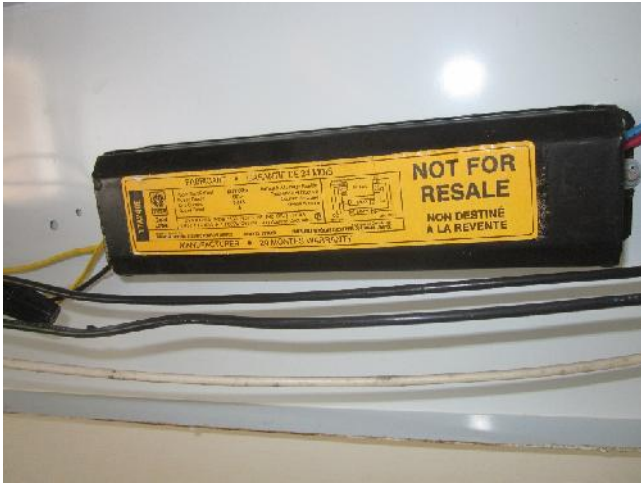
One Gold Label light ballast (Serial #17A240E) was inspected in the Room 1 and was labelled as non-PCB containing (refer to Photo 33, Appendix B4). Note that one light ballast was inspected at the time of the site visit.

Photo 33: View of fluorescent light ballast, cabin interior.

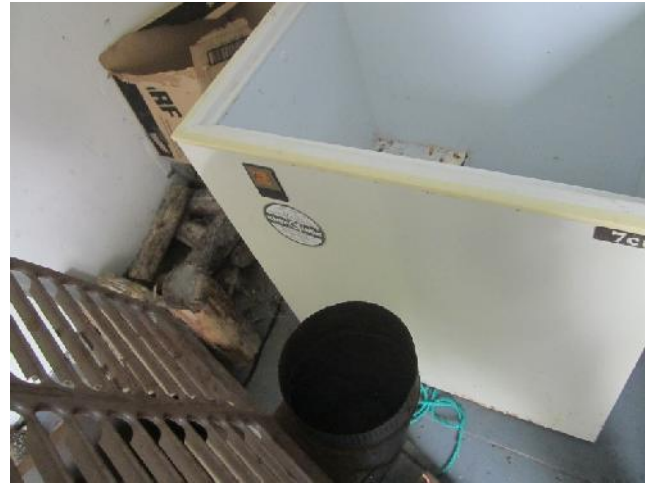
Based on observations made during the site visit, ODSs are present in the accommodations cabin in the form of refrigerant R12 contained in a freezer located in Room 1 (refer to Photo 34, Appendix B4). This refrigerant (R12) is a hydrochlorofluorocarbon (HCFC) and is regulated under the Federal Halocarbon Regulations.

Photo 34: View of freezer, containing R12 reffridgerant, cabin interior.

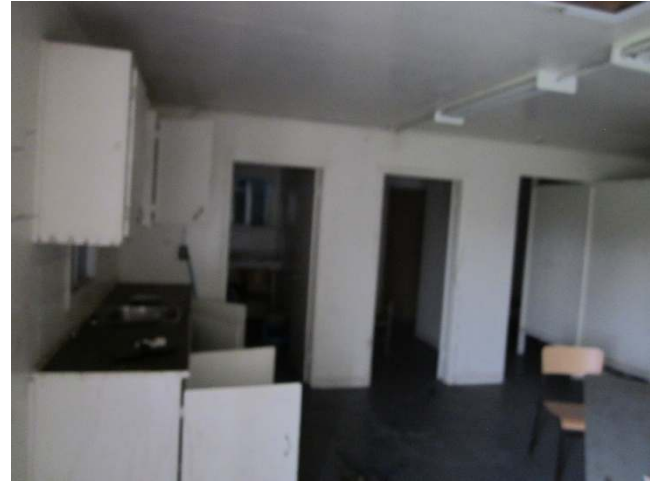
Since the actual date that Hungry Grove Camp was constructed is unknown (assumed to be late 1960's/early 1970's), it is possible that lead solder is present in any plumbing and piping (i.e., cast iron and copper piping) in the accommodations cabin, as lead solder for use in potable water distribution pipes was not banned until the late 1980s (refer to Photo 6, Appendix B5).

Photo 6: View of the kitchen/bunk area at Hungry Grove Pond Camp.

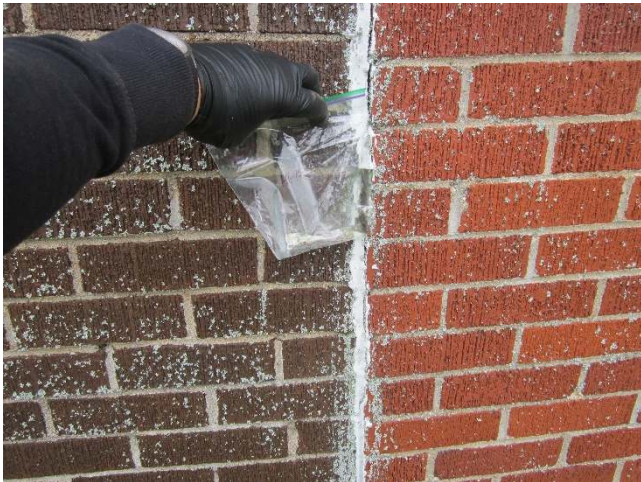
was collected from previous location of the chimney on the accommodations cabin, and analyzed for asbestos content (refer to Photos 15, 20 and 22, Appendix B5). Asbestos was not detected in the caulking/sealant samples analyzed.

Photo 15: View of bulk material sample HG-AS3, white caulking, cabin exterior.

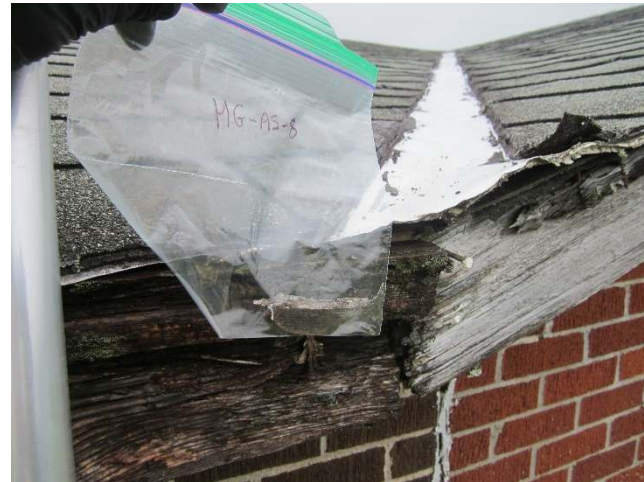
Photo 20: View of bulk material sample HG-AS8, black caulking, cabin exterior.

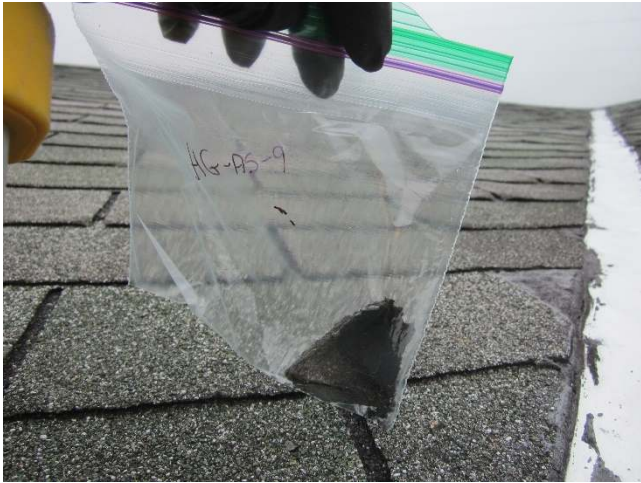
During the Pre-Demolition HBMA site visit, one (1) sample of black shingle and tar (HG-AS9) was collected from the roof of the accommodations cabin and one (1) sample of black shingle and tar (HG-PP-AS2) was collected from the roof of the accommodations cabin and analyzed for asbestos content (refer to Photo 21 and 27, Appendix B5). Asbestos was detected in HG-AS9 containing 4.8 % chrysotile asbestos. According to the NL asbestos abatement regulations (Reg. 111/98), this material is considered asbestos-containing materials. Asbestos was not detected in the other shingle and tar sample collected from the outhouse.

Photo 21: View of bulk material sample HG-AS9, black shingle and tar, cabin exterior. **4.8 % Crysofile Asbestos.**

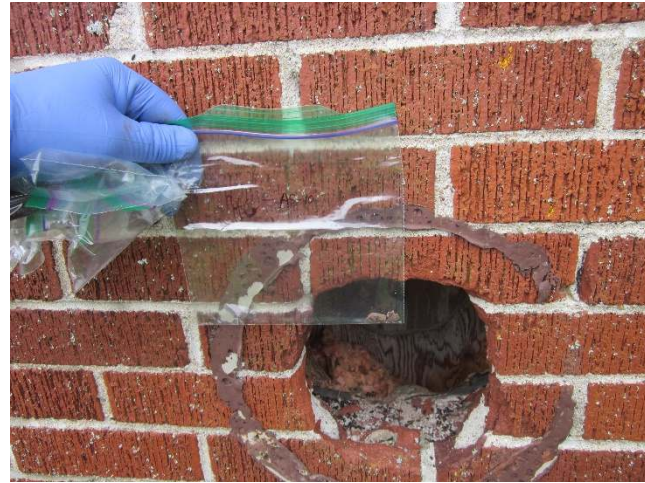
Photo 22: View of bulk material sample HG-AS10, red sealant, cabin exterior.

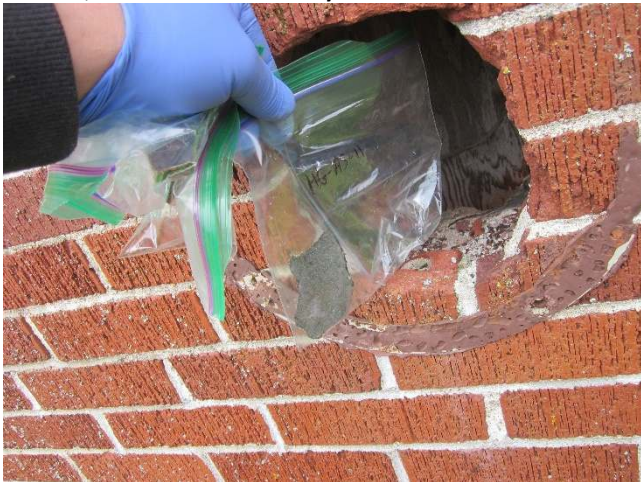
During the Pre-Demolition HBMA site visit, two (2) samples of tar paper (HG-AS11 and HG-AS13) and one (1) sample of black pressed board (HG-AS-12) were collected from the exterior of the accommodations building and analyzed for asbestos content (refer to Photo 23 to 25, Appendix B5). Asbestos was not detected in the pressed board or tar paper samples analyzed.

Photo 23: View of bulk material sample HG-AS11, tar paper, cabin exterior.

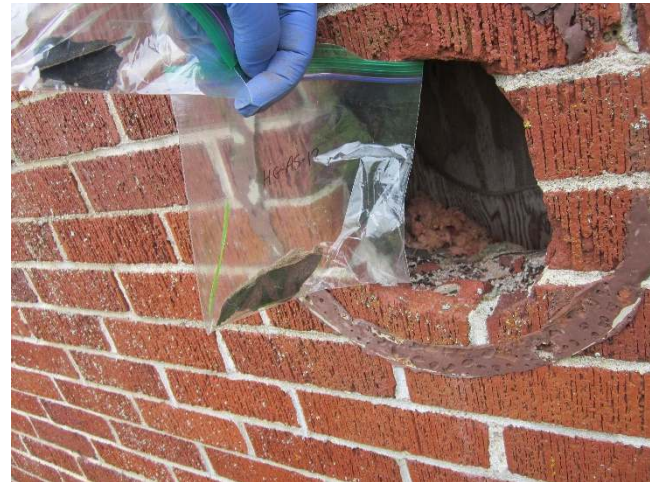
Photo 24: View of bulk material sample HG-AS12, pressed board, cabin exterior.

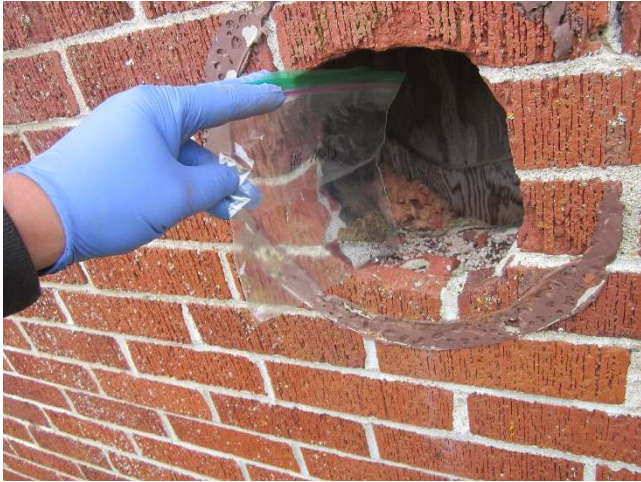
Photo 25: View of bulk material sample HG-AS-13, tar paper, cabin exterior.

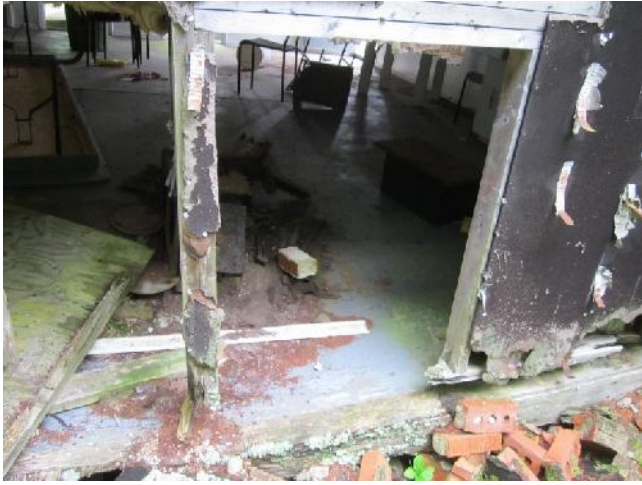
Due to the level of dilapidation at the accommodations cabin, it was unsafe to enter the building to obtain any additional asbestos samples (refer to Photo 2, 3 and 9, Appendix B2).

Photo 9: View of collapsed room, on eastern corner of the accommodations cabin.

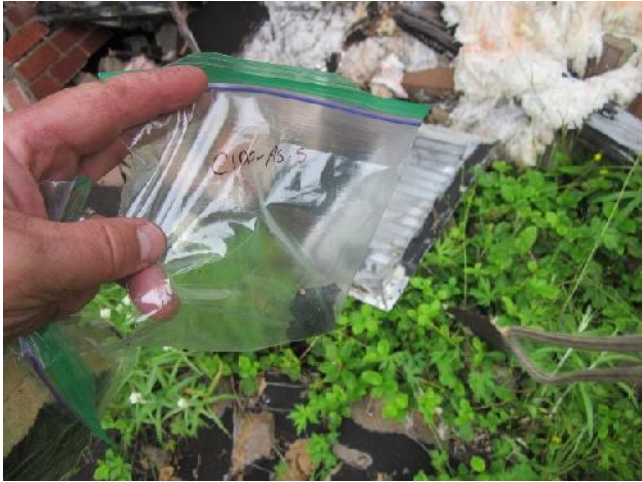
Photo 17: View of bulk material sample C100-AS-5, black tar, cabin exterior.  
**21.2 % Cryotile Asbestos**

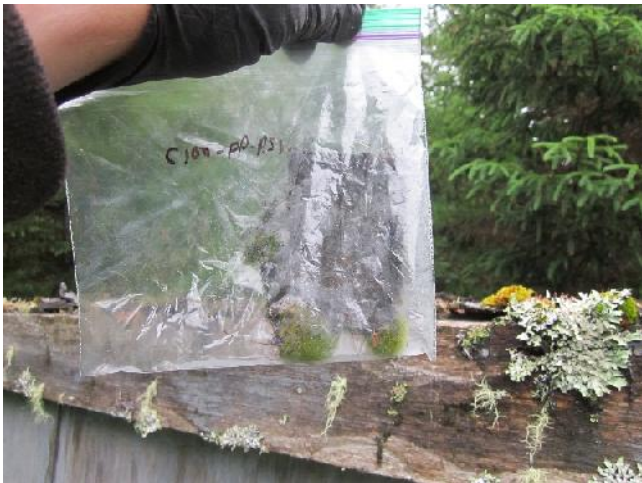
Photo 19: View of bulk material sample C100-PP-AS1, black felt and tar, outhouse exterior. **1.1 % Cryotile Asbestos**

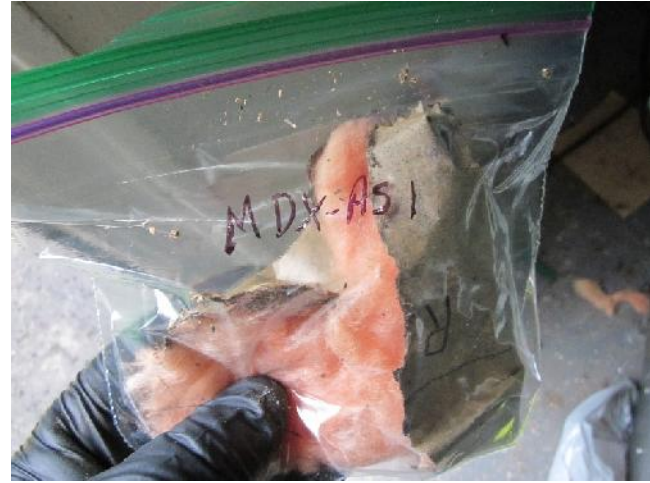
During the Pre-Demolition HBMA site visit, pink fiberglass insulation was observed between the particle board and plywood in the walls of the accommodations cabin. During the Pre-Demolition HBMA site visit, one (1) sample of black paper on pink fiberglass insulation (MDX-AS1) was collected from the wall of the accommodations cabin and analyzed for asbestos content (refer to Photo 14, Appendix B7). Asbestos was not detected in the insulation sample collected from the accommodations cabin.

Photo 14: View of bulk material sample MDX-AS1, black paper on fibreglass insulation, Room 1.

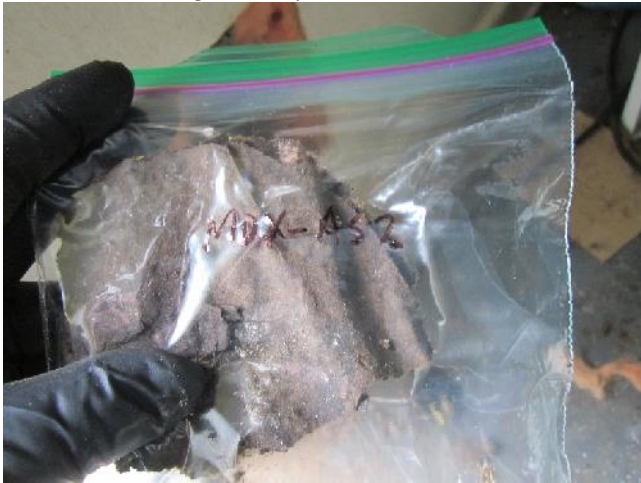
During the Pre-Demolition HBMA site visit, one (1) sample of black pressed board and tar paper (MDX-AS2) from the exterior of the accommodations cabin and analyzed for asbestos content (refer to Photo 15, Appendix B7). Asbestos was not detected in the pressed board / tar paper sample analyzed.

Photo 15: View of bulk material sample MDX-AS2, black pressboard and tar paper, Room 1.

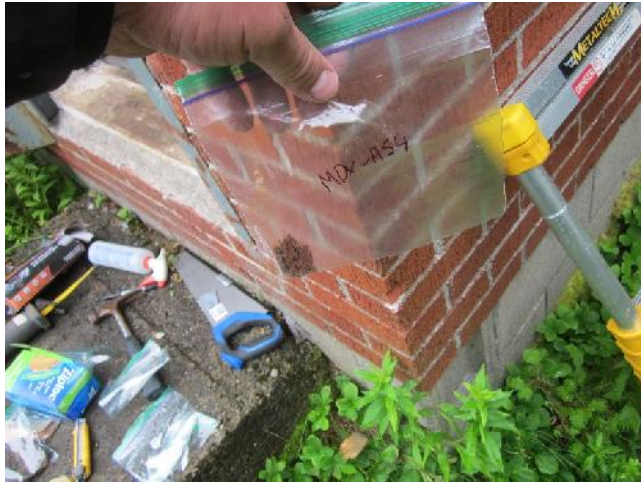
Photo 17: View of bulk material sample MDX-AS4, red brick, cabin exterior.

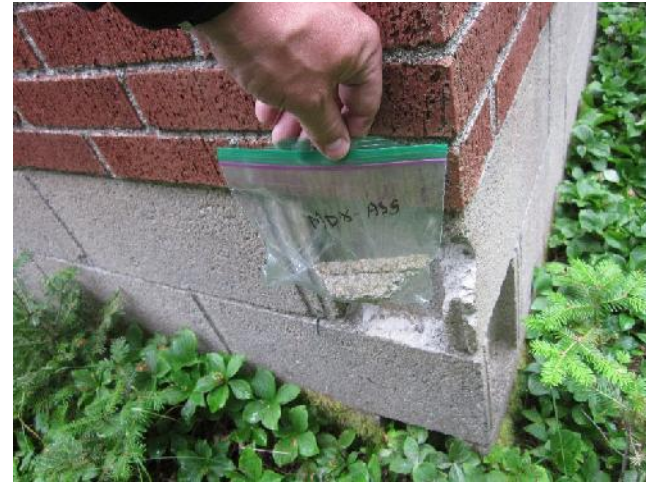
Photo 18: View of bulk material sample MDX-AS5, concrete block, cabin exterior.

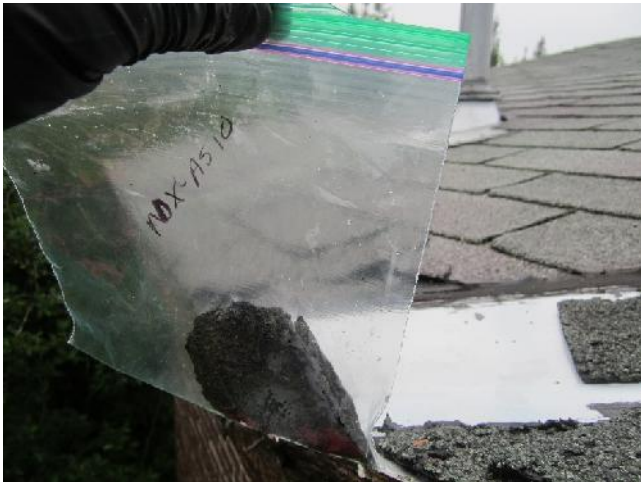
During the Pre-Demolition HBMA site visit, one (1) sample of black shingle and tar (MDX-AS10) and one (1) sample of green/black shingle and tar (MDX-AS11) was collected from the roof of the accommodations cabin and one (1) sample of black shingle and tar (MDX-PP-AS1) was collected from the roof of the accommodations cabin and analyzed for asbestos content (refer to Photos 23 to 25, Appendix B7). Asbestos was detected in MDX-PP-AS1 containing 0.79 % chrysotile asbestos. According to the NL asbestos abatement regulations (Reg. 111/98), this material is not considered asbestos-containing materials.

Photo 23: View of bulk material sample MDX-AS10, black shingle and tar, cabin exterior.

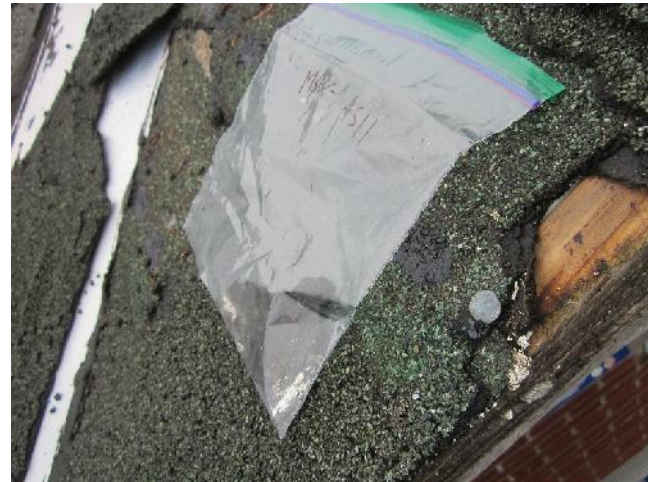
Photo 24: View of bulk material sample MDX-AS11, green/black shingle and tar, cabin exterior.

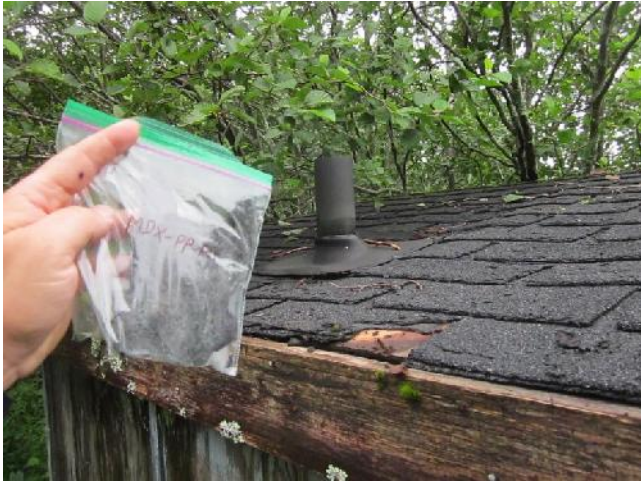
Photo 25: View of bulk material sample MDX-PP-AS1, black shingle and tar, outhouse exterior.

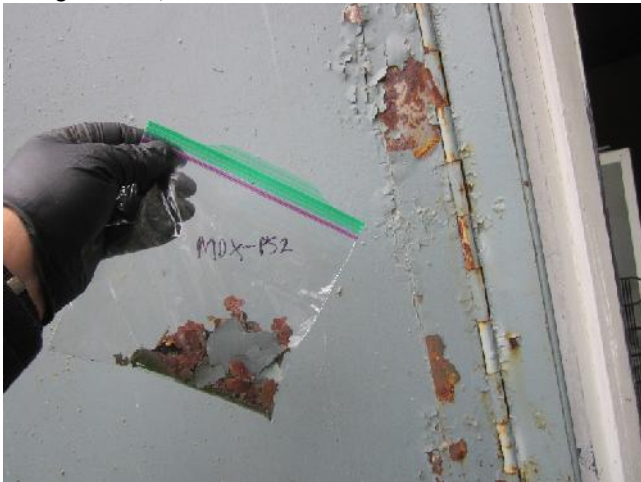
Photo 27: View of paint sample MDX-PS2, grey, cabin exterior.

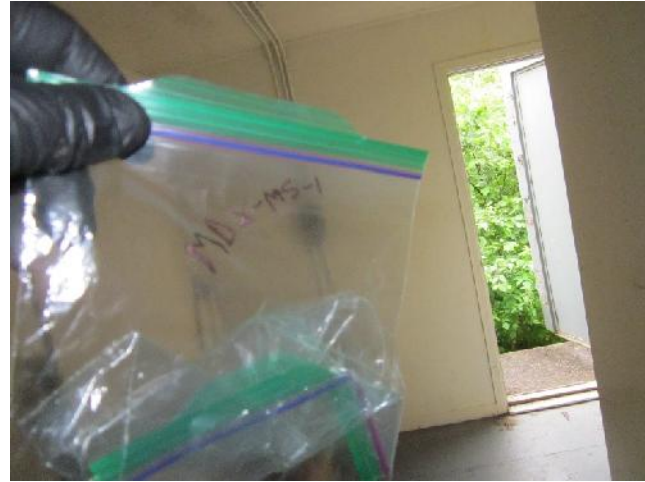
Wood inspected the interior areas of the accommodations cabin and outhouse for visual or olfactory evidence of suspected mould. SVG was noted on much of the ceiling and wall surfaces inside the accommodations cabin during the Pre-Demolition HBMA site visit. A sample, MDX-MS1, was collected in Room 3 (refer to Figure 7.2, Appendix A7 and Photo 30, Appendix B7).

Photo 30: View of mould sample MDX-MS-1, cabin interior.

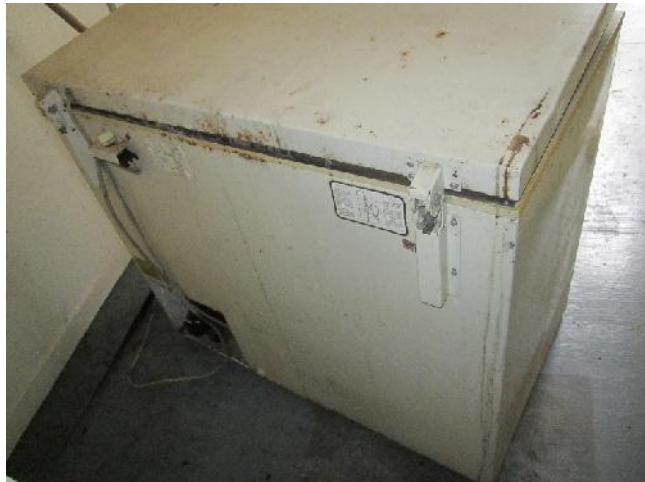
Based on observations made during the site visit, ODSs are present in the accommodations cabin in the form of refrigerant R12 contained in a refrigerator located in Room 1 (refer to Photo 5, Appendix B7) and a freezer located in Room 3 (refer to Photo 32, Appendix B7). This refrigerant (R12) is a hydrochlorofluorocarbon (HCFC) and is regulated under the Federal Halocarbon Regulations.

Photo 32: View of freezer, containing R12 reffridgerant, cabin interior.
