NEWFOUNDLAND AND LABRADOR HYDRO

PRE-DEMOLITION HBMA, FORMER CONSTRUCTION  
CAMP SITES, TL228, NL

MARCH 15, 2023

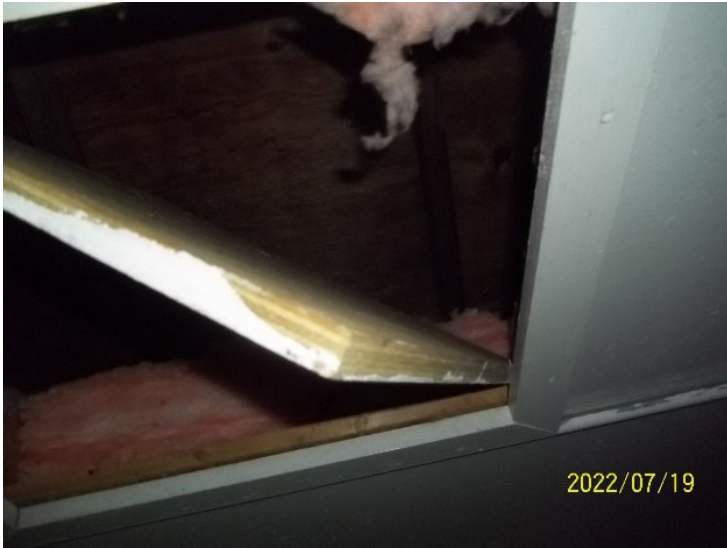
During the Pre-Demolition HBMA site visit, fiberglass batt insulation was observed in the attic and walls of the accommodations cabin (refer to Photos 9 and 12, Appendix B2). Thermal system insulation was not observed at Camp 50.

Photo 9: View of the attic in the accommodations cabin at Camp 50.

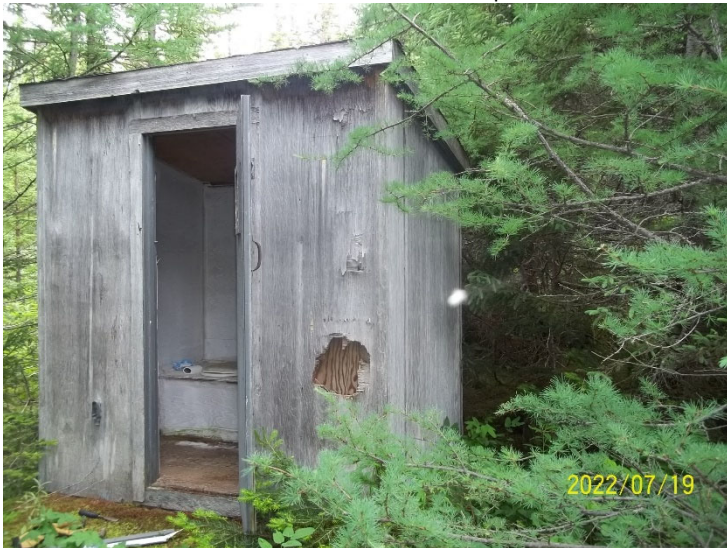
The outhouse is a one-storey, rectangular structure with a footprint area of approximately 3.2 m<sup>2</sup> (1.8 m x 1.8 m) (refer to Figure 2.2, Appendix A2 and Photo 11, Appendix B2). The structure of the outhouse consists of wood framing. The foundation of the outhouse consists of a concrete pad. The exterior walls on the outhouse are finished with painted plywood and the roof is finished with asphalt shingles. Interior wall and ceiling finishes in the outhouse consist of painted and unpainted plywood. Floor finishes consist of unpainted plywood. The outhouse does not contain any lighting or heating.

Photo 11: View of the outhouse at Camp 50 site.

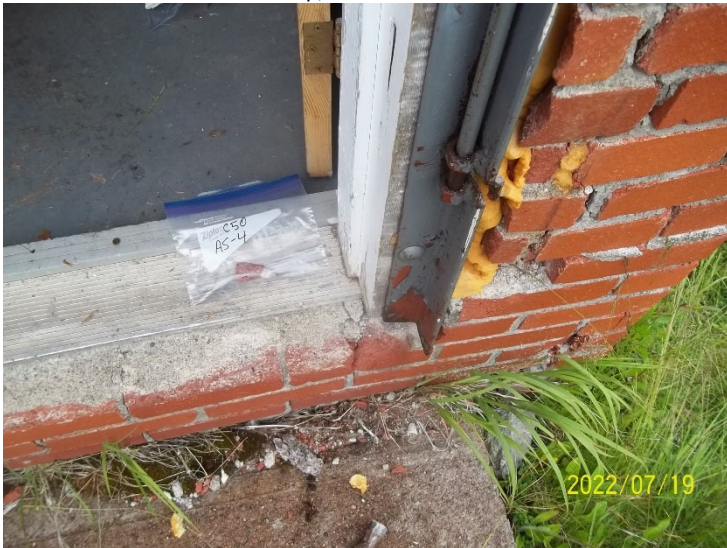
Photo 15: View of bulk material sample C50 AS-4, brick and mortar, cabin exterior.

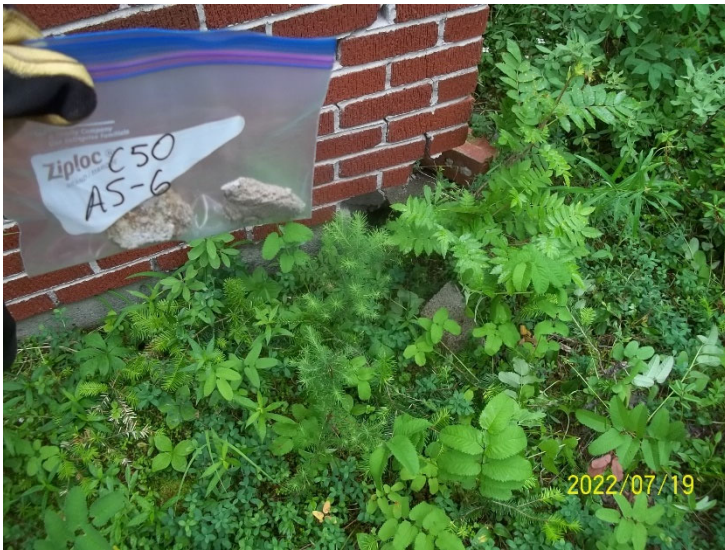
Photo 17: View of bulk material sample C50 AS-6, cinder block and mortar, cabin exterior.

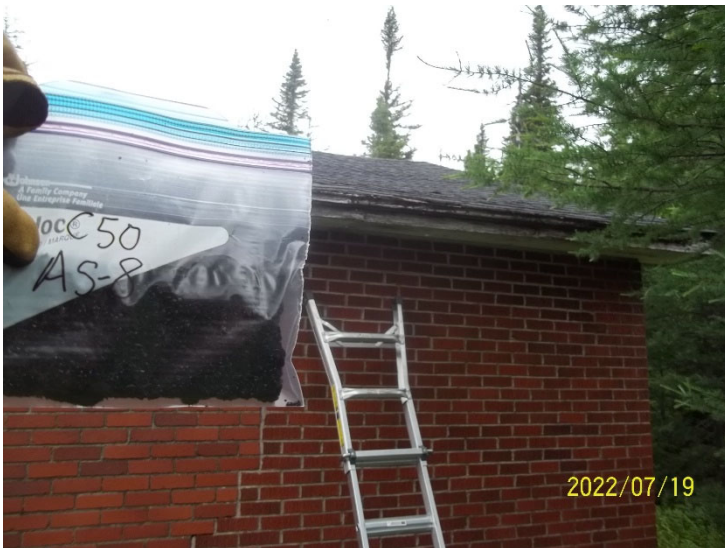
During the Pre-Demolition HBMA site visit, one (1) sample of asphalt shingle with tar paper and another asphalt shingle (C50 AS-7) and one (1) sample of asphalt shingle with tar paper (C50 AS-8) were collected from the roof of the accommodations cabin and one (1) sample of asphalt shingle with tar paper (C50 AS-10) was collected from the roof of the outhouse and analyzed for asbestos content (refer to Photos 18, 19 and 21, Appendix B2). Asbestos was detected in C50 AS-10-Shingle at a concentration of 0.30% chrysotile asbestos. According to the NL asbestos abatement regulations (Reg. 111/98), this material is not considered asbestos-containing materials. Asbestos was not detected in the other roofing material samples.

Photo 19: View of bulk material sample C50 AS-8, shingle and tar paper, cabin exterior.

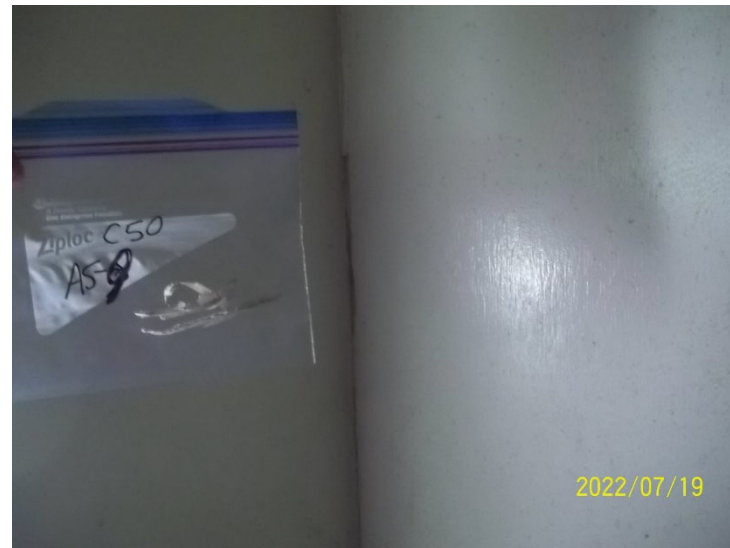
One (1) sample of caulking (C50 AS-9), plus one (1) blind field duplicate (C50 AS-DUP1; duplicate of C50 AS-9), was collected from a wall inside of the accommodations cabin and analyzed for asbestos content (refer to Photo 20, Appendix B2). Asbestos was not detected in the caulking samples.

Photo 20: View of bulk material sample C50 AS-9, caulking, cabin interior.

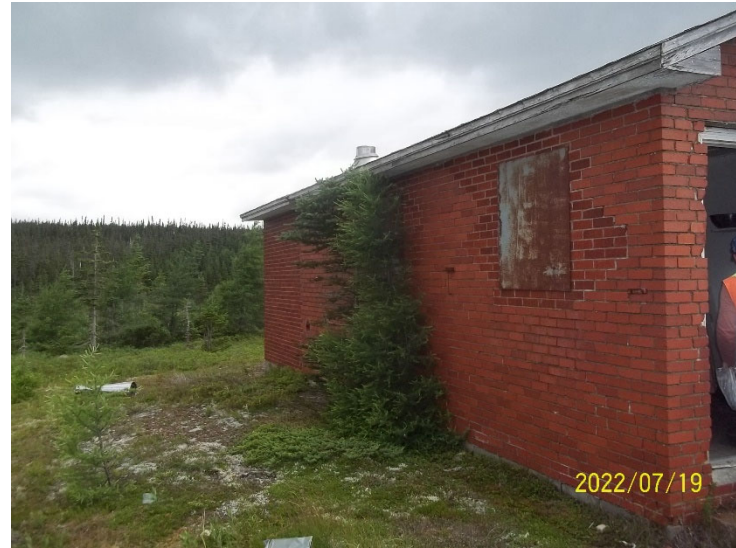
Photo 2: View of the accommodations cabin at Camp 98.

It is important to note that, due to height constraints, no samples of building materials around roof penetrations (e.g., caulking or sealants around vents or chimneys) or roof seams were collected for analysis (refer to Photos 2 and 4, Appendix B3).

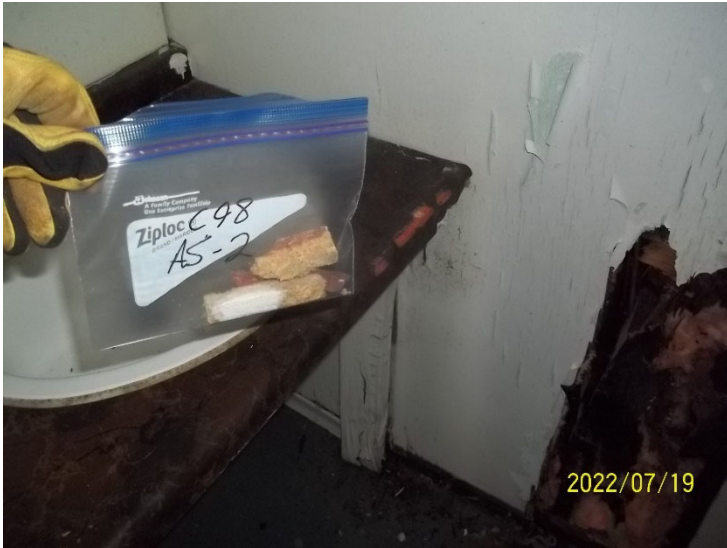
During the Pre-Demolition HBMA site visit, two (2) samples of countertop mastics (C98 AS-1 and C98 AS-2) were collected from the accommodations cabin and analyzed for asbestos content (refer to Photos 12 and 13, Appendix B3). Asbestos was not detected in the countertop mastic samples.

Photo 13: View of bulk material sample C98 AS-2, countertop mastic, cabin interior.

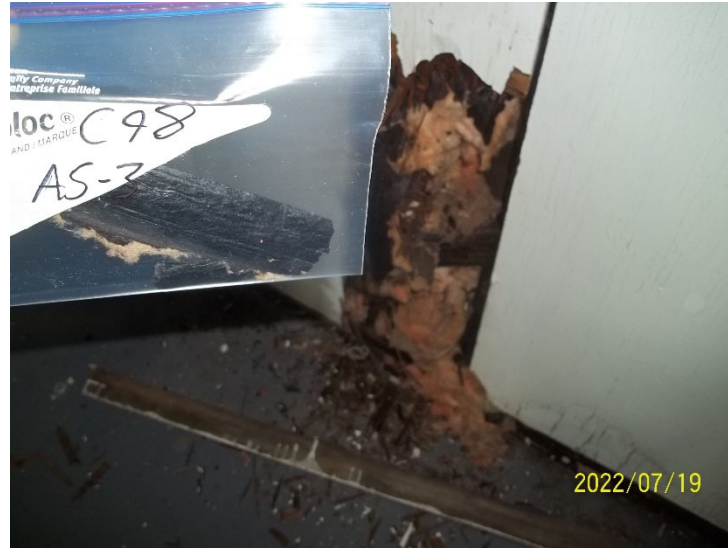
One (1) sample of tar paper backing on the building insulation (C98 AS-3) was collected from the wall of the accommodations cabin and analyzed for asbestos content (refer to Photo 14, Appendix B3). One (1) sample of foil paper (C98 AS-12) was also collected from the wall of the accommodations cabin and analyzed for asbestos content (refer to Photo 23, Appendix B3). Asbestos was not detected in the tar paper and foil paper samples.

Photo 14: View of bulk material sample C98 AS-3, tar paper, cabin interior.

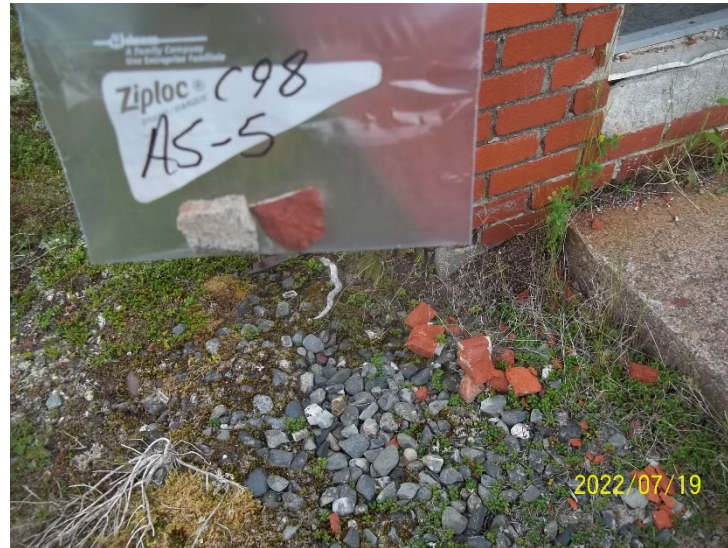
During the Pre-Demolition HBMA site visit, one (1) sample of brick and mortar (C98 AS-5) and one (1) sample of brick (C98 AS-6) were collected from the exterior of the accommodations cabin and analyzed for asbestos content (refer to Photos 16 and 17, Appendix B3). Asbestos was not detected in the brick and mortar samples.

Photo 16: View of bulk material sample C98 AS-5, brick and mortar, cabin exterior.

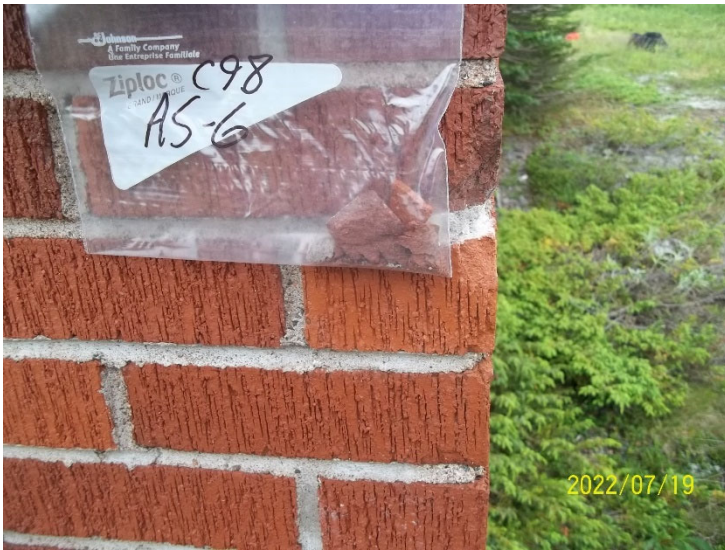
Photo 17: View of bulk material sample C98 AS-6, brick and mortar, cabin exterior.

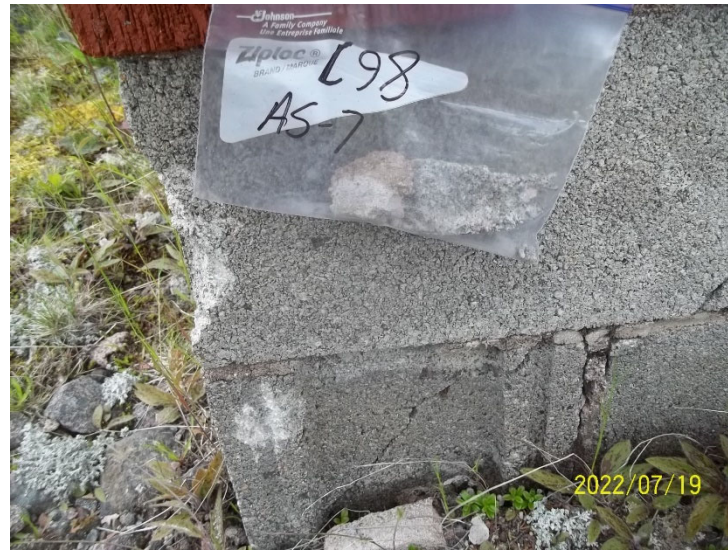
During the Pre-Demolition HBMA site visit, one (1) sample of cinder block and mortar (C98 AS-7) was collected from the concrete foundation of the accommodations cabin and one (1) sample of concrete (C98 AS-11) was collected from the foundation of the outhouse and analyzed for asbestos content (refer to Photos 18 and 22, Appendix B3). Asbestos was not detected in the cinder block/mortar and concrete samples.

Photo 18: View of bulk material sample C98 AS-7, cinder block and mortar, cabin exterior.

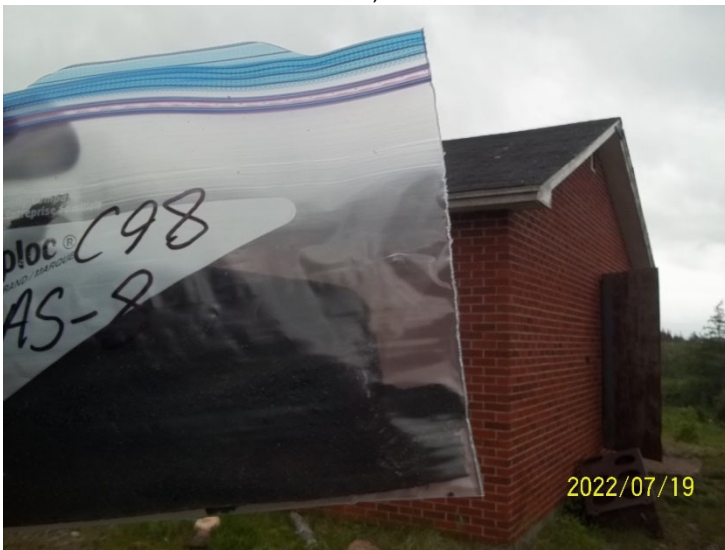
During the Pre-Demolition HBMA site visit, two (2) samples of asphalt shingle with tar paper (C98 AS-8 and C98 AS-9) were collected from the roof of the accommodations cabin and one (1) sample of asphalt shingle (C98 AS-10) was collected from the roof of the outhouse and analyzed for asbestos content (refer to Photos 19, 20 and 21, Appendix B3). Asbestos was not detected in the roofing material samples.

Photo 19: View of bulk material sample C98 AS-8, shingle, cabin exterior.

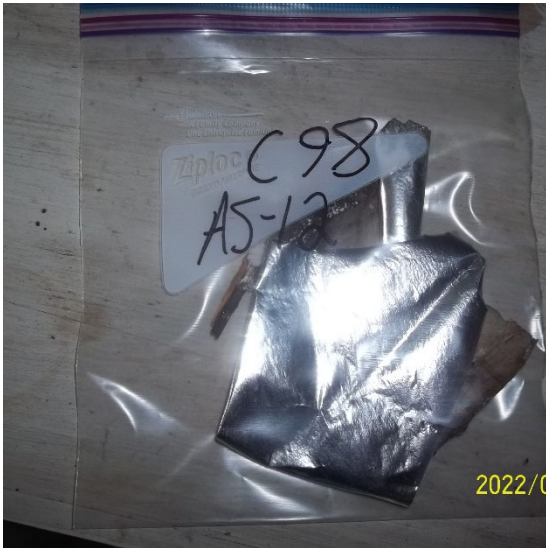
Photo 23: View of bulk material sample C98 AS-12, foil paper, cabin interior.

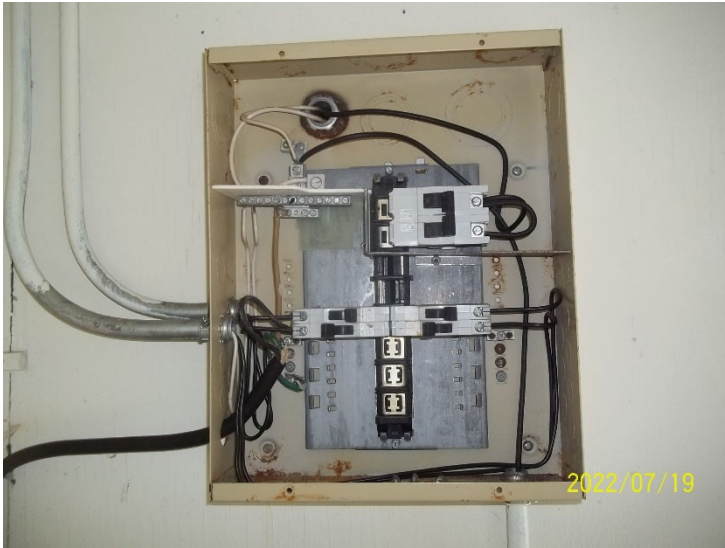
Other potential ACMs were observed (or suspected to be present) and were not sampled due to the nature of the materials and/or hazards associated with sampling these materials. These materials included, but are not limited to, electrical and mechanical components and insulators such as wiring and gaskets, caulking or sealants around or along roof seams, vent pipes, chimneys, electrical conduits or other penetrations, and undercoatings on sinks (refer to Photos 29 and 30, Appendix B3).

Photo 29: View of electrical panel, cabin interior.

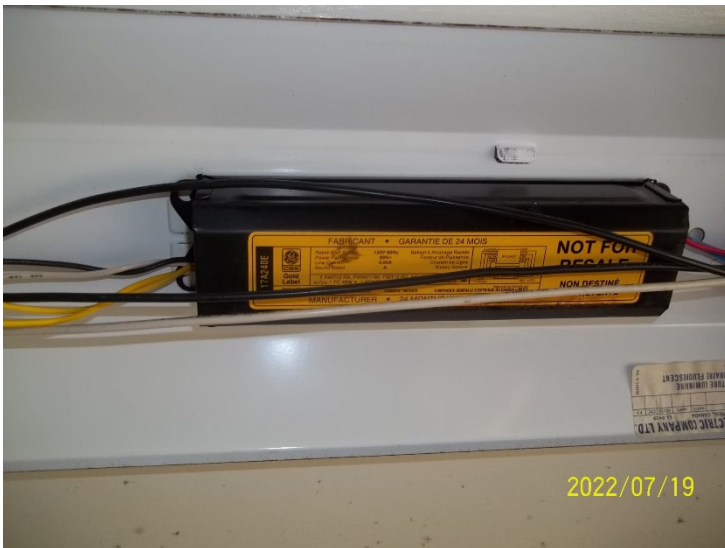
Photo 31: View of fluorescent light ballast inside the accommodations cabin.

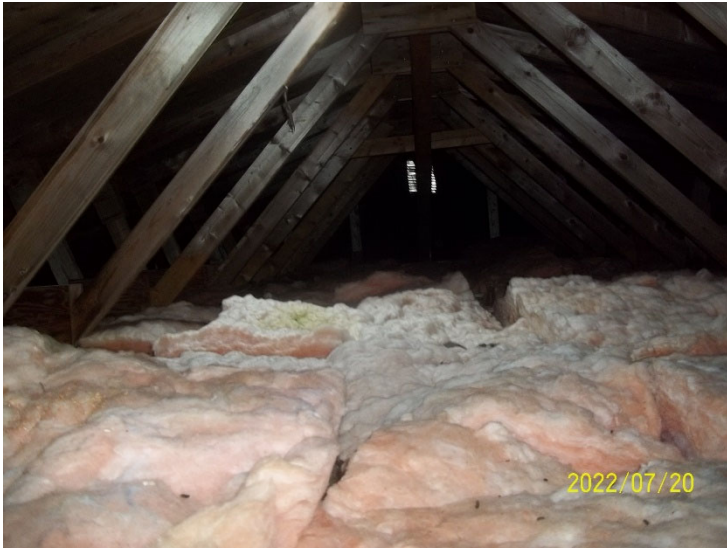
Photo 5: View of the attic in the accommodations cabin at Rainy Lake Camp.

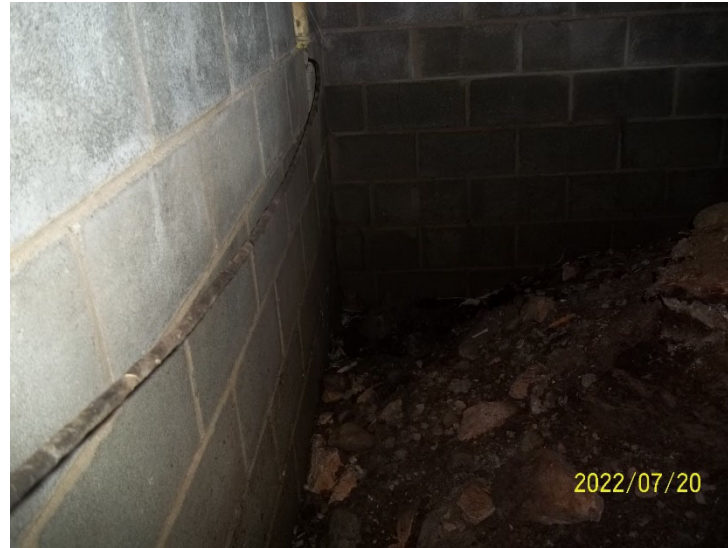
Photo 6: View of the crawl space beneath the accommodations cabin at Rainy Lake Camp.

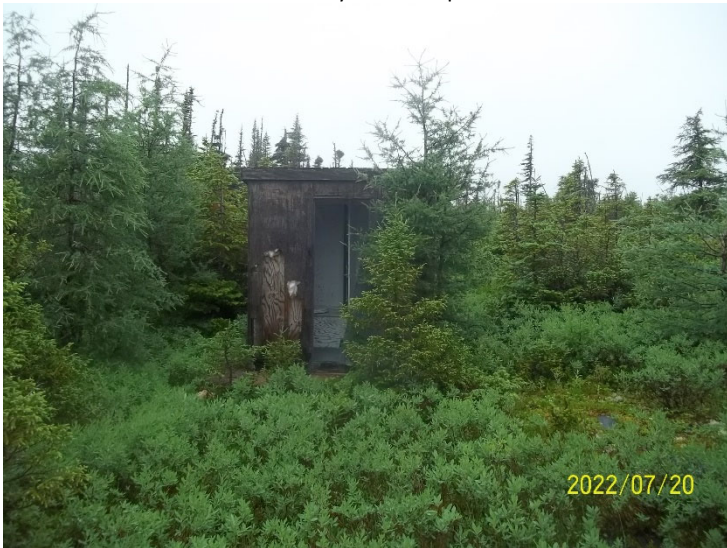
The outhouse is a one-storey, rectangular structure with a footprint area of approximately 2.7 m<sup>2</sup> (1.5 m x 1.8 m) (refer to Photo 7, Appendix B4). The structure of the outhouse consists of wood framing. The foundation of the outhouse consists of concrete blocks. The exterior walls on the outhouse are finished with painted plywood and the roof is finished with asphalt shingles. Interior wall and ceiling finishes in the outhouse consist of painted plywood. Floor finishes consist of painted plywood. The outhouse does not contain any lighting or heating.

Photo 7: View of the outhouse at Rainy Lake Camp.

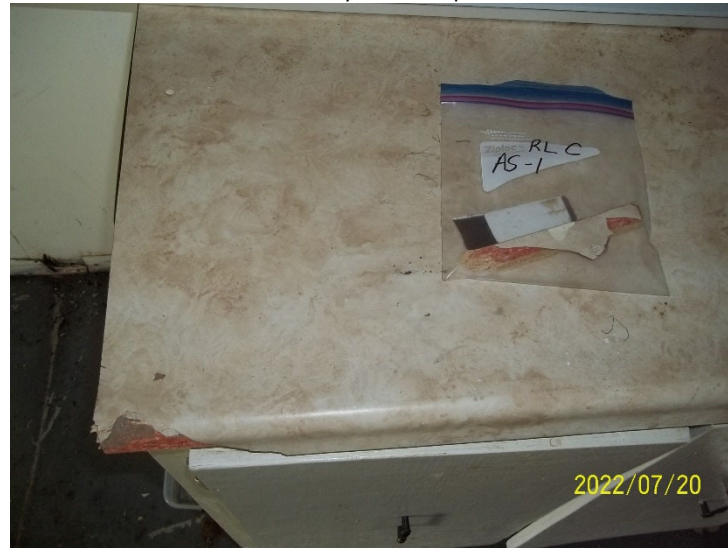
Photo 8: View of bulk material sample RLC AS-1, countertop mastic, cabin interior.

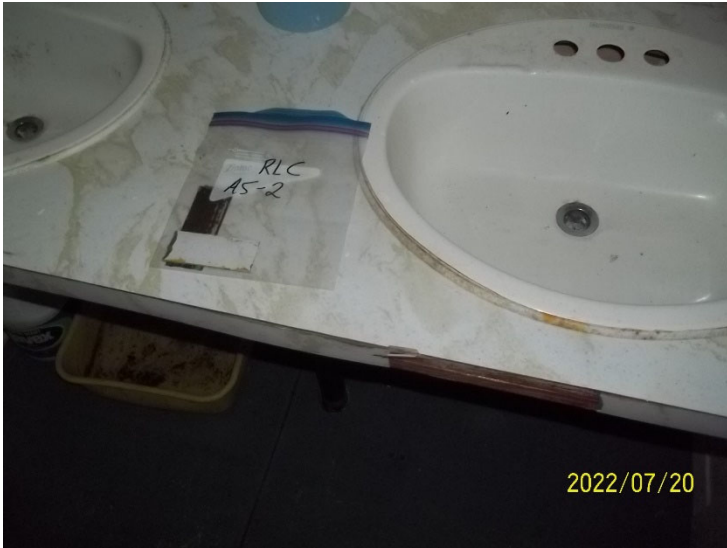
Photo 9: View of bulk material sample RLC AS-2, countertop mastic, cabin interior.

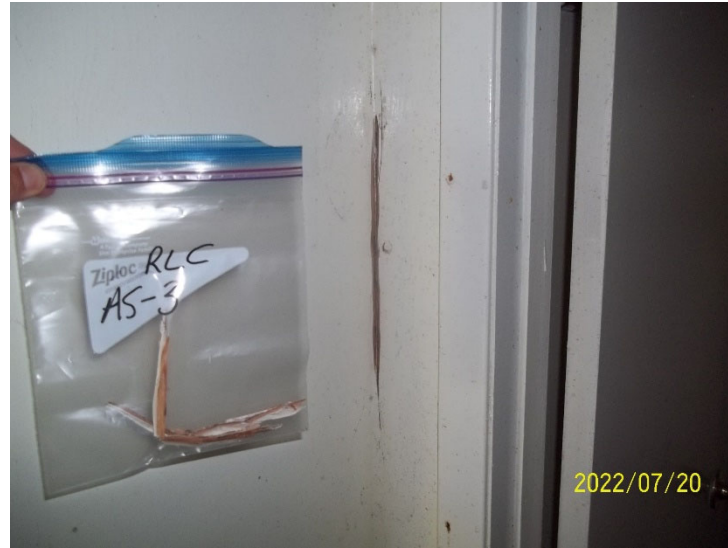
Photo 10: View of bulk material sample RLC AS-3, caulking, cabin interior.

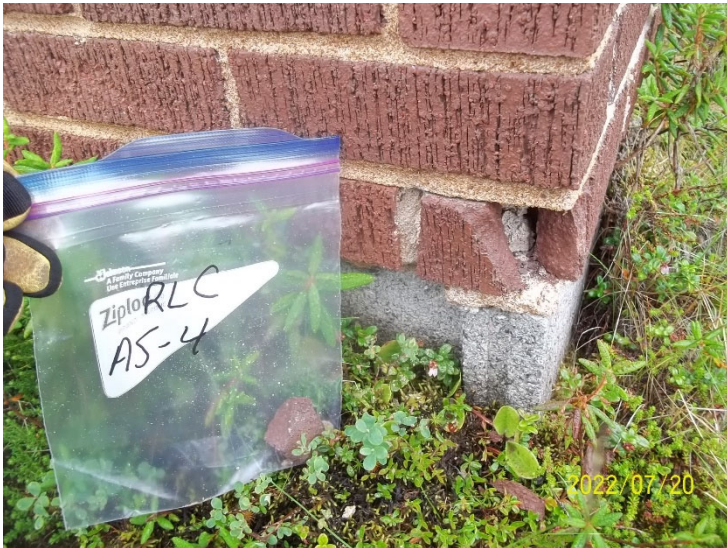
Photo 11: View of bulk material sample RLC AS-4, brick and mortar, cabin interior.

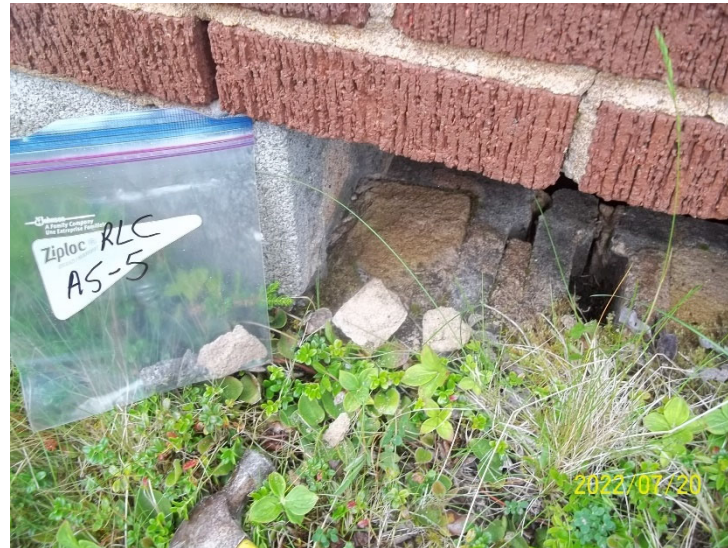
Photo 12: View of bulk material sample RLC AS-5, cinder block and mortar, cabin exterior.

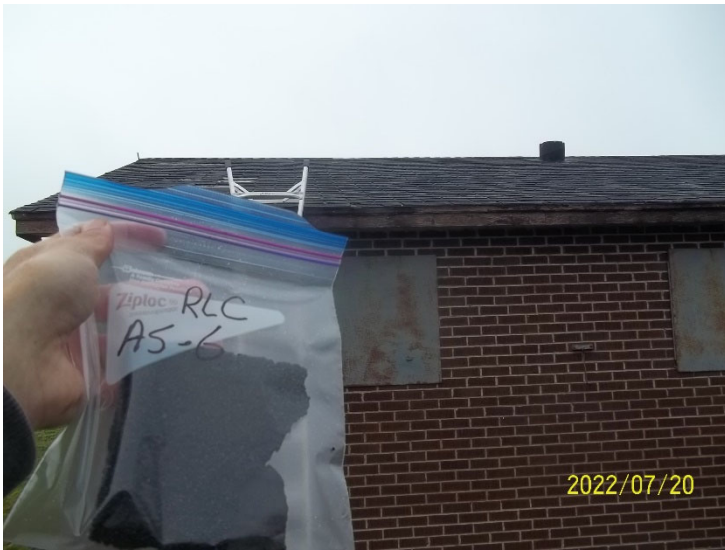
Photo 13: View of bulk material sample RLC AS-6, shingle, cabin exterior.

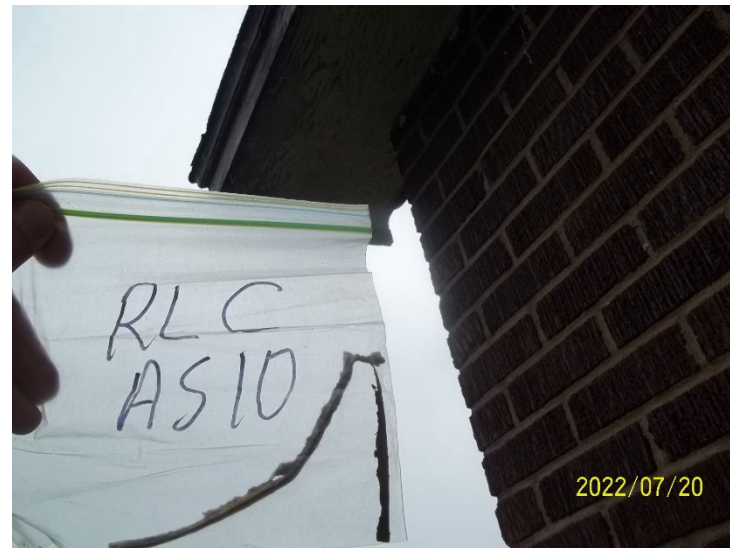
Photo 16: View of bulk material sample RLC AS-10, caulking, cabin exterior.

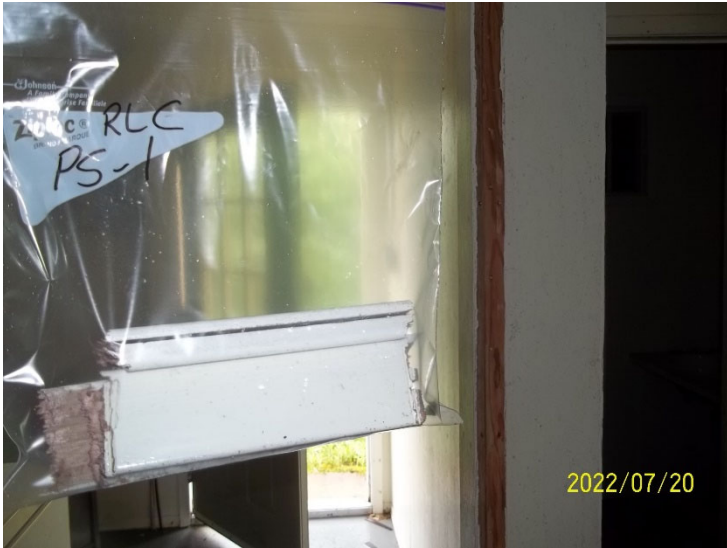
Photo 17: View of paint sample RLC PS-1, wall, cabin interior.

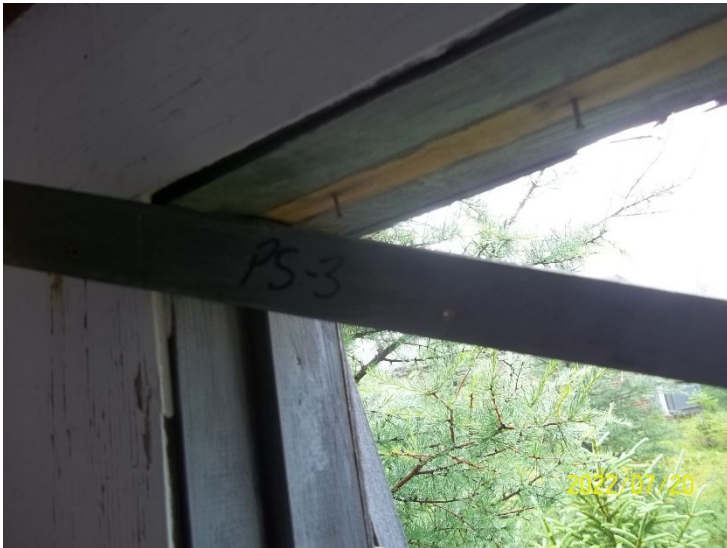
Photo 19: View of paint sample RLC PS-3, wall, outhouse interior.

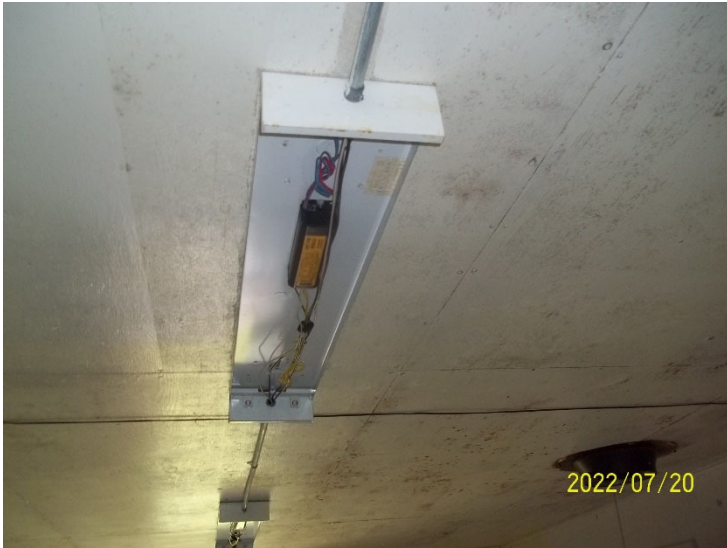
Photo 21: View of fluorescent light fixtures, cabin interior.

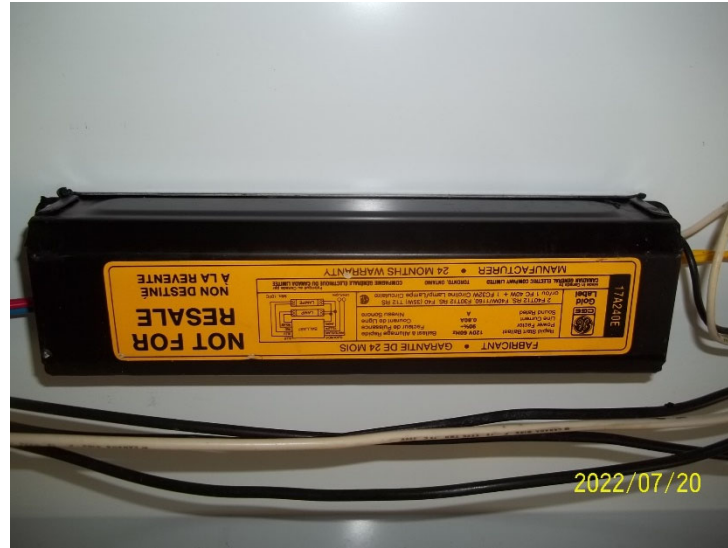
Photo 22: View of fluorescent light ballast, cabin interior.

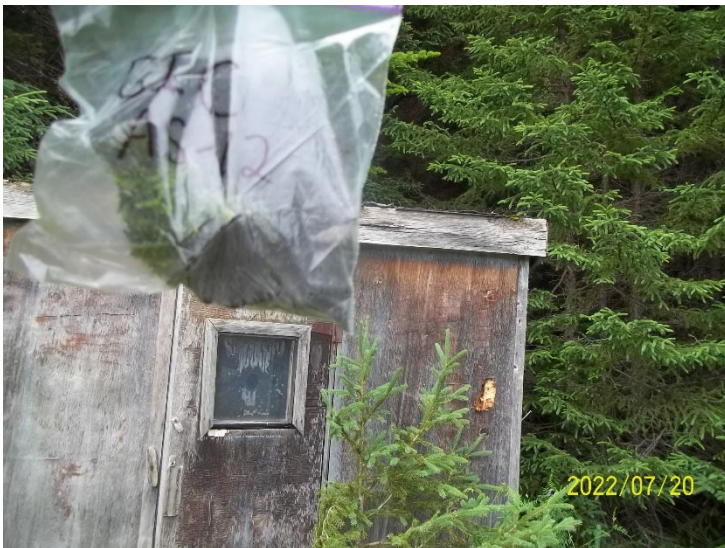
Three (3) samples of caulking (GIC AS-9, GIC AS-10 and GIC AS-11) were collected from the exterior of the accommodations cabin and analyzed for asbestos content (refer to Photos 20, 21 and 22, Appendix B5). Asbestos was not detected in the caulking samples.

Photo 22: View of bulk material sample GIC AS-11, caulking, cabin exterior.
