Big Meadow Bog Hydrology Restoration: As Built Report

March 16, 2018
FINAL

Prepared by:
East Coast Aquatics Inc.
3 Middle St. Bridgetown, NS, B0S 1C0
(902) 665-4682
www.eastcoastaquatics.ca

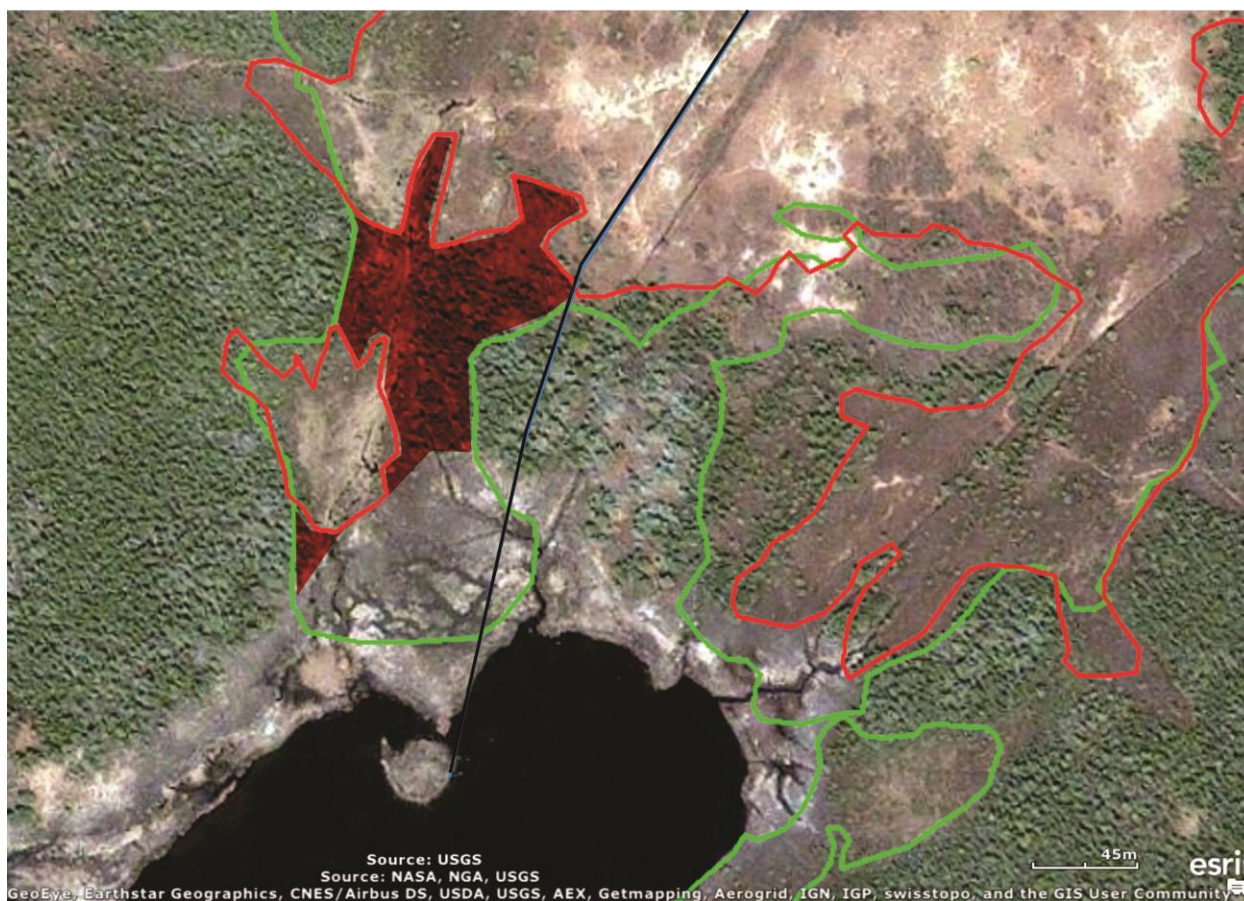
Figure 5: An area adjacent to the southwest ditch totaling approximately 0.72 ha had been encroached by trees in BMB on NCC lands (shaded red) since 1955. This area had all trees felled for the hydrological recovery of the bog and associated lagg.

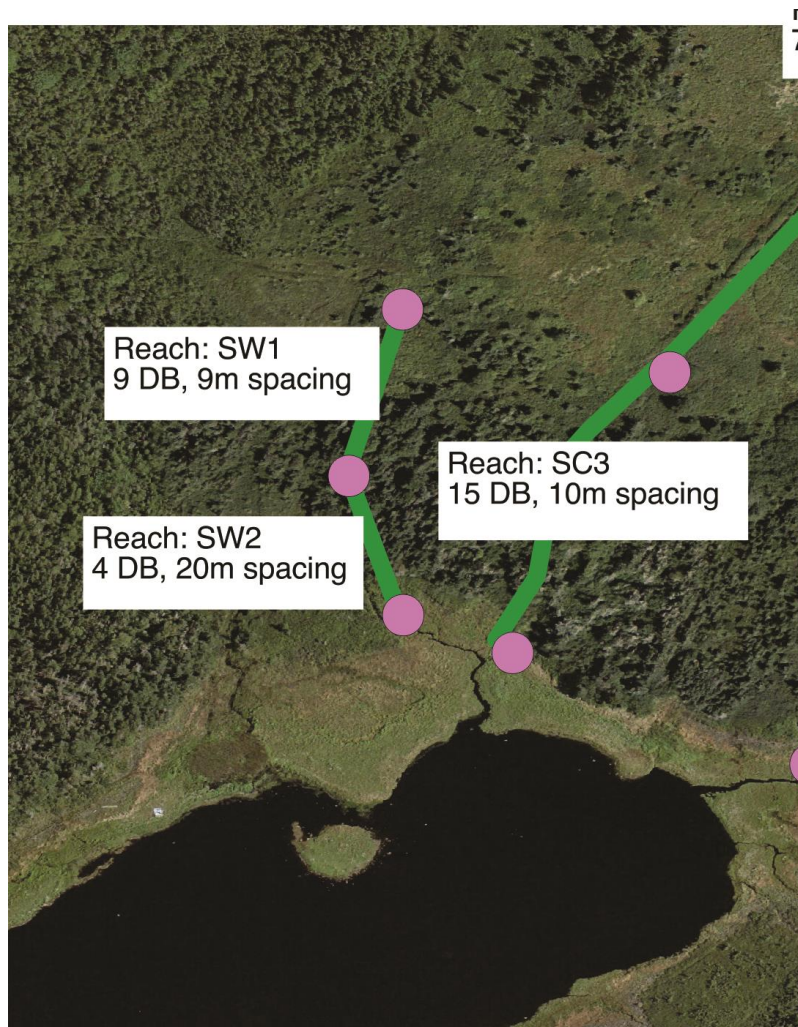
Figure 6: Two defined slope reaches with appropriate ditch block spacing have been identified for the south west ditch (left portion of image). Thirteen ditch blocks were prescribed.

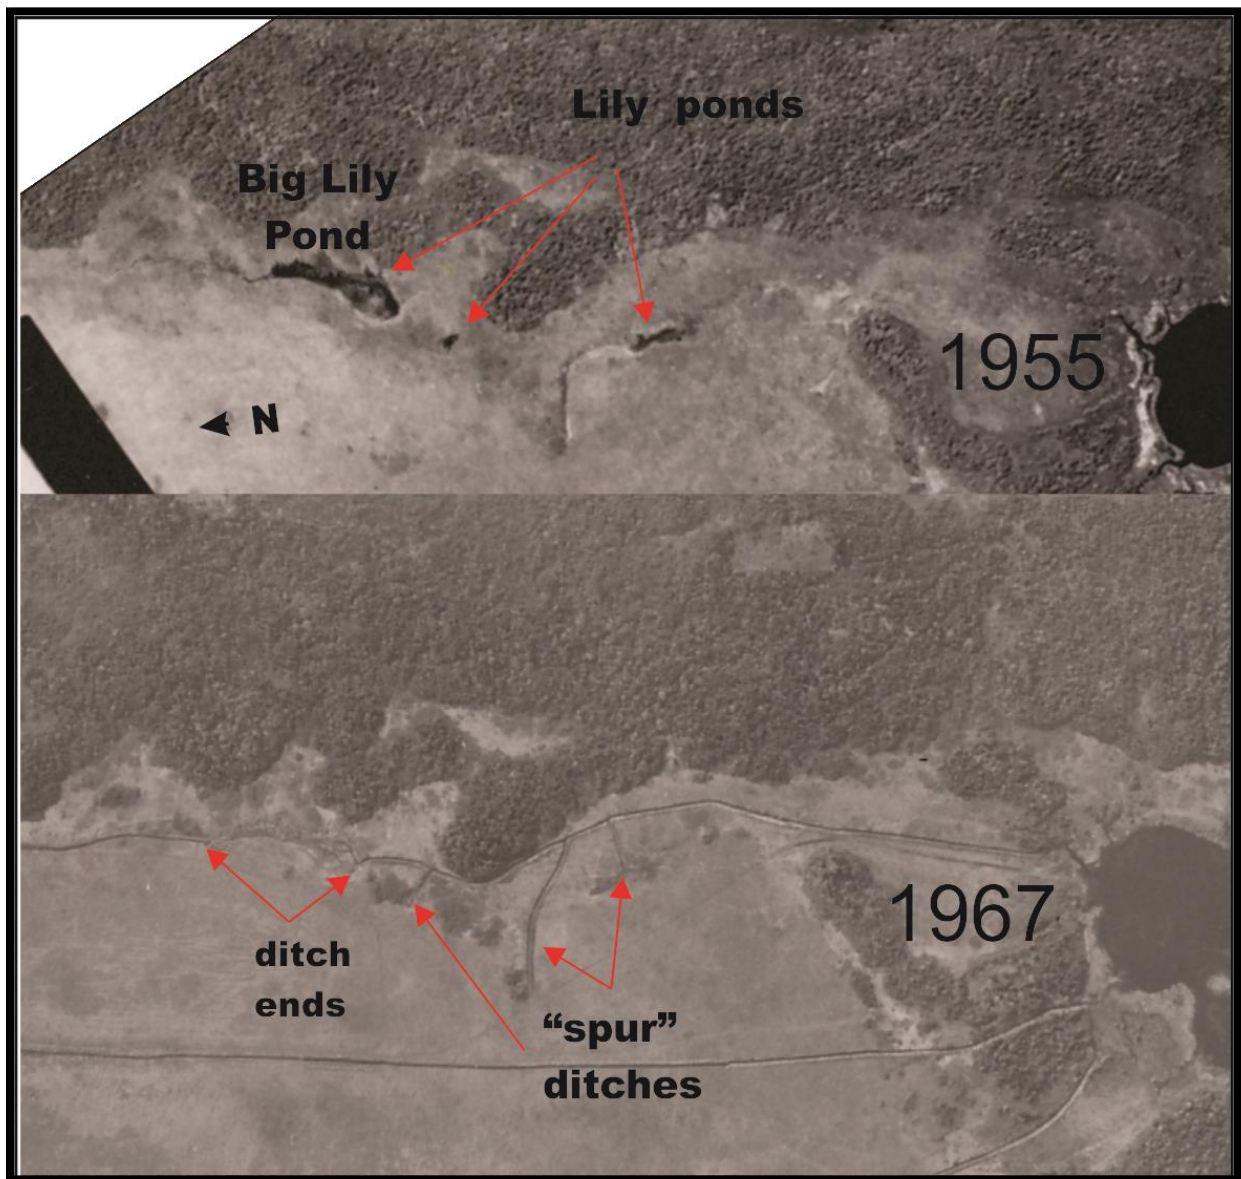
Figure 18: This time series of the "Lily Ponds" and the spur ditches in the south east of Big Meadow Bog clearly shows the transition from standing water prior to the ditching of BMB to the drained landscape of 1967.

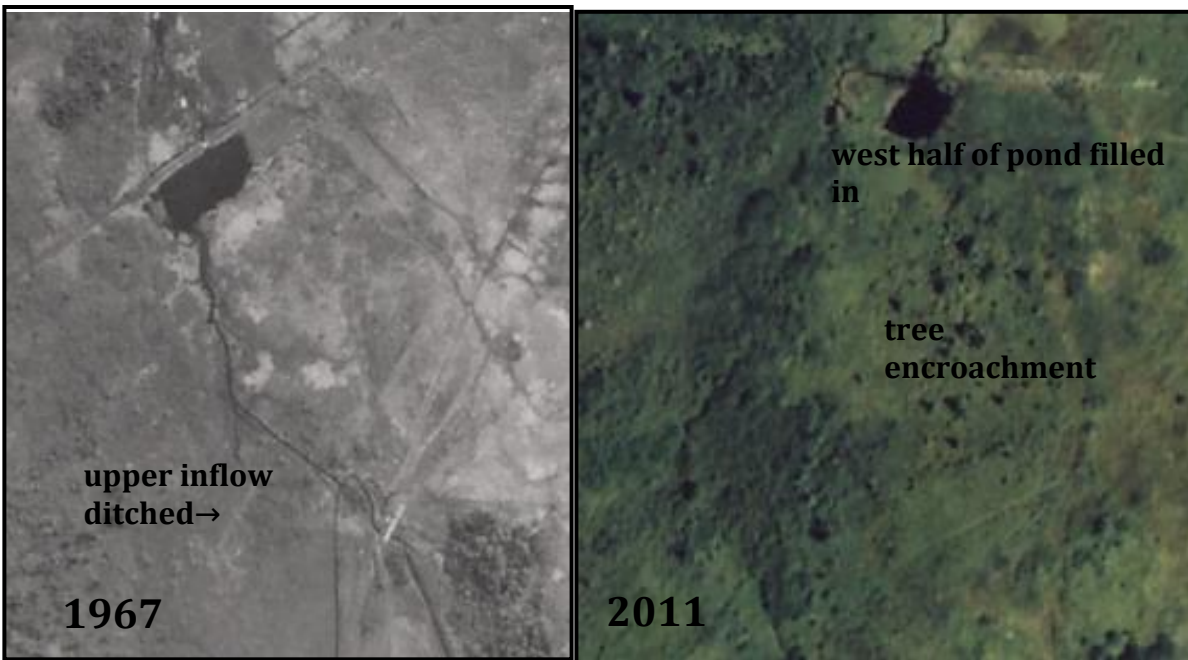
Figure 24: Jimmy's Pond shown in 1967 (L) with east, central, and north outlet ditching. Greater than 50% of the pond area is infilled as of 2011.

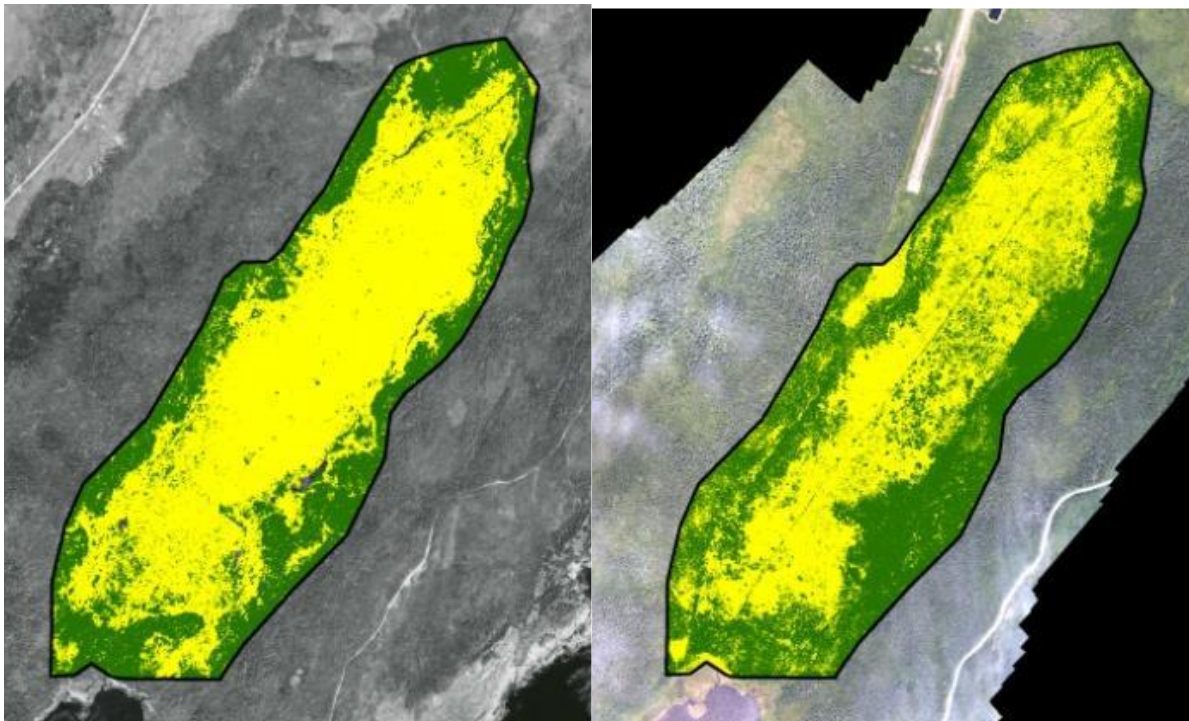
Figure 30: Supervised Maximum Likelihood habitat classification by polygons (Model 1) for 1955 (L) and 2015 (R) (Source. Toms 2015). Green indicates woody vegetation coverage on Big Meadow Bog, and the image demonstrates both a dense encroachment along the margins of the bog and a general sparse encroachment of trees across the open bog.

The spatial extent of woody vegetation encroachment was assessed by Brad Toms, Mersey Tobeatic Research Institute (2015), and his findings were used to direct tree removal. Toms indicated approximately 9.6 ha of open area within BMB has been lost to tree encroachment since 1955 (see Figure 30), with a clear decrease in bog width as well as a decrease in the ratio of open habitat to forested habitat. Much of the most densely forested areas that have encroached the bog are on the west side of BMB, and ECA estimated 5.9 ha of the 9.6 ha lost open area occurs on NCC land and along the western lagg area. Another 1.6 ha of dense encroached forest lies around the Lily Ponds on the south eastern lagg, as shown in Figure 31. Smaller areas of dense woods have encroached in various other areas of the perimeter of BMB, and there had been a general sparse colonization of large trees and tall shrubs across much of the open bog, with a slight concentration in the central bog east of the central ditch.

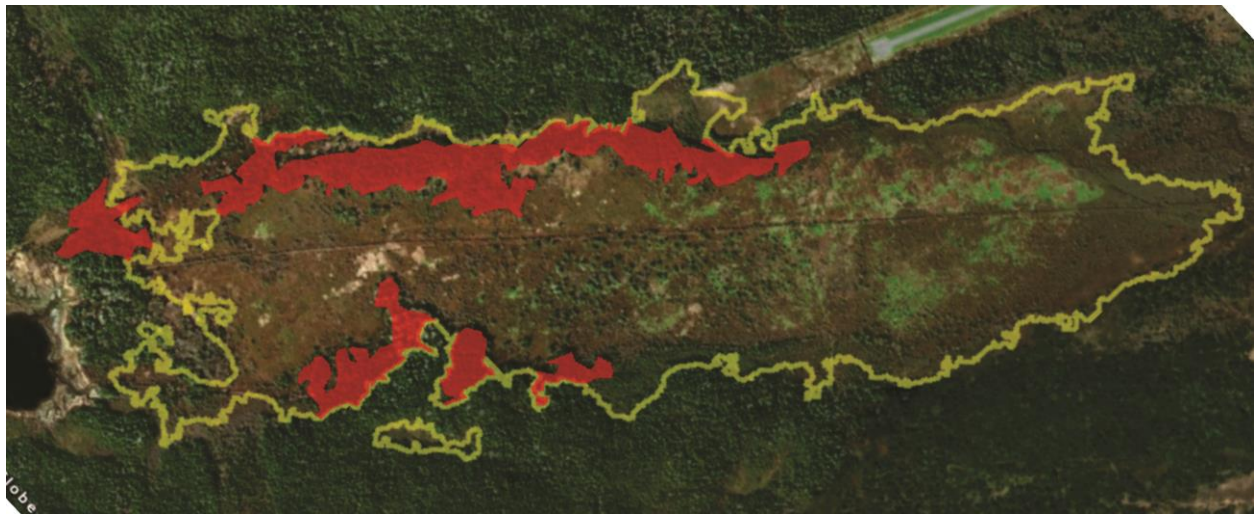
Figure 31: The 1955 treeline boundary around Big Meadow Bog is shown as a yellow line. As of 2011, the densest stands of forest that had encroached on the bog are shown in red and are concentrated in the southern half of BMB along the lagg areas (Source: modified from Toms 2015).

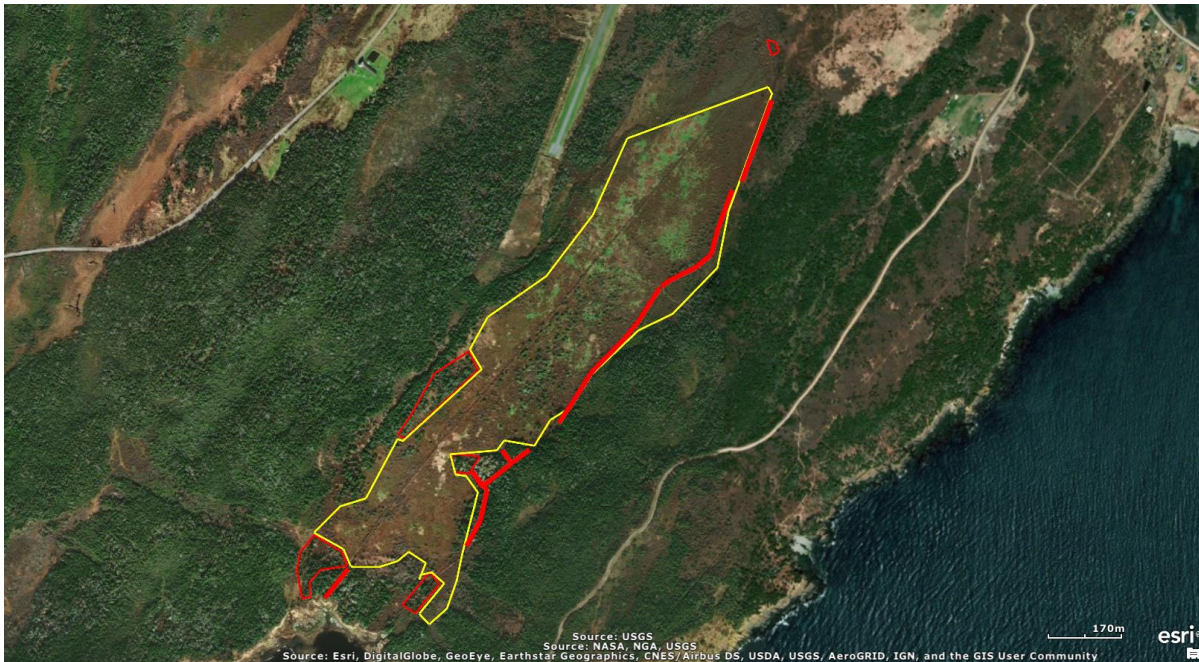
Figure 32: As part of the restoration efforts, removal of sparse tree cover occurred over some 31ha within the area defined by the yellow line. Dense tree removal occurred within red polygons (1.5ha) and along ditch corridors indicated with a red line.

The felling of woody vegetation as part of the restoration efforts occurred across approximately 33 ha of the main bog from the central bog outward toward the east and west ditches. As shown in Figure 32 and 33, all the sparse growth was felled, as well as dense areas around the south west and south east ditches, and a dense area along the west central lagg. Dense growth was also removed from corridors along the south central and west ditches to allow machine access for restoration. White spruce, Grey birch, Black spruce, alder and Wild Raisin were the predominant species cut. To a lesser extent Larch and other species were encountered.
