Aquatic Habitat Restoration in Nova Scotia

PROJECTS BY EAST COAST AQUATICS INC.

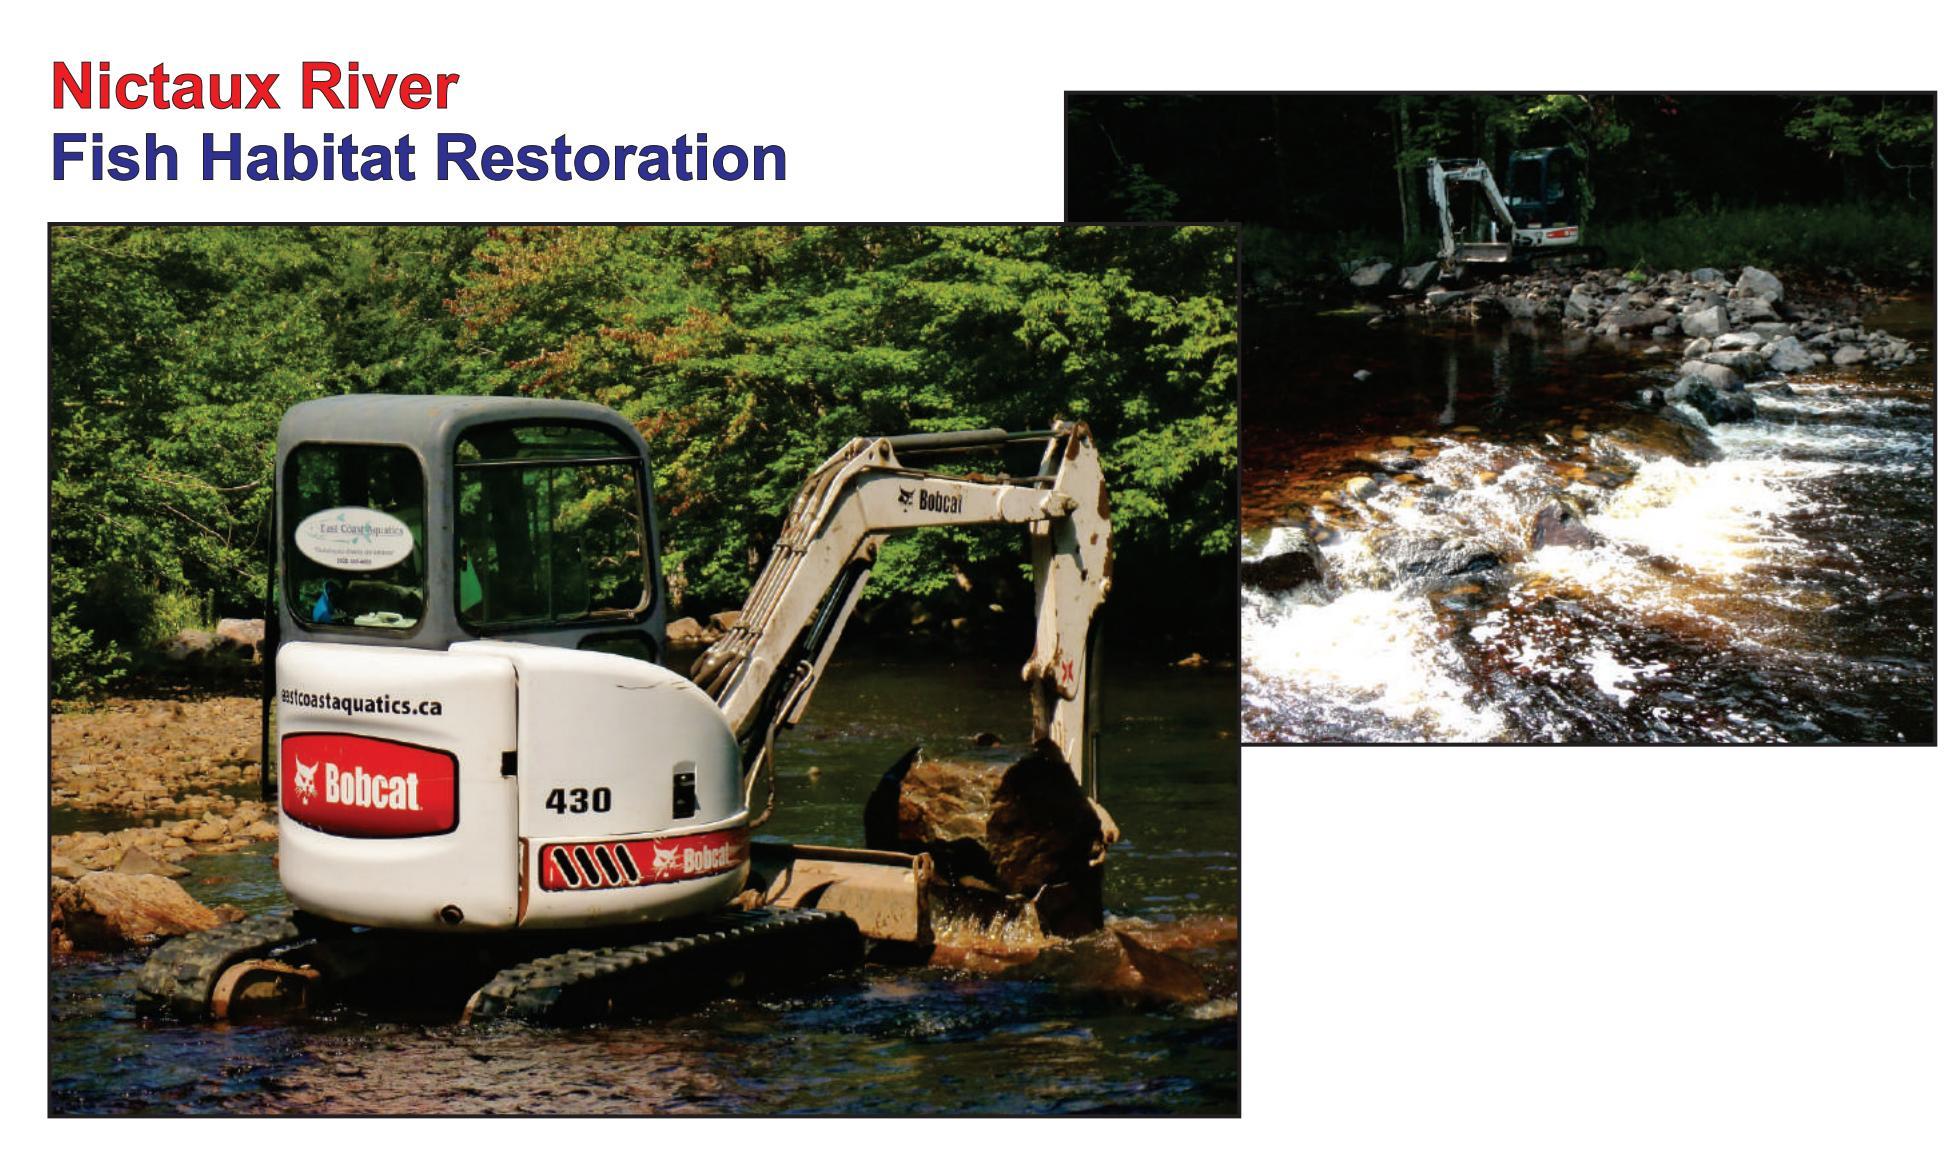
Stream habitat restoration structures installed in the Nictaux River during the early 1990's had structurally failed. ECA rebuilt a number of the rock sill and deflectors, and added new habitat complexing structures such as boulder clusters and large woody debris placements. The former establish primary pool and riffle sequencing, while the latter improve overall habitat productivity for salmon and trout found within the system.

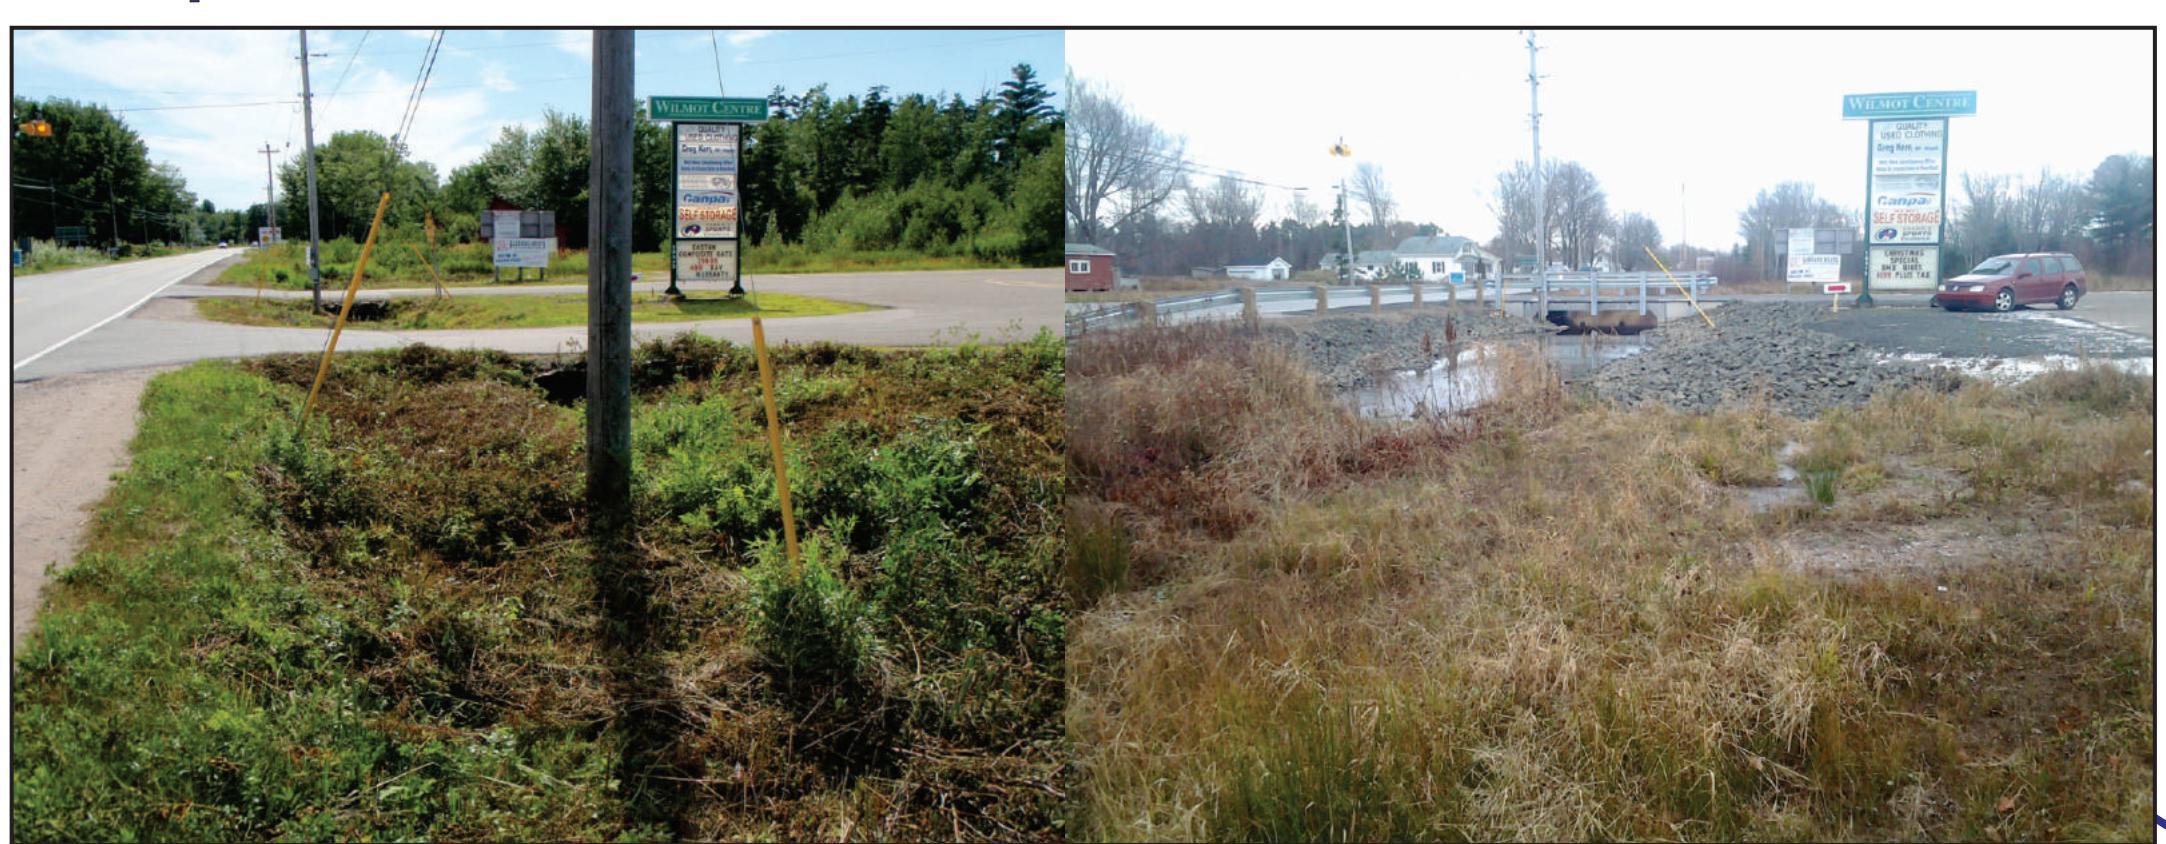
Wilmot **Floodplain Restoration**

After years of local development encroachment on this small watercourse, chronic flooding affected Highway 1 in Wilmot. ECA used natural templates, watershed calculations, and historic air photo analysis to determine the natural flood plain had been eliminated and the channel constricted. Provincial Transportation used the ECA restoration design to re-establish a flood plain wetland and alleviate risk of highway flooding.

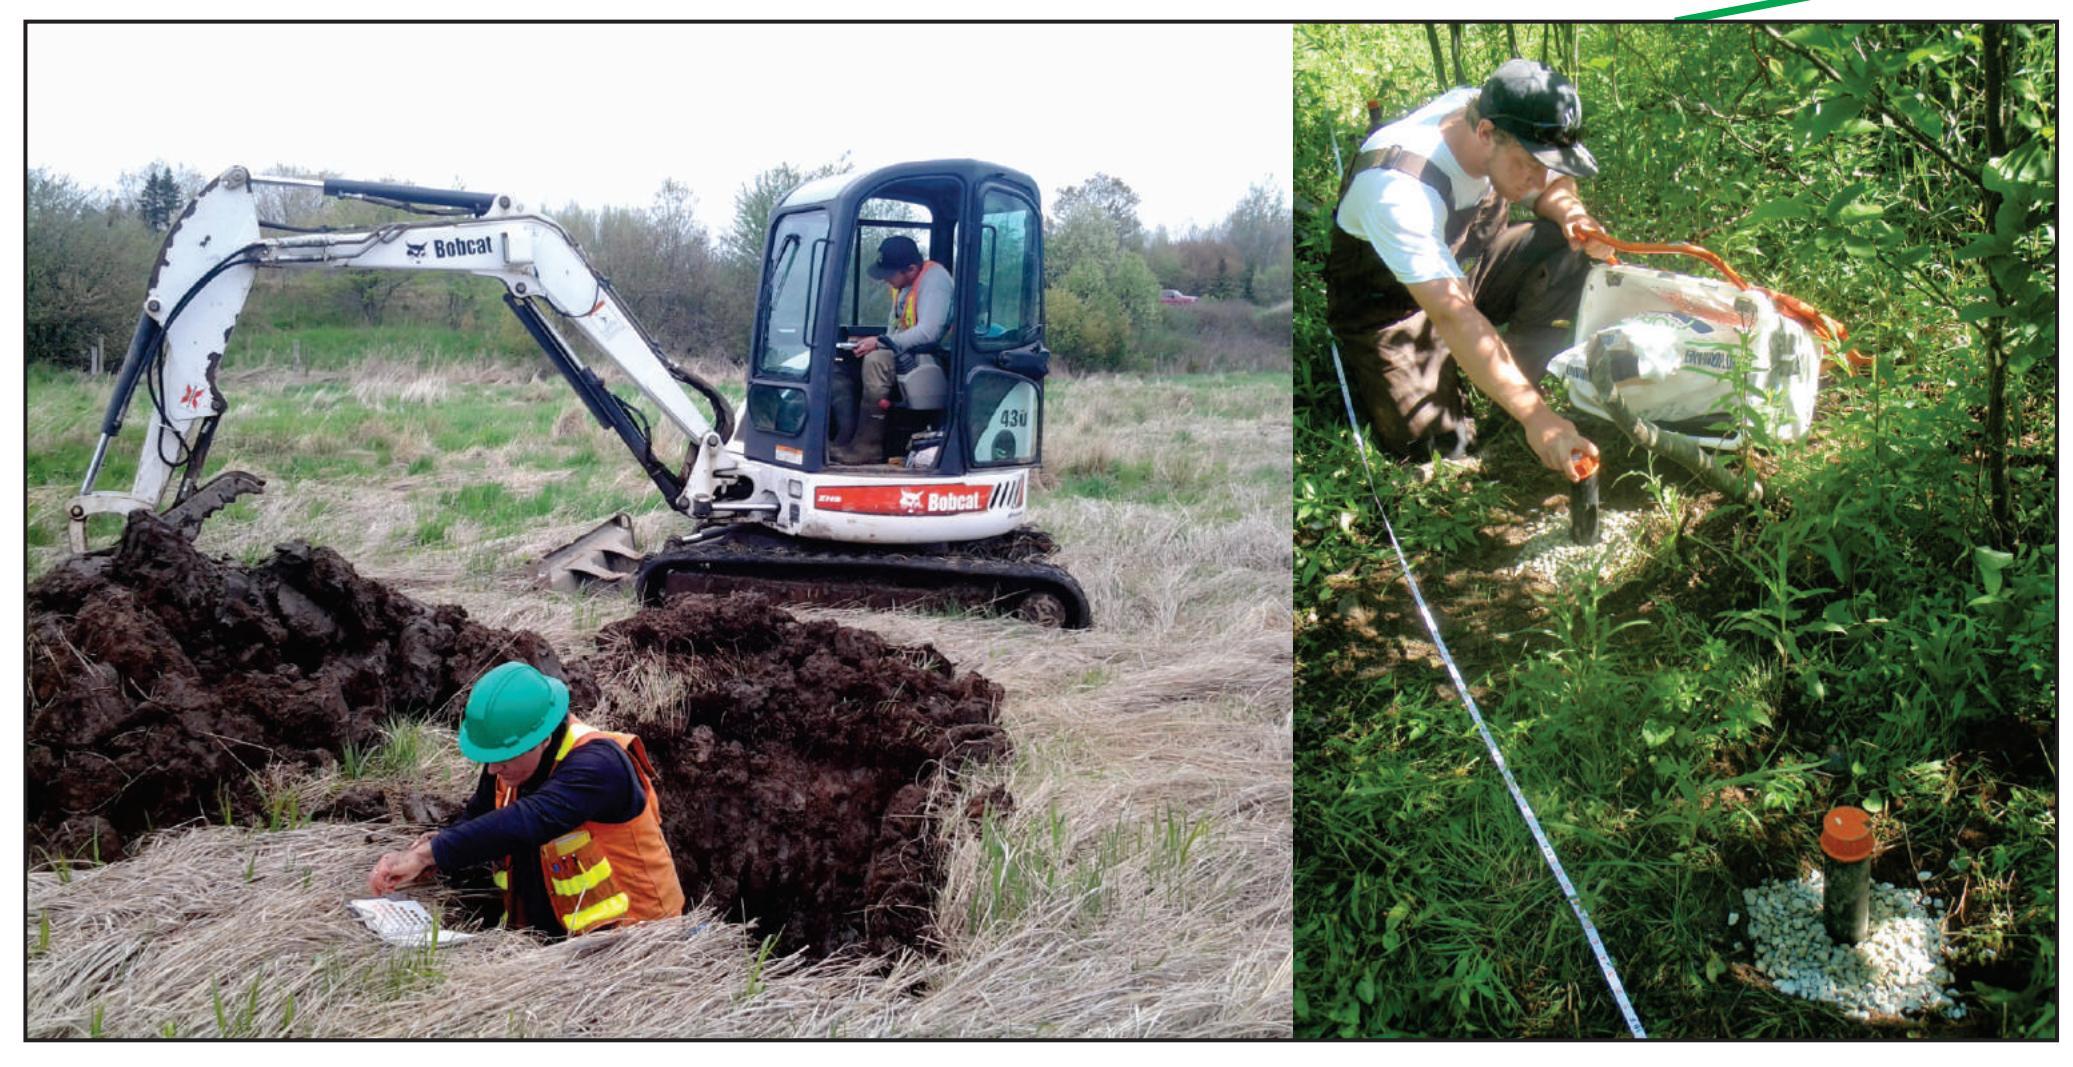
Bishop Farm Wetland Restoration

As part of our design of an impending project we have assessed soil profiles and installed shallow water monitoring wells to help determine both how to construct restoration structures, and whether we have achieved biological targets in the long run post construction. Restoring natural drainage and water retention at this 7 ha site will be part of the approach to returning it to a productive natural marsh.

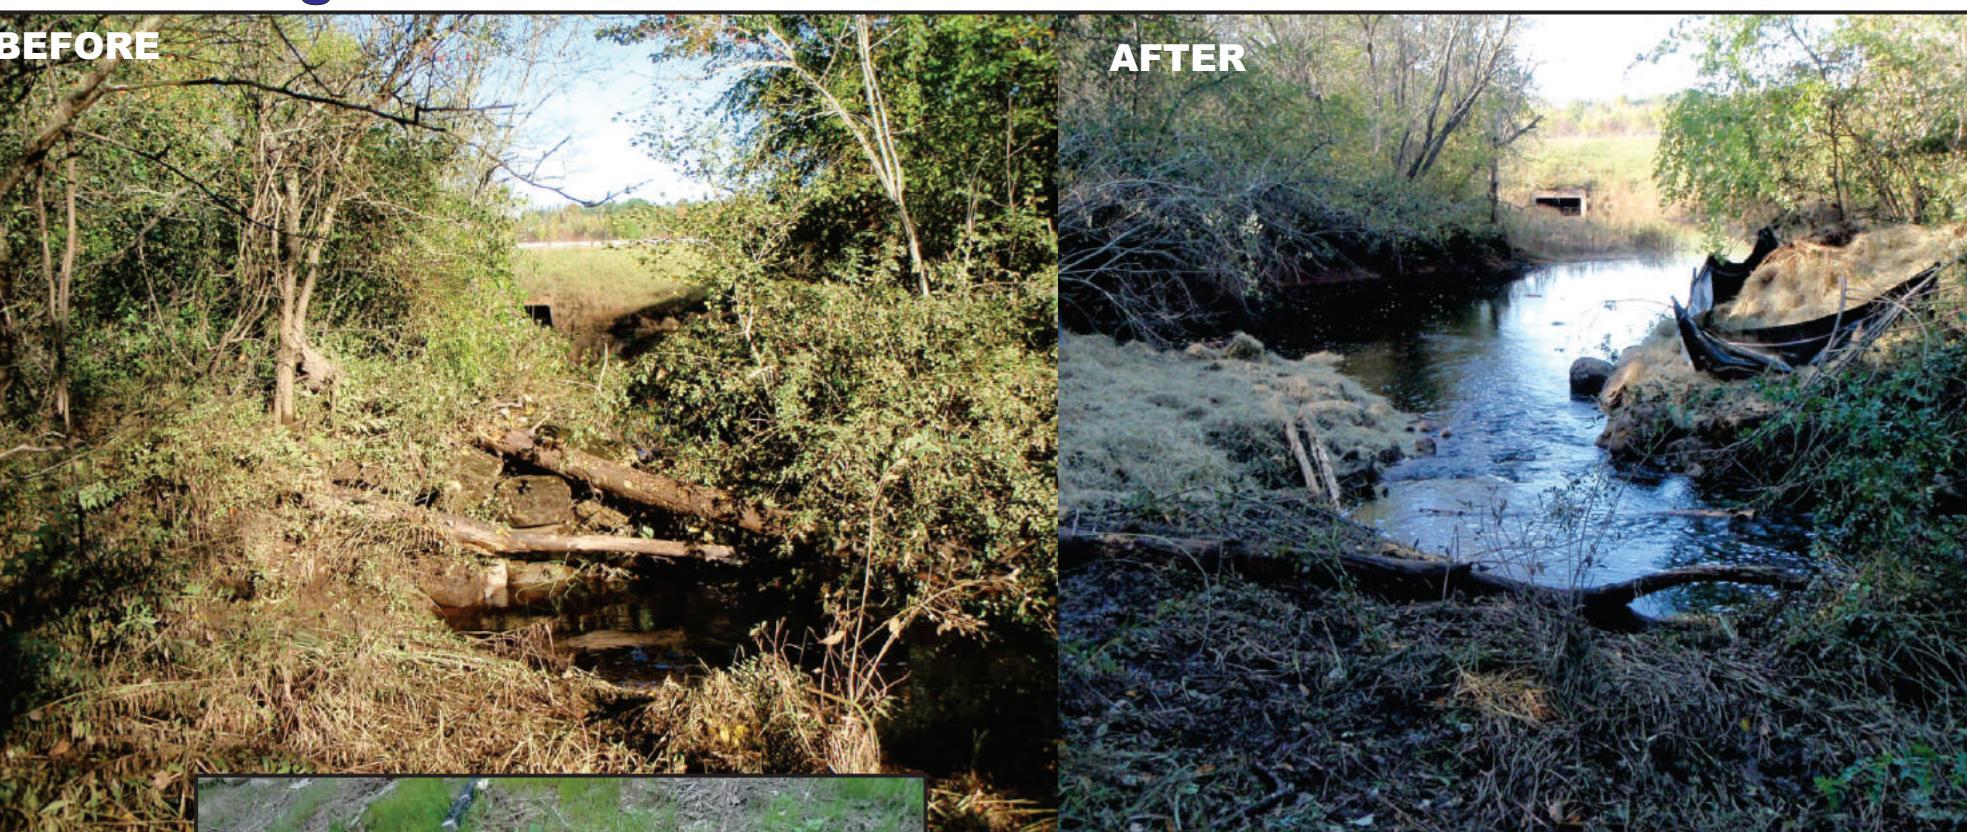
An old collapsed culverted road crossing at the head of tide on Black Brook was impeding fish passage and posing a risk of significant sediment/debris impacts to habitat. ECA removed the culvert and roadway and recontoured the channel and

floodplain to align with the natural annual and multi-year flood return profiles respectively. Hawthorn and alder clumps were salvaged and planted to provide quick woody plant growth within the seeded and mulched restoration site.

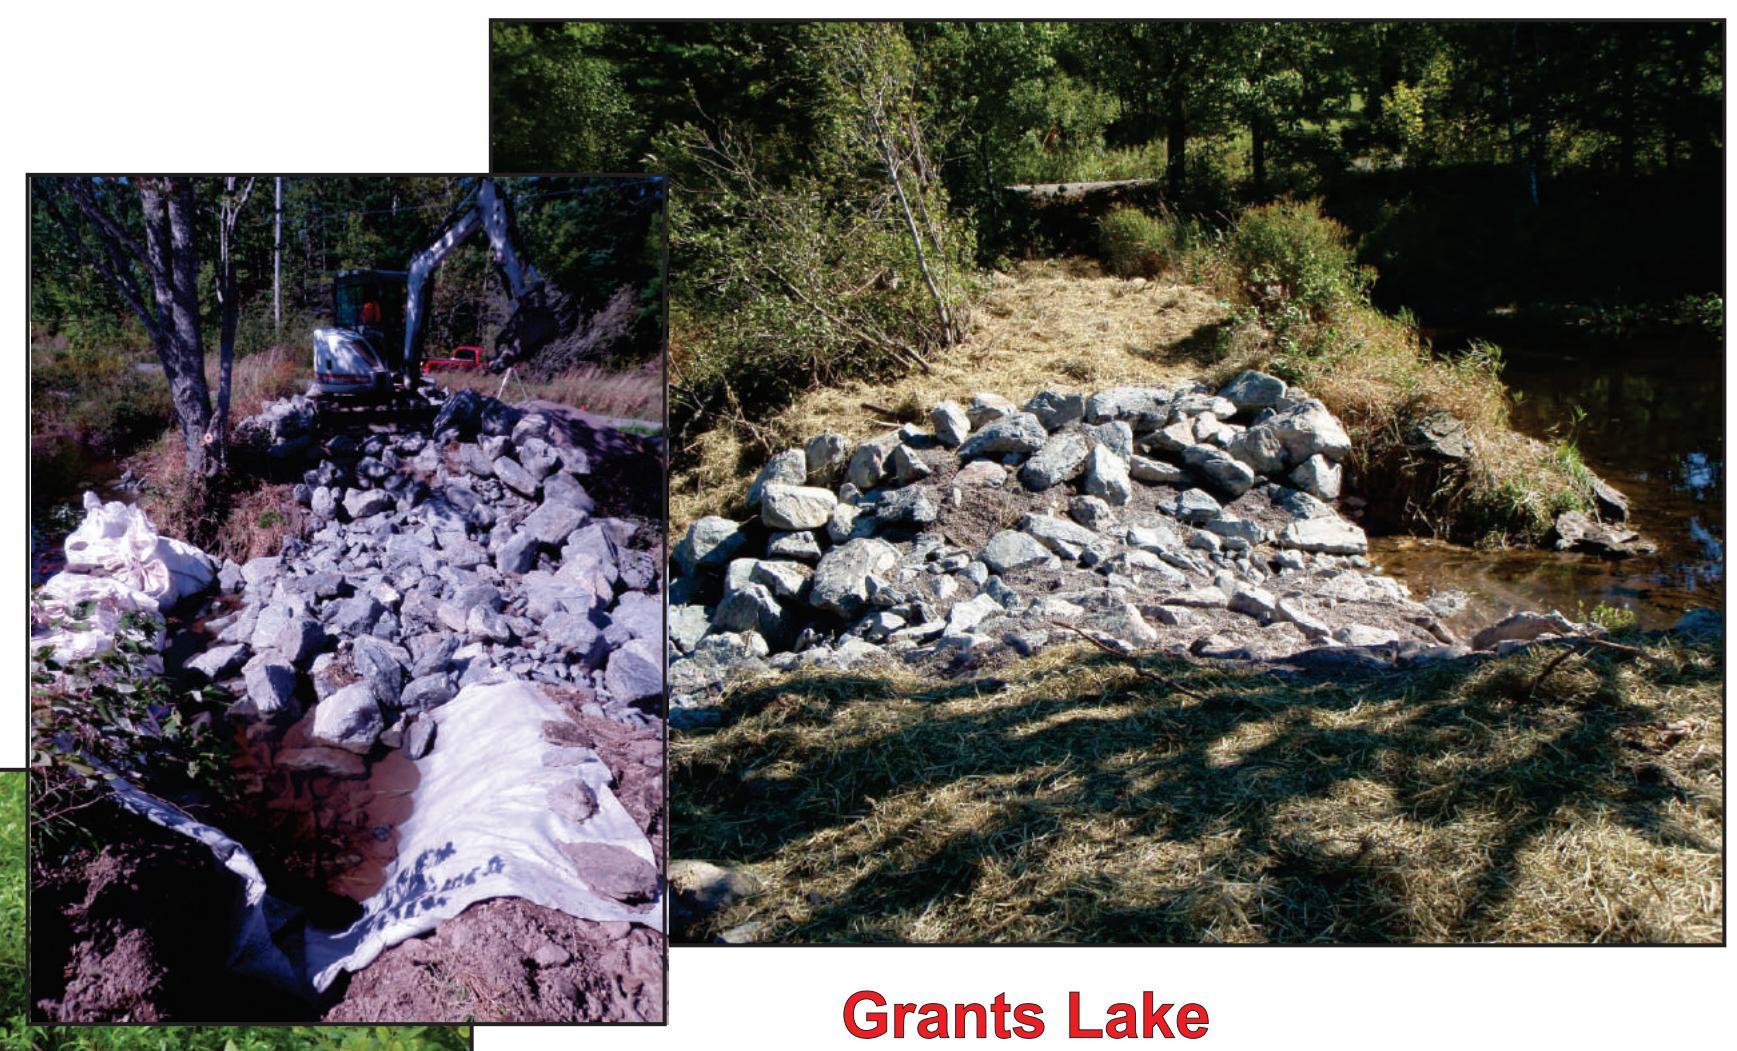
Outlet Control Remediation An old wooden outlet control structure at Grants Lake was failing beyond repair (left). This was resulting in a loss of productive lacustrine wetland and fish habitat. ECA used a coffer dam to isolate the work area before constructing a naturalized control using various sized washed boulder, cobble,

and pebble materials (center). Using natural lake edge zone elevations, the outlet structure elevation was established to maintain productive aquatic habitats.
