**PRE-DEMOLITION  
HAZARDOUS BUILDING MATERIALS ASSESSMENT  
FORMER CONSTRUCTION CAMP SITES  
BAY D'ESPOIR – AVALON TRANSMISSION LINE (TL202/TL206)  
NEWFOUNDLAND AND LABRADOR**

**Newfoundland and Labrador Hydro,  
a Nalcor Energy Company**  
Hydro Place, 500 Columbus Drive  
PO Box 12400  
St. John's, NL A1B 4K7

April 2019

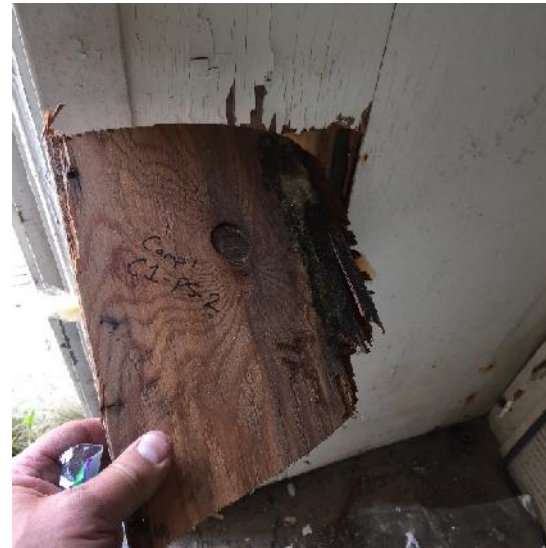
During the Pre-Demolition HBMA site visit, six (6) samples (C1-PS1 to C1-PS6) were collected from painted surfaces of the accommodations cabin and three (3) samples (C1-PP-PS1 to C1-PP-PS3) were collected from painted surfaces of the outhouse and analyzed for lead, mercury and PCB content (refer to Photos 23 to 31, Appendix B2). Paint sample descriptions and lead, mercury and PCBs analytical results are summarized in Tables C2-2 to C2-4, Appendix C2. Sample locations and analytical results are graphically illustrated in Figure 2.1, Appendix A2.

Photo 24: View of paint sample C1-PS2, wall, cabin interior.

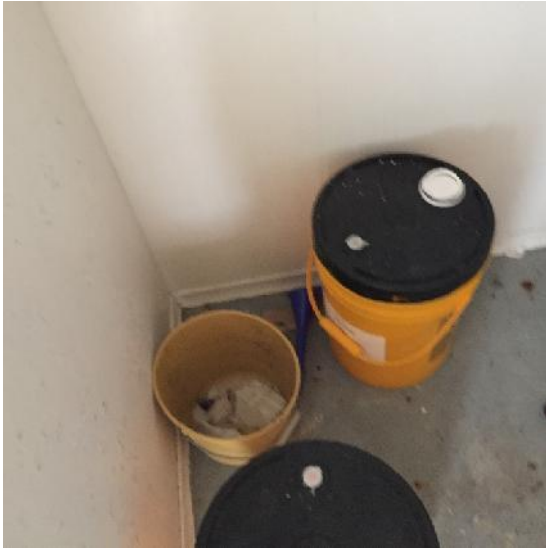
Photo 37: View of kerosene located on the interior of the accommodations cabin.

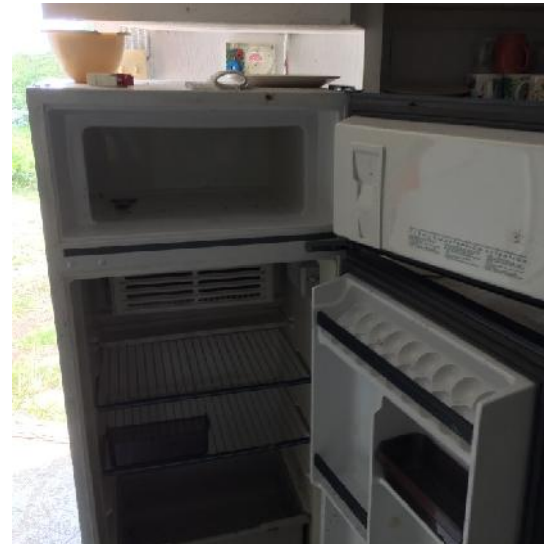
Photo 31: View of kelvinator freezer (R12 refridgerant containing), cabin interior.

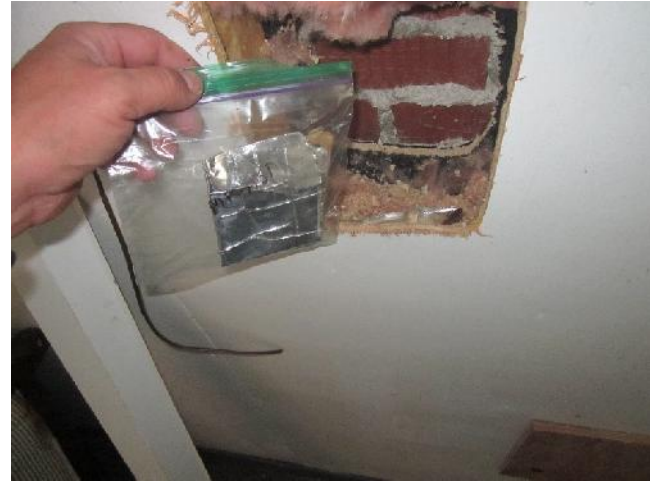
During the Pre-Demolition HBMA site visit, pink fiberglass insulation was observed between the particle board and plywood in the walls of the accommodations cabin. During the Pre-Demolition HBMA site visit, one (1) sample of foil with paper backing (collected from the pink fiberglass insulation) (MP-AS1) was collected from within the wall cavity of the accommodations cabin and analyzed for asbestos content (refer to Photo 14, Appendix B4). Asbestos was not detected in the insulation sample collected from the accommodations cabin.

Photo 14: View of bulk material sample MP-AS1, foil with paper backing, Room 1.

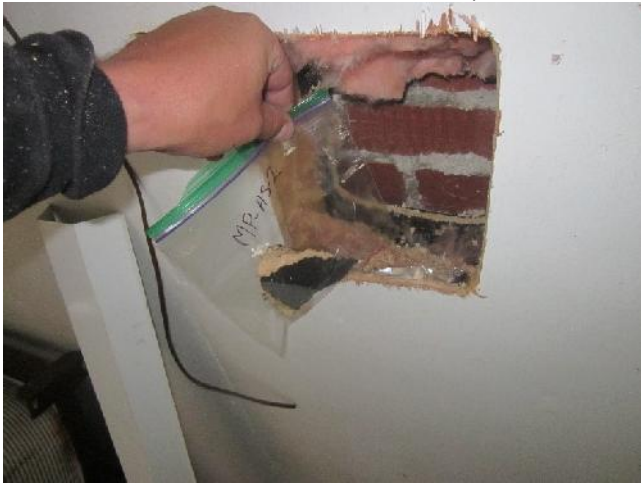
During the Pre-Demolition HBMA site visit, one (1) sample of black pressed board (MP-AS2) and one (1) sample of tar paper (MP-AS3) was collected from the exterior of the accommodations cabin and analyzed for asbestos content (refer to Photos 15 and 16, Appendix B4). Asbestos was not detected in the pressed board and tar paper samples analyzed.

Photo 15: View of bulk material sample MP-AS2, black pressboard, Room 1.

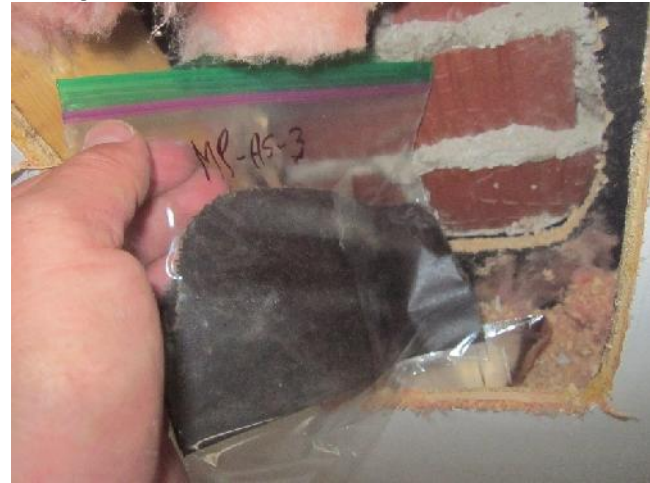
Photo 16: View of bulk material sample MP-AS3, tar paper, cabin exterior.

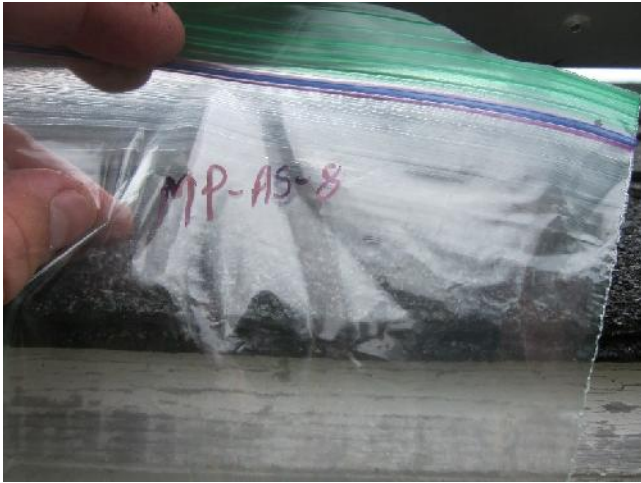
During the Pre-Demolition HBMA site visit, one (1) sample of black shingle and tar (MP-AS8) was collected from the roof of the accommodations cabin and one (1) sample of black shingle and tar (MP-PP-AS1) was collected from the roof of the outhouse and analyzed for asbestos content (refer to Photos 21 to 24, Appendix B4). Asbestos was not detected in the roofing samples collected from the accommodations cabin and outhouse.

Photo 21: View of bulk material sample MP-AS8, shingle and tar, cabin exterior.

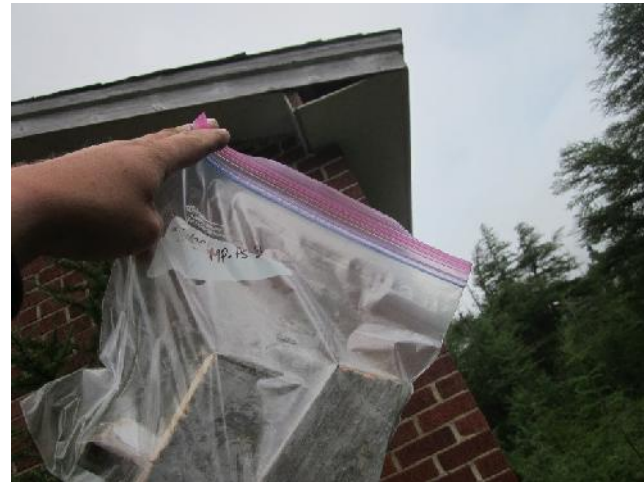
Photo 28: View of paint sample MP-PS3, white, cabin exterior.

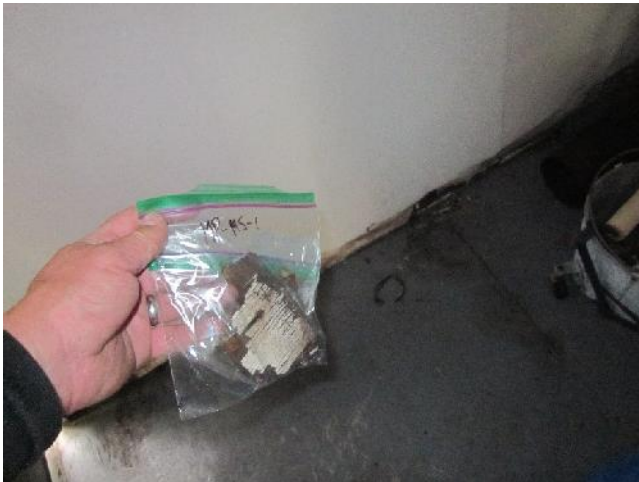
Photo 31: View of mould sample MP-MS1, cabin interior.

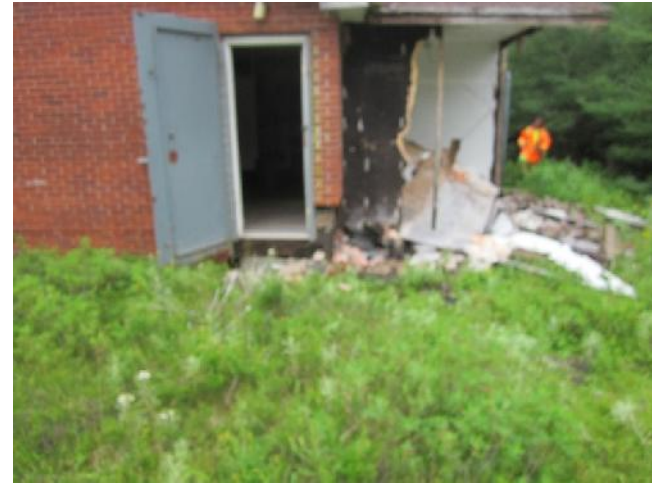
Photo 2: View of the accommodations cabin at Camp 100, looking north.

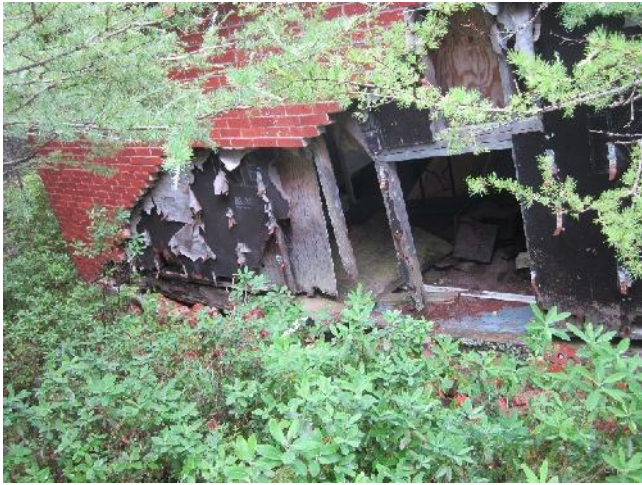
Photo 3: View of the accommodations cabin at Camp 100, looking northeast.

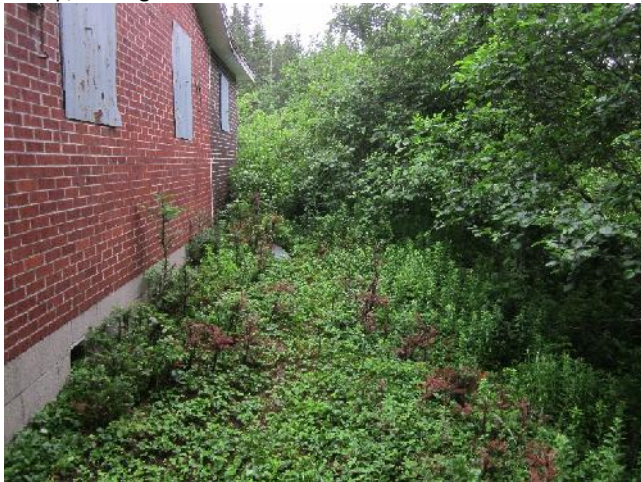
Photo 3: View of the accommodations cabin at Medonnegonik Camp, looking east.

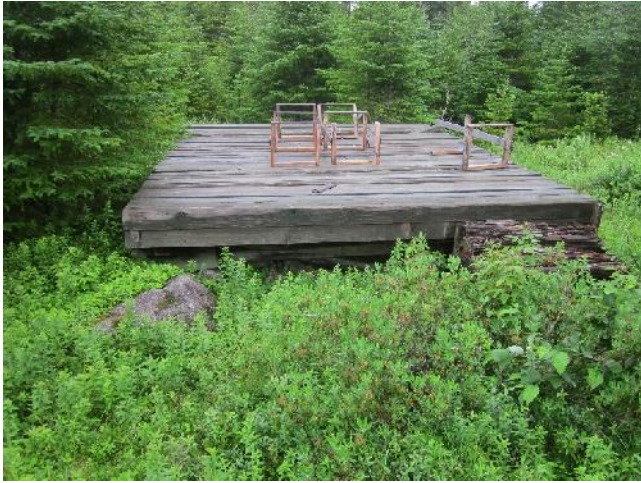
Photo 13: View of helipad adjacent to the accommodations cabin at Medonnegonik Camp.

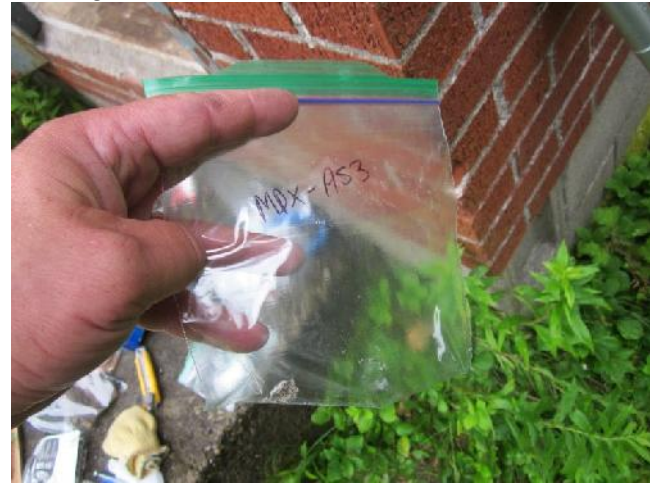
During the Pre-Demolition HBMA site visit, one (1) sample of grey mortar on red brick (MDX-AS3), one (1) sample of red brick (MDX-AS4), one (1) sample of concrete block (MDX-AS5), one (1) sample of grey mortar on concrete block (MDX-AS6), one (1) sample of brown brick (MDX-AS8) and one (1) sample of grey mortar on brown brick (MDX-AS9) collected from the exterior of the accommodations cabin and analyzed for asbestos content (refer to Photos 16, 17, 18, 19, 21 and 22, Appendix B7). Asbestos was not detected in the brick, concrete and mortar samples analyzed.

Photo 16: View of bulk material sample MDX-AS3, grey mortar, cabin exterior.

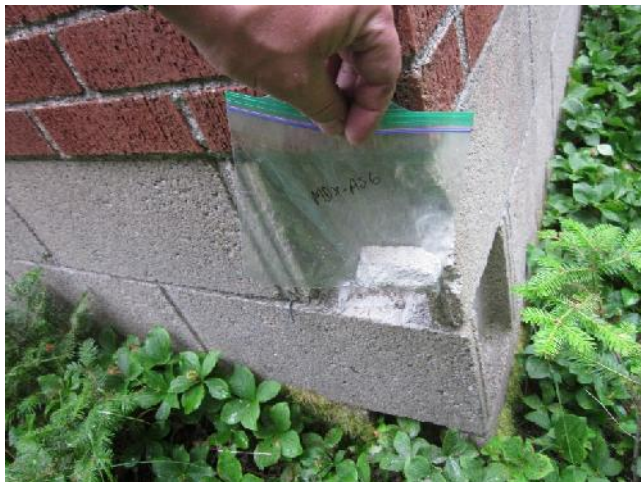
Photo 19: View of bulk material sample MDX-AS6, grey mortar, cabin exterior.

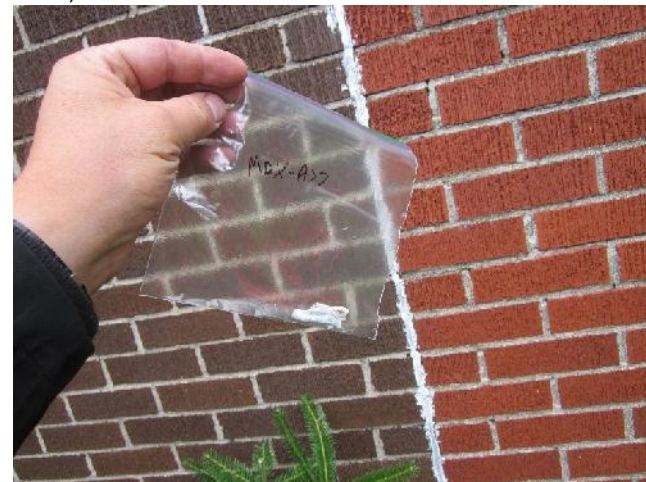
During the Pre-Demolition HBMA site visit, one (1) sample of white caulking (MDX-AS7) was collected from around the brick on the accommodations cabin and analyzed for asbestos content (refer to Photo 20, Appendix B7). Asbestos was not detected in the caulking sample collected from the accommodations cabin.

Photo 20: View of bulk material sample MDX-AS7, white caulking, cabin exterior.

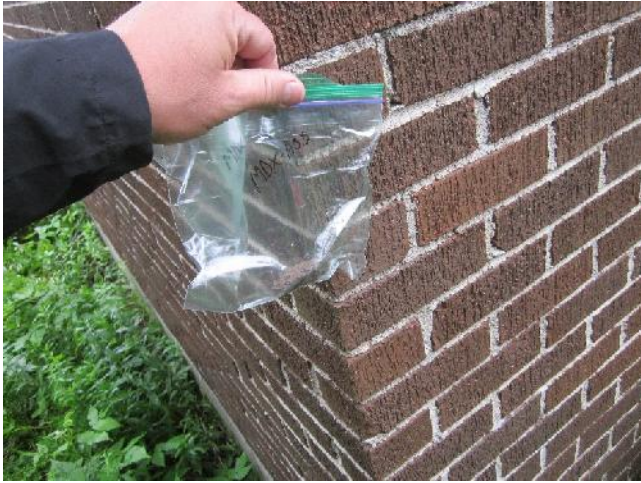
Photo 21: View of bulk material sample MDX-AS8, brown brick, cabin exterior.

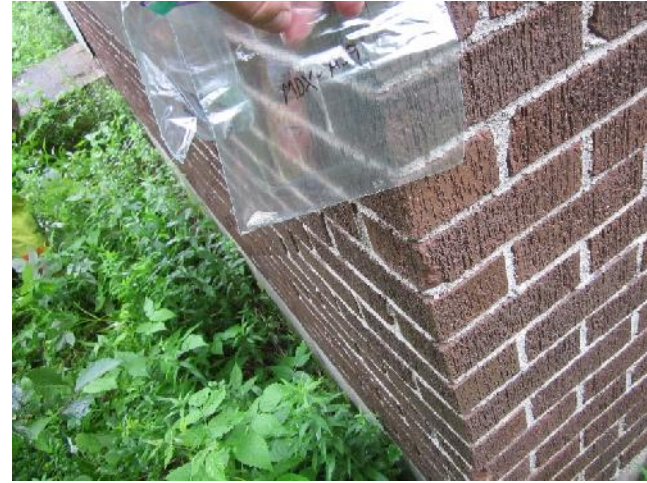
Photo 22: View of bulk material sample MDX-AS9, grey mortar, cabin exterior.

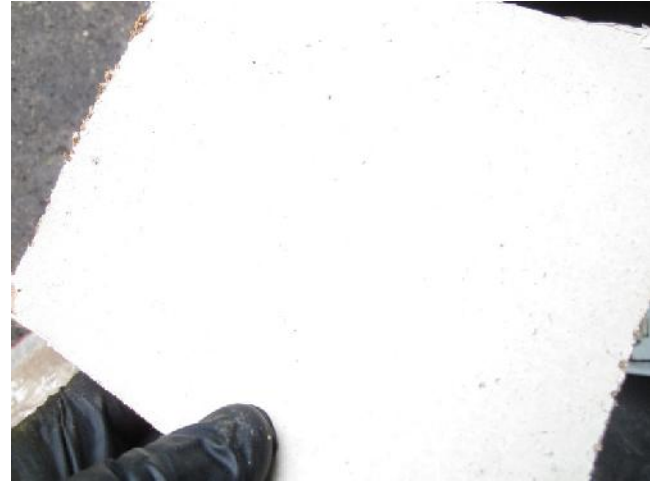
During the Pre-Demolition HBMA site visit, three (3) samples (MDX-PS1 to MDX-PS3) were collected from painted surfaces of the accommodations cabin and one (1) sample (MDX-PP-PS1) collected from painted surfaces of the outhouse and analyzed for lead, mercury and PCB content (refer to Photos 26 to 29, Appendix B7). Paint sample descriptions and lead, mercury and PCBs analytical results are summarized in Tables C7-2 to C7-4, Appendix C7. Sample locations and analytical results are graphically illustrated on Figure 7.2, Appendix A7.

Photo 26: View of paint sample MDX-PS1, white, cabin interior.

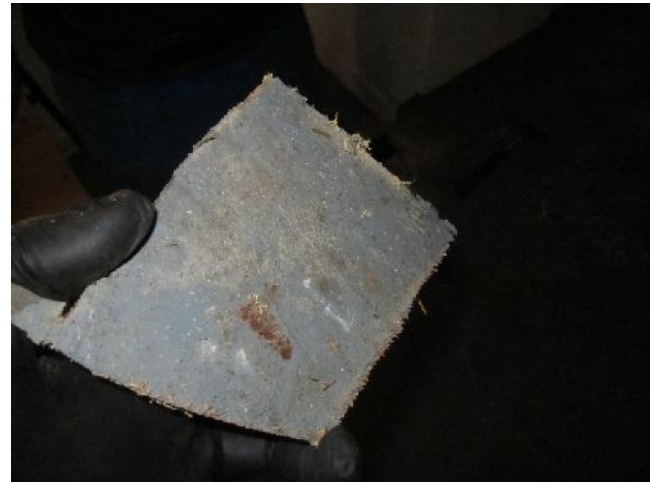
Photo 28: View of paint sample MDX-PS3, grey, cabin interior.

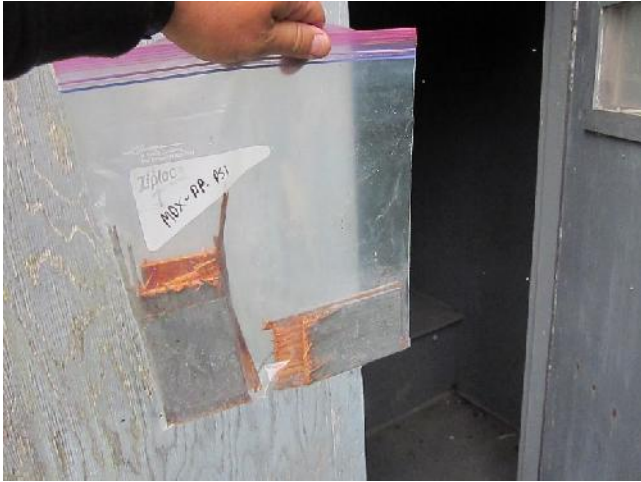
Photo 29: View of paint sample MDX-PP-PS1, grey, cabin exterior.

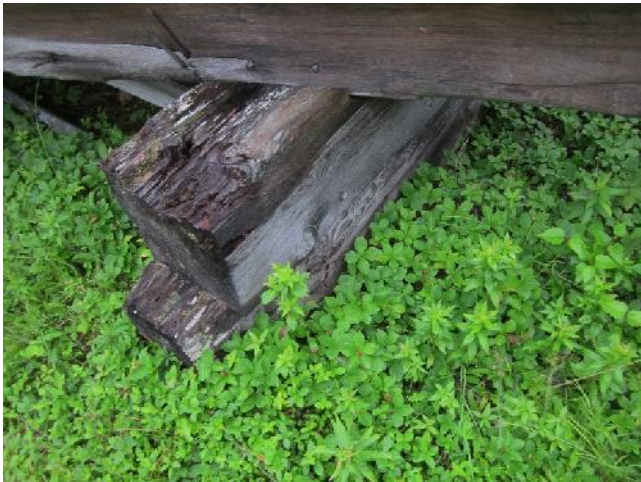
During the Pre-Demolition HBMA site visit, suspected "creosote treated" inorganic (i.e., chromated copper arsenate (CCA)) preservatives appear to have been applied to wood that was used as the foundation of the outhouse. One (1) sample of treated wood (MDX-TW1) was collected from the foundation and analyzed for leachable benzo(a)pyrene and leachable cresols to determine whether or not the treated wood would be considered hazardous waste upon removal from the site, if required (refer to Photo 31, Appendix B7). The bulk sample description and leachable treated wood parameter analytical results are summarized in Table C7-6, Appendix C7. The sample location and analytical results are graphically illustrated on Figure 7.2, Appendix A7.

Photo 31: View of treated wood sample MDX-TW1, heli-pad.
