NEWFOUNDLAND AND LABRADOR HYDRO

PRE-DEMOLITION HBMA, FORMER CONSTRUCTION  
CAMP SITES, TL228, NL

MARCH 15, 2023

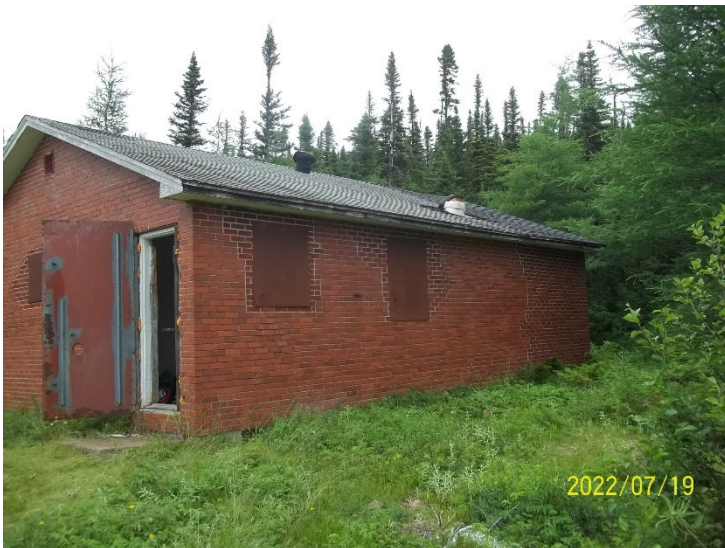
Photo 3: View of accommodations cabin at Camp 50.

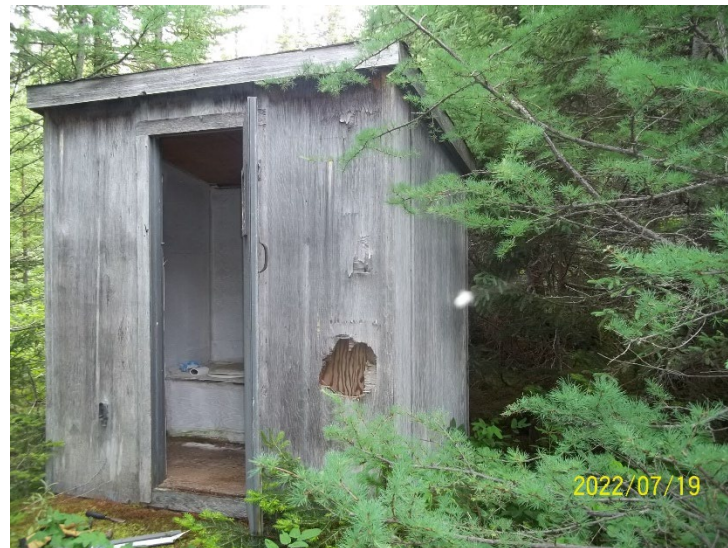
Photo 4: View of the outhouse at Camp 50.

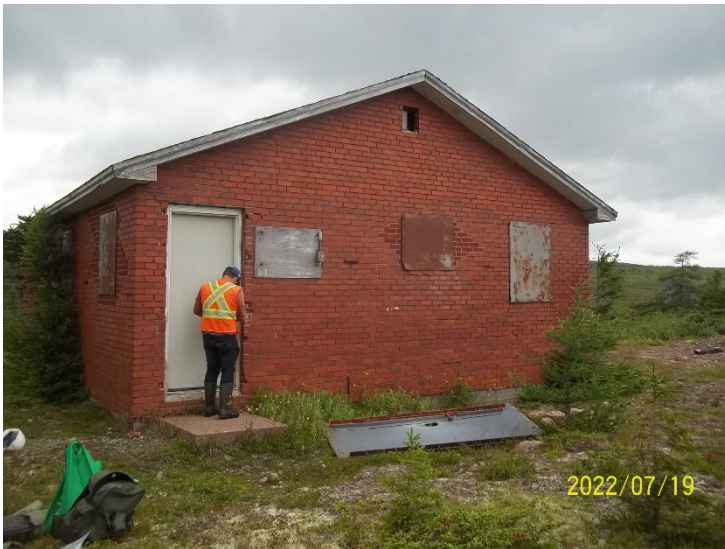
Photo 7: View of accomodations cabin at Camp 98.

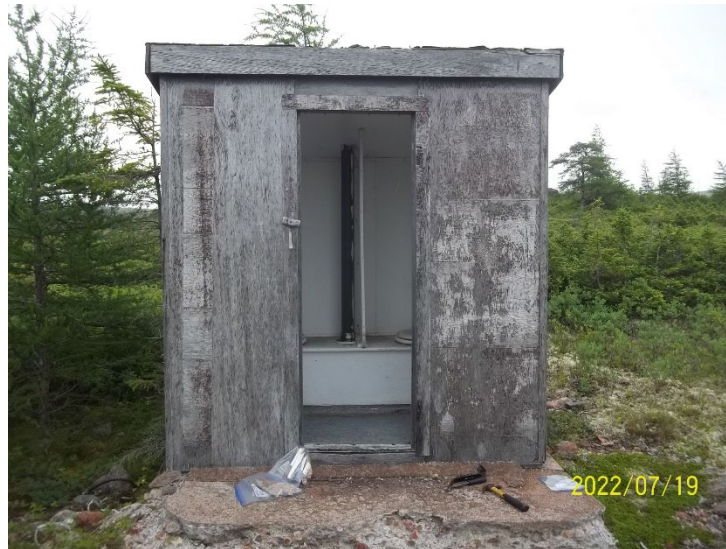
Photo 8: View of the outhouse at Camp 98.

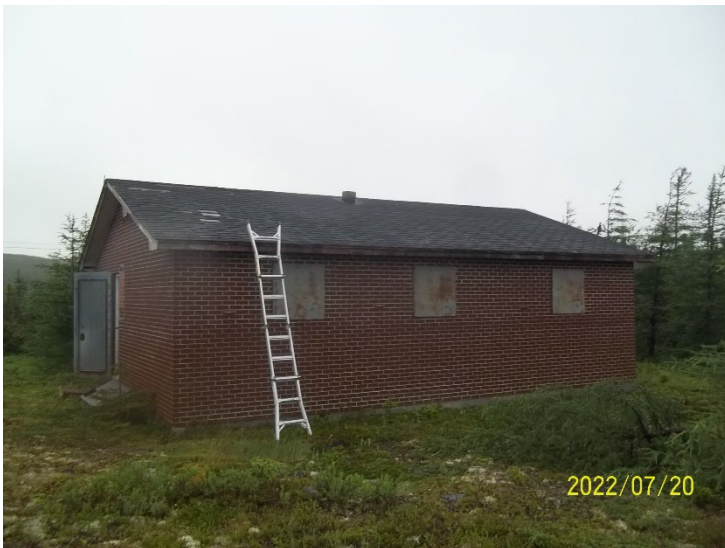
Photo 11: View of accommodations cabin at Rainy Lake Camp.

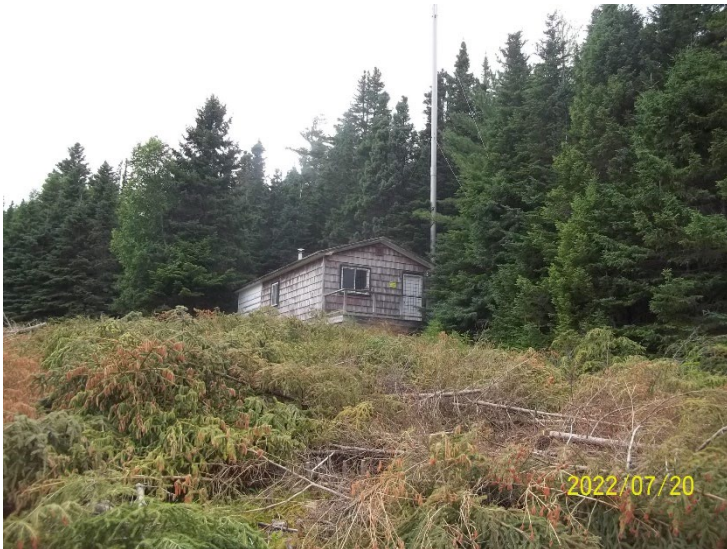
Photo 15: View of accomodations cabin at Glover Island Camp.

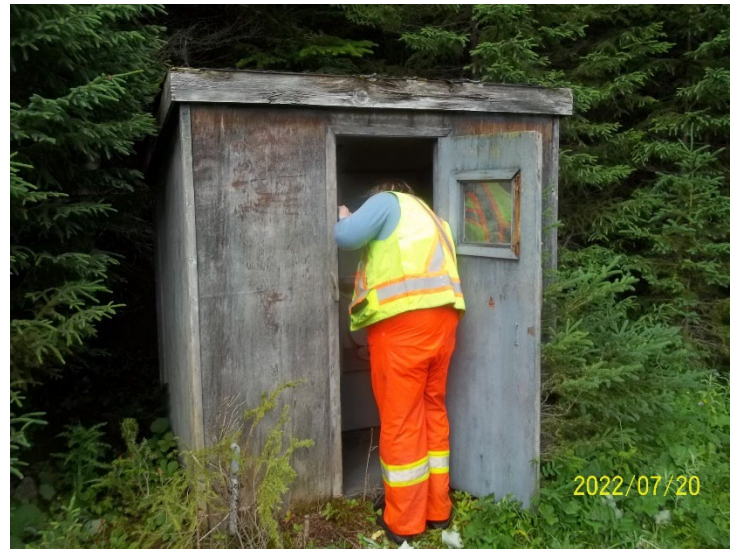
Photo 16: View of the outhouse at Glover Island Camp.

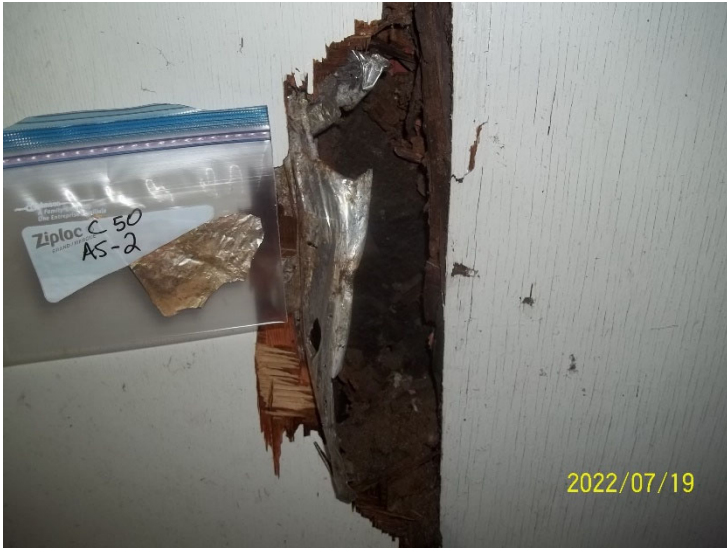
One (1) sample of foil wrap was collected from a wall of the accommodations cabin and analyzed for asbestos content (refer to Photo 13, Appendix B2). Asbestos was not detected in the foil wrap sample.

Photo 13: View of bulk material sample C50 AS-2, foil wrap, cabin interior.

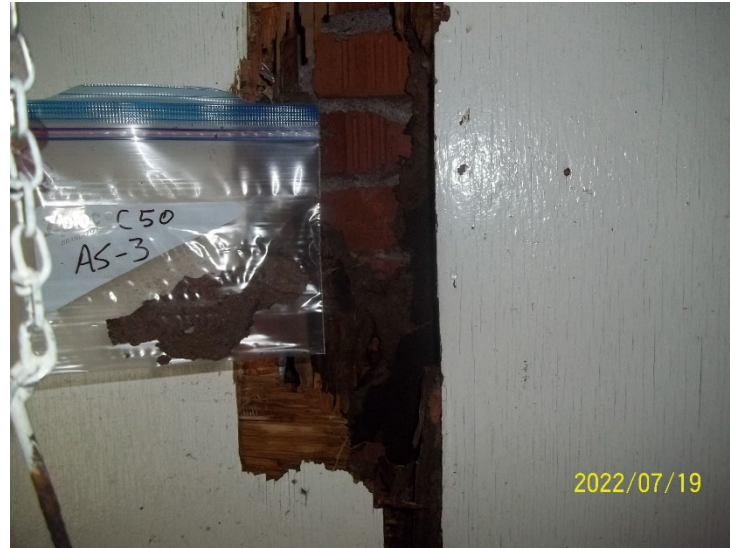
Photo 14: View of bulk material sample C50 AS-3, particle board, cabin interior.

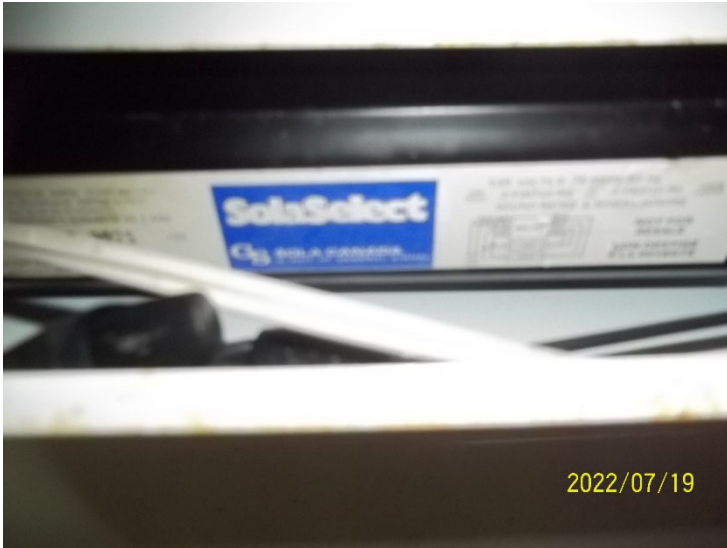
Photo 25: View of fluorescent light ballast inside the accomodations cabin.

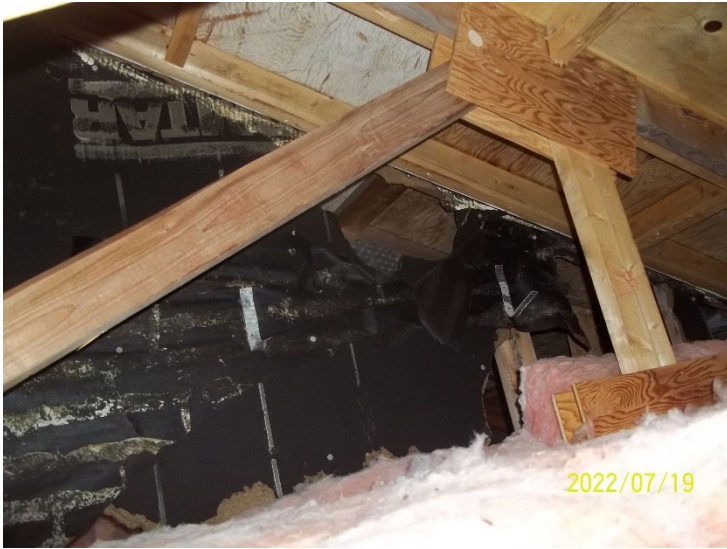
During the Pre-Demolition HBMA site visit, fiberglass insulation was observed in the attic and walls of the accommodations cabin (refer to Photos 9 and 14, Appendix B3). Thermal system insulation was not observed at Camp 98.

Photo 9: View of the attic in the accommodations cabin at Camp 98.

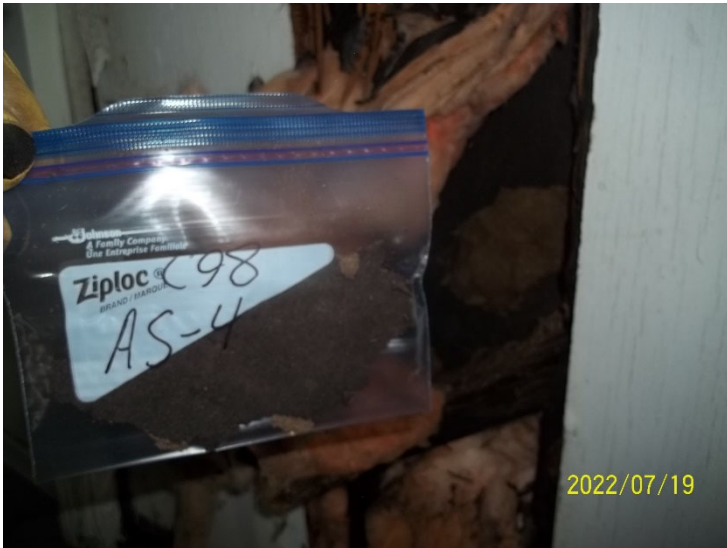
During the Pre-Demolition HBMA site visit, one (1) sample of particle board with tar paper backing (C98 AS-4), plus one (1) blind field duplicate (C98 AS-DUP1; duplicate of C98 AS-4), was collected from a wall in the accommodations cabin and analyzed for asbestos content (refer to Photo 15, Appendix B2). Asbestos was not detected in the particle board/tar paper samples.

Photo 15: View of bulk material sample C98 AS-4, particle board, cabin interior.

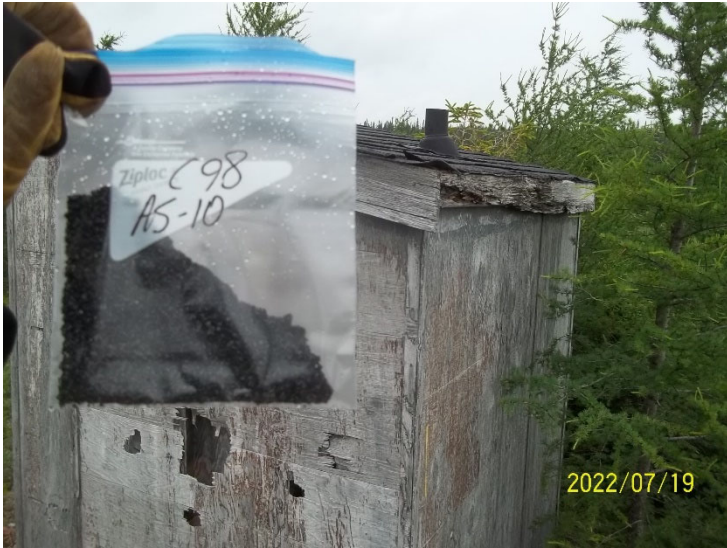
During the Pre-Demolition HBMA site visit, two (2) samples of asphalt shingle with tar paper (C98 AS-8 and C98 AS-9) were collected from the roof of the accommodations cabin and one (1) sample of asphalt shingle (C98 AS-10) was collected from the roof of the outhouse and analyzed for asbestos content (refer to Photos 19, 20 and 21, Appendix B3). Asbestos was not detected in the roofing material samples.

Photo 21: View of bulk material sample C98 AS-10, shingle, outhouse exterior.

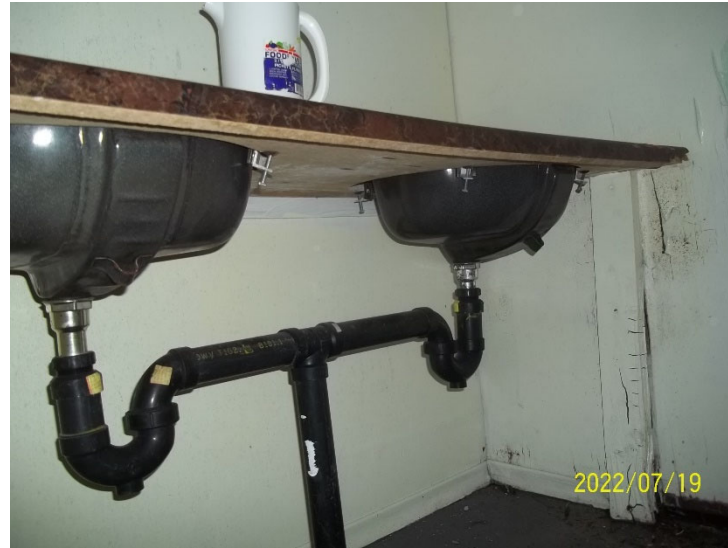
Other potential ACMs were observed (or suspected to be present) and were not sampled due to the nature of the materials and/or hazards associated with sampling these materials. These materials included, but are not limited to, electrical and mechanical components and insulators such as wiring and gaskets, caulking or sealants around or along roof seams, vent pipes, chimneys, electrical conduits or other penetrations, and undercoatings on sinks (refer to Photos 29 and 30, Appendix B3).

Photo 30: View of undercoating on sinks, cabin interior.

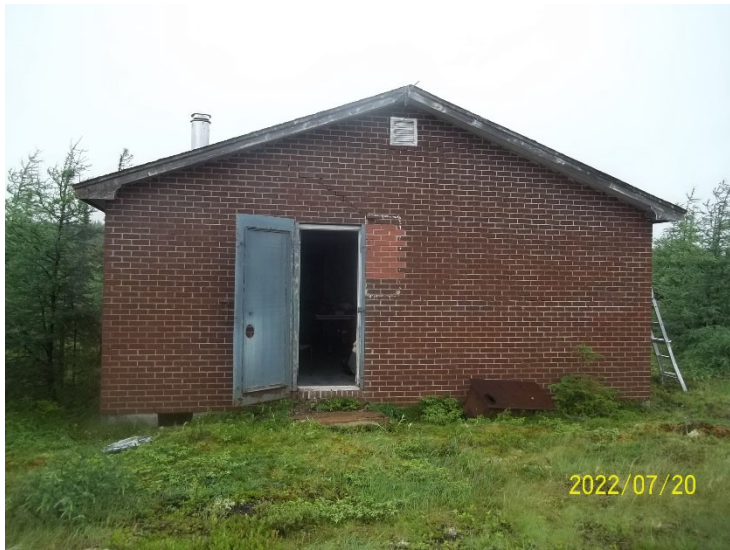
Other potential ACMs were observed (or suspected to be present) and were not sampled due to the nature of the materials and/or hazards associated with sampling these materials. These materials included, but are not limited to, electrical and mechanical components and insulators such as wiring and gaskets, caulking or sealants around or along roof seams, vent pipes, chimneys, electrical conduits or other penetrations, and undercoatings on sinks (refer to Photos 1 and 2, Appendix B4).

Photo 1: View of the accommodations cabin at Rainy Lake Camp.

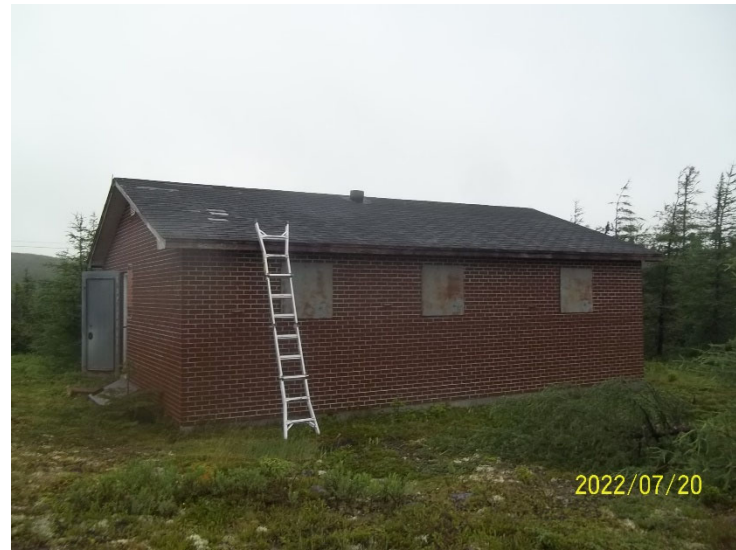
Photo 2: View of the accommodations cabin at Rainy Lake Camp.

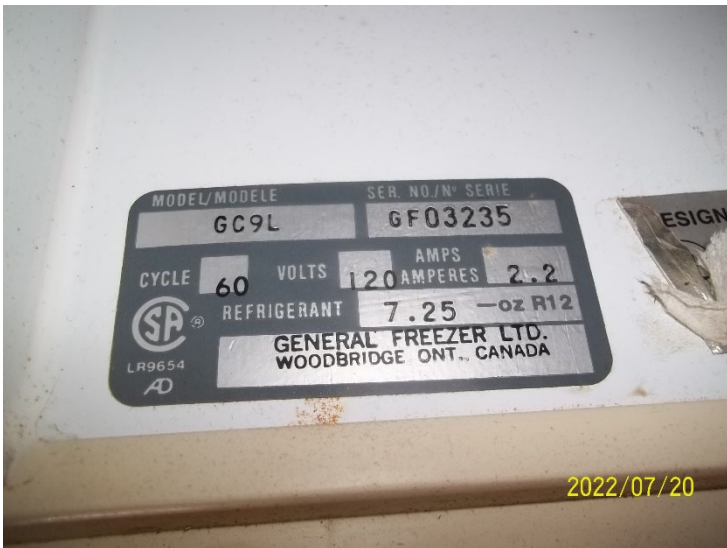
Photo 23: View of freezer label, cabin interior.

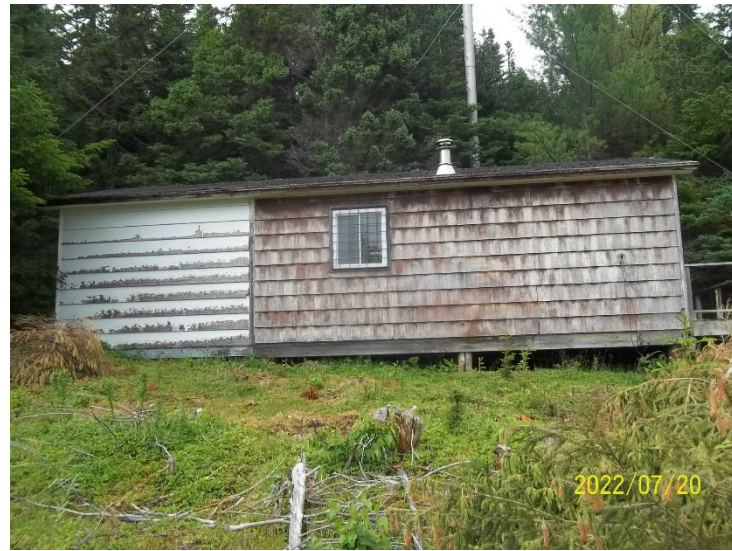
It is important to note that, due to height constraints, no samples of building materials around roof penetrations (e.g., caulking or sealants around vents or chimneys) or roof seams were collected for analysis (refer to Photo 2, Appendix B5).

Photo 2: View of the accommodations cabin at Glover Island Camp site.

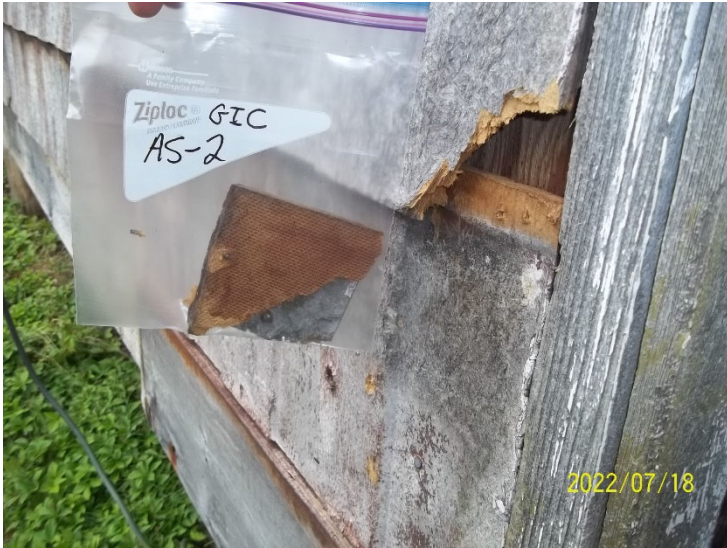
During the Pre-Demolition HBMA site visit, one (1) sample of particle board with caulking and tar paper (GIC AS-1) and one (1) sample of particle board (GIC AS-2), plus one (1) blind field duplicate (GIC AS-DUP1; duplicate of GIC AS-2), were collected from an exterior wall of the accommodations cabin and analyzed for asbestos content (refer to Photos 12 and 13, Appendix B5). Asbestos was not detected in the particle board/caulking/tar paper samples.

Photo 12: View of bulk material sample GIC AS-1, particle board with tar paper and caulking, cabin exterior.

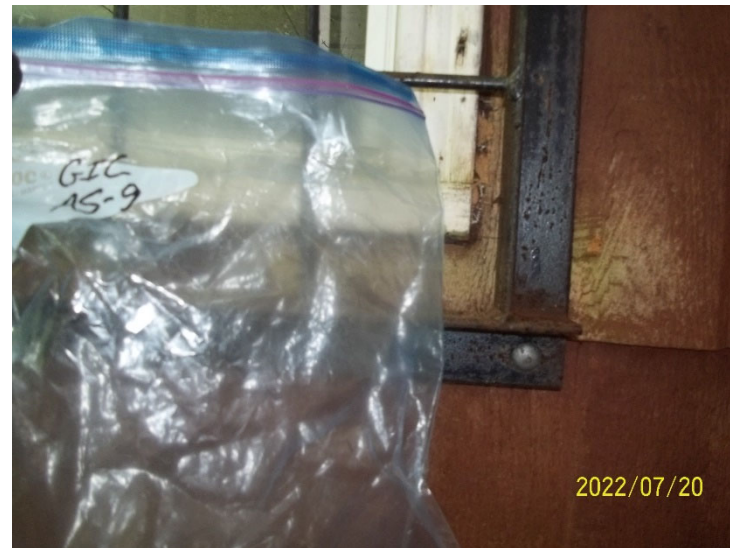
One (1) sample of putty (GIC AS-8) was collected from around a pipe penetration in the floor of the accommodations cabin and analyzed for asbestos content (refer to Photo 19, Appendix B5). Asbestos was detected in GIC AS-8 at a concentration of 9.7% chrysotile asbestos.

Photo 19: View of bulk material sample GIC AS-8, putty, cabin interior.  
**9.7% Chrysotile asbestos.**

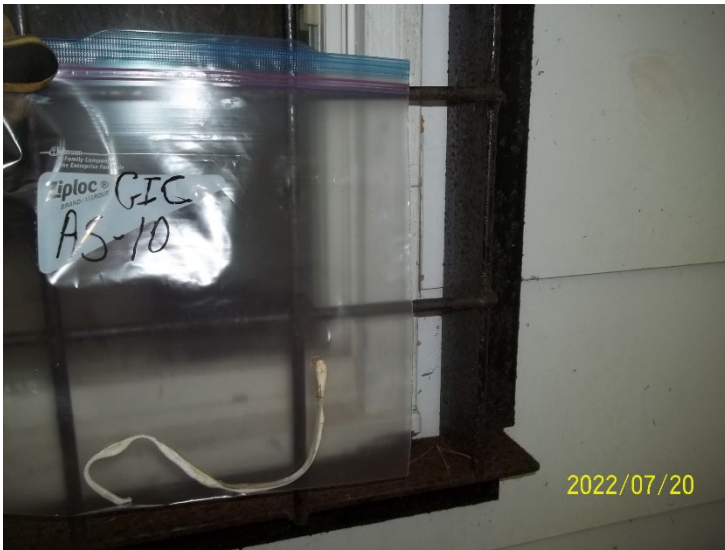
Three (3) samples of caulking (GIC AS-9, GIC AS-10 and GIC AS-11) were collected from the exterior of the accommodations cabin and analyzed for asbestos content (refer to Photos 20, 21 and 22, Appendix B5). Asbestos was not detected in the caulking samples.

Photo 20: View of bulk material sample GIC AS-9, caulking, cabin exterior.
